GROUP ELE	MODEL 2017-2018MY Sorento (UMa)
	NUMBER 165	DATE February 2019
TECHNICAL SERVICE BULLETIN		
SUBJECT: DRIVER'S DOOR MODULE LOGIC IMPROVEMENT

This bulletin provides the procedure to improve the logic of the Driver's Door Module (DDM) on some 2017-2018MY Sorento (UMa) vehicles, produced from April 4, 2016 through August 23, 2017, which may experience the absence of the Auto Door Lock/Unlock option select in the instrument cluster. To correct this concern, apply the improved logic to the DDM using the KDS ECU Upgrade function as described in this bulletin. For confirmation that the latest reflash has been applied to a vehicle you are working on, verify the ROM ID using the table on page 2 of this bulletin.

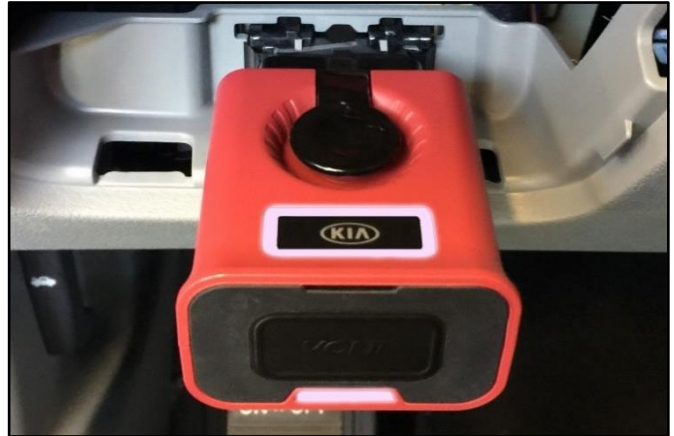
1. Connect the VCI-II to the OBD-II connector, located under the driver's side of the instrument panel.

The ECU upgrade function on KDS operates wirelessly. It is not necessary to perform the upgrade via USB cable.

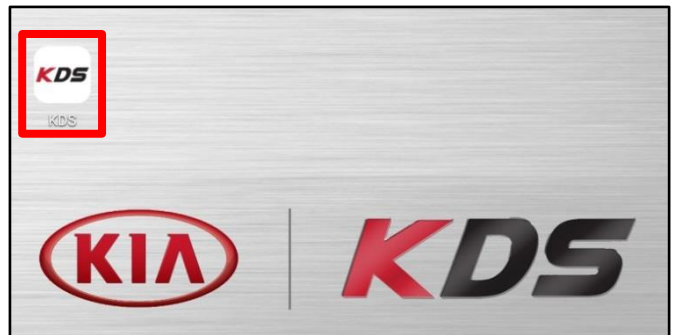
2. With the ignition ON, turn ON the KDS tablet. Select **KDS** from the home screen.
