# Technical Service Bulletin

SUBJECT:			No: <b>TSB-19-13-002</b>
<b>ENGINE STALLING IN COLD CONDITIONS WITH SPECIFIC OPERATIONS</b>			DATE: <b>February 2019</b>
			MODEL: <b>2018-2019 Eclipse Cross</b>
<b>CIRCULATE TO:</b>	<input type="checkbox"/> GENERAL MANAGER	<input checked="" type="checkbox"/> PARTS MANAGER	<input checked="" type="checkbox"/> TECHNICIAN
<input checked="" type="checkbox"/> SERVICE ADVISOR	<input checked="" type="checkbox"/> SERVICE MANAGER	<input checked="" type="checkbox"/> WARRANTY PROCESSOR	<input type="checkbox"/> SALES MANAGER

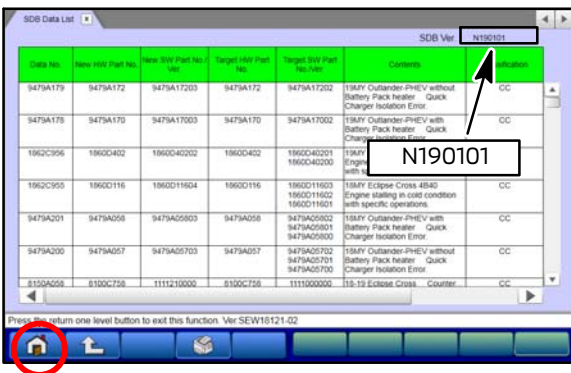
c. Click "SDB Data List."

d. Confirm that the database number displayed in the upper right above the chart is **N190101 or higher**

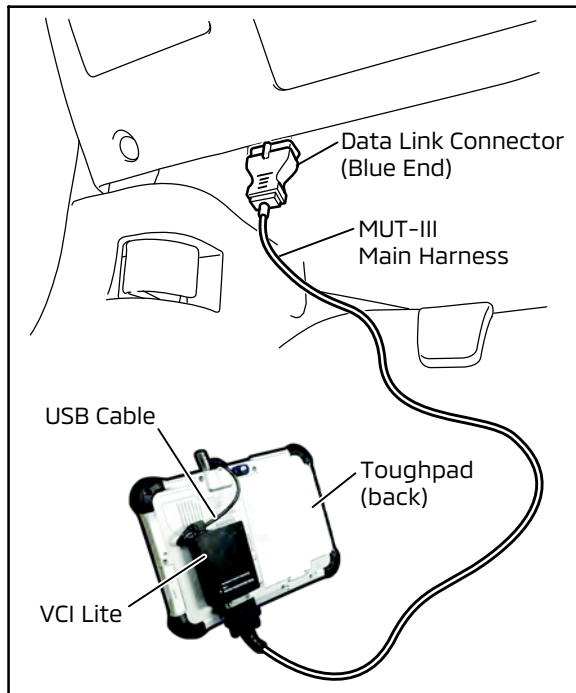
**NOTE: VCI Lite and MEDIC 4.0 Toughpad shown for illustration purposes only.**

- Turn the MEDIC PC/tablet on. If the battery indicator in the lower right hand corner of the screen does not show a full charge, it is recommended that either the battery be charged prior to beginning, or be used with the A/C power adaptor connected.
- Connect the USB cable to the VCI/VCI Lite.
- When the laptop/tablet displays the MUT-III main screen, connect the USB cable to the device.
- Connect the MUT-III main harness with the blue DLC connection to the VCI/VCI Lite.
- Connect the blue connection of the MUT-III main harness to the vehicle's data link connector.
- For VCI only (p/n MB991824): Turn the VCI power switch ON. Verify that the indicator lamp in the upper right corner of the screen is green.

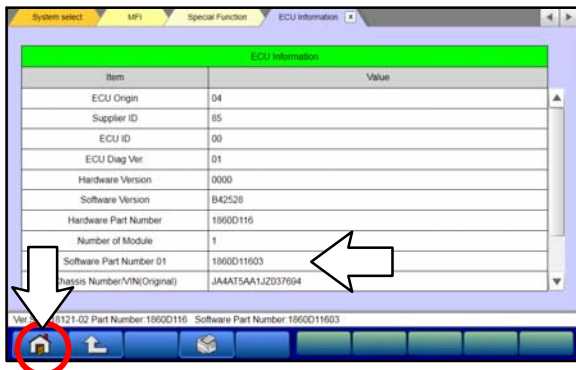
c. Select "ECU Information."

d. If the Software Part Number listed is **not** at the latest level (shown in the **"Engine ECU Reprogramming Chart"** in this TSB), proceed with the next step. Click the Home button to return to the System Select screen.

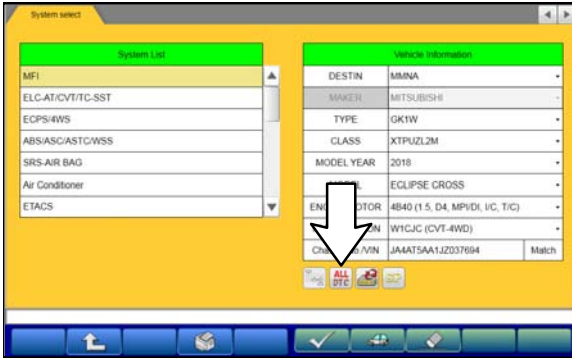
6. Before reprogramming, perform an **"Erase and Read All DTCs"** to clear any DTCs that may have set.

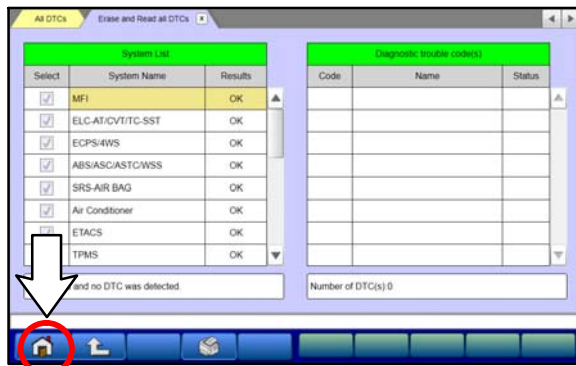
7. When DTC erasing is completed, click the check mark in the pop-up message that reads "All erasing and checks are completed."

a. If any DTCs return after erasing is completed, click the check mark to clear the window. Diagnose and repair per the Service Manual.

b. If DTCs do not return, click the check mark to clear the window, then click the Home icon in the lower left to return to the System Select menu.

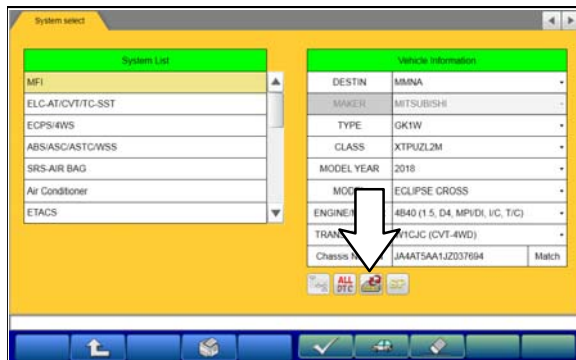
8. **Reprogram the Engine ECU** following the steps below.

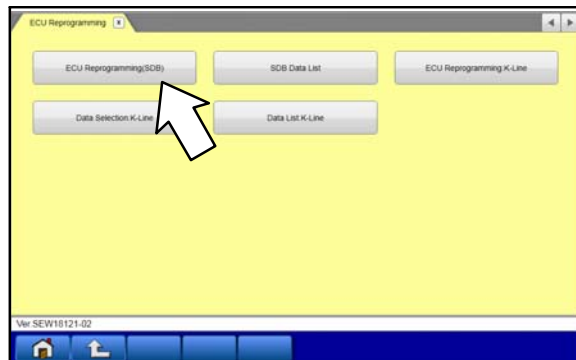
a. On the System Select page, click on the Reprogram button.

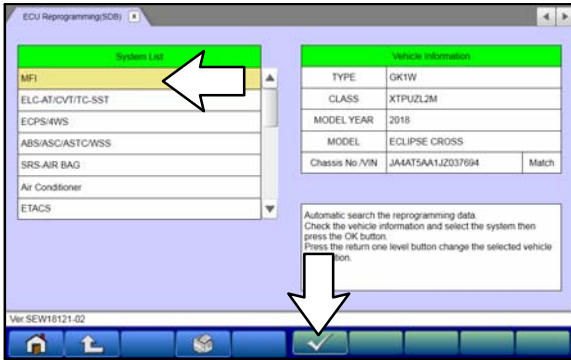
b. Select "ECU Reprogramming (SDB)."

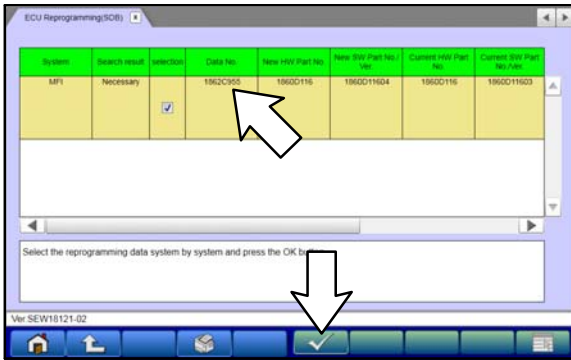
c. Select **"MFI"** in the System List, then click the check mark.

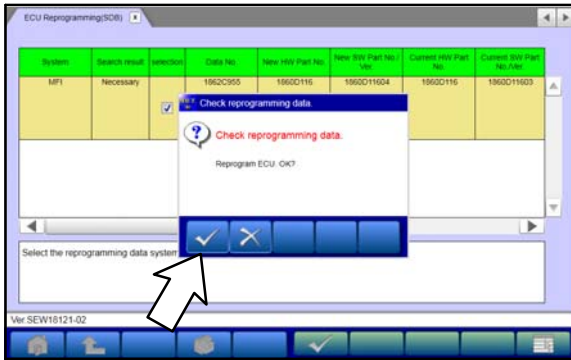
d. Verify that the correct data file listed in the table matches the one in the **"Engine ECU Reprogramming Chart."**

e. Click the check mark at the bottom of the page to initiate reprogramming.

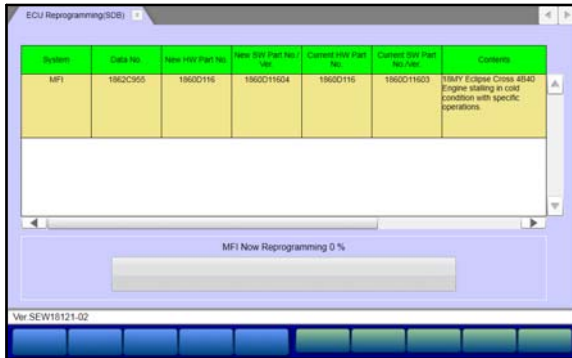
f. Click the check mark in the "Check reprogramming data" dialog box.

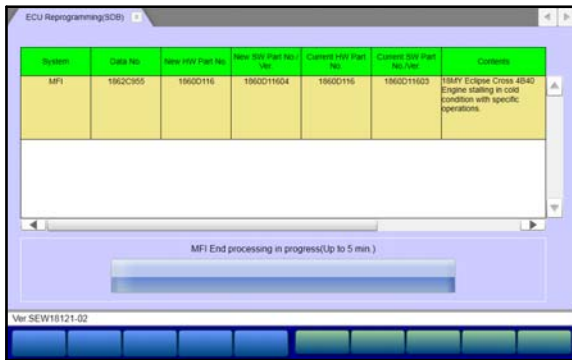
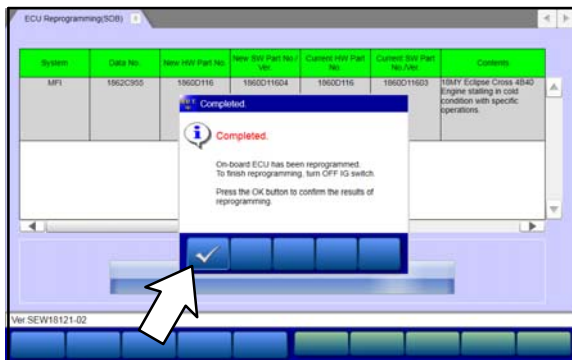
- g. Once the reprogramming is initiated, the screen shown will indicate the reprogramming progress.

**NOTE: Do NOT disturb the cables or turn off the ignition during reprogramming.**

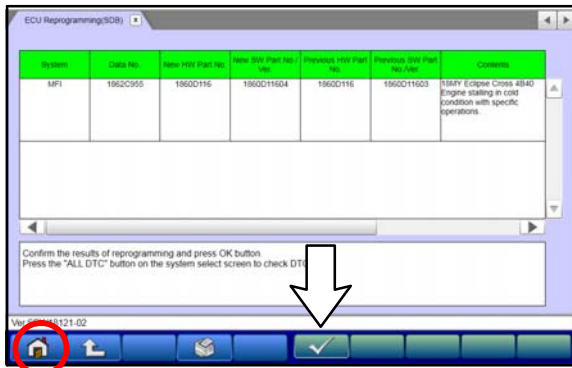
- h. Once reprogramming is completed, click the check mark in the "Completed" dialog box.

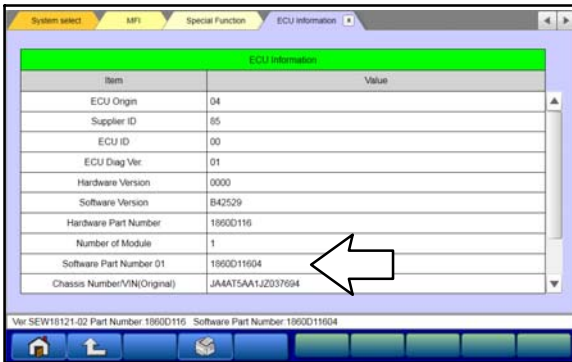
- i. Verify the correct information is listed in the table. Click the check mark at the bottom of the page, then click the Home button to return to the System Select screen.

9. Perform an "Erase and Read All DTCs" again to clear any DTCs that may have set.  
**For instructions, refer to steps 6 and 7 in this TSB.**
10. Confirm the software version has been updated.  
**For instructions, refer to step 5 in this TSB.**

Confirm "Software Part Number" now matches the NEW one shown in the **"Engine ECU Reprogramming Chart"** in this TSB.
