Quick tip

Title: Remote start with extended range

(Only applies to 2019 Tiguan LWB, Jetta, GLI built after CW36/18, Atlas built after CW42/2018)

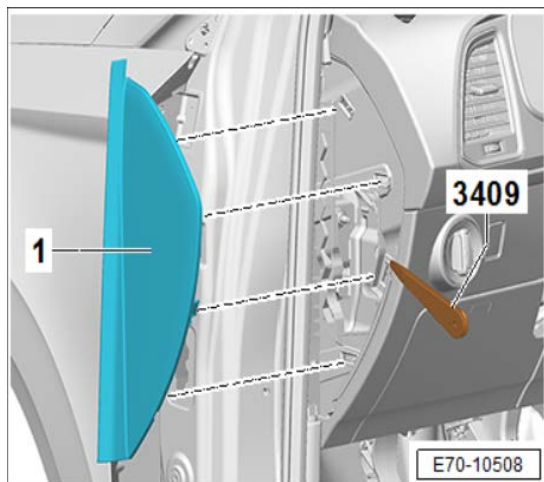
Step 1:

- Bend the door seal molding outward in the instrument panel cover area.
- Pry out the instrument panel side cover -1- with the -3409- near the catches.
- Pull the cover toward the rear and remove it.

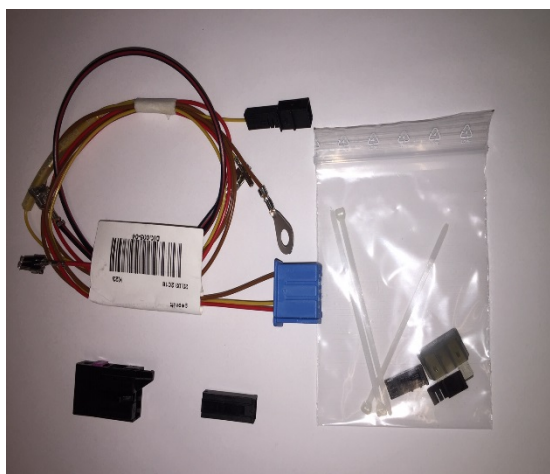
Step 7:

- Insert red wire into the fuse holder.
- Insert black/red wire into fuse holder.
- Insert the 2-amp fuse into the fuse holder.
- Insert the red/black wire into the connector.
