LEAF Instrument Panel Dealer Inventory

Reference: PC685
Date: March 15, 2019

INSTRUMENT PANEL REPLACEMENT

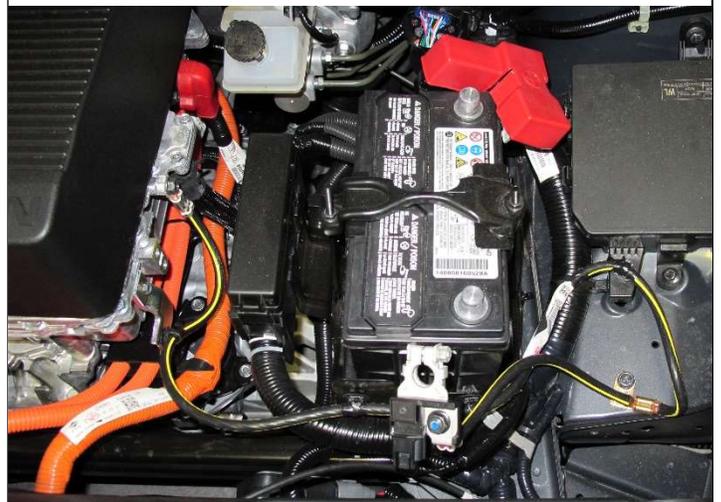
Figure 1

1. Disconnect both of the 12V battery terminals. (Figure 1)
 - Open the hood
 - Disconnect both terminals from the 12V battery
 - Wait at least 3 minutes

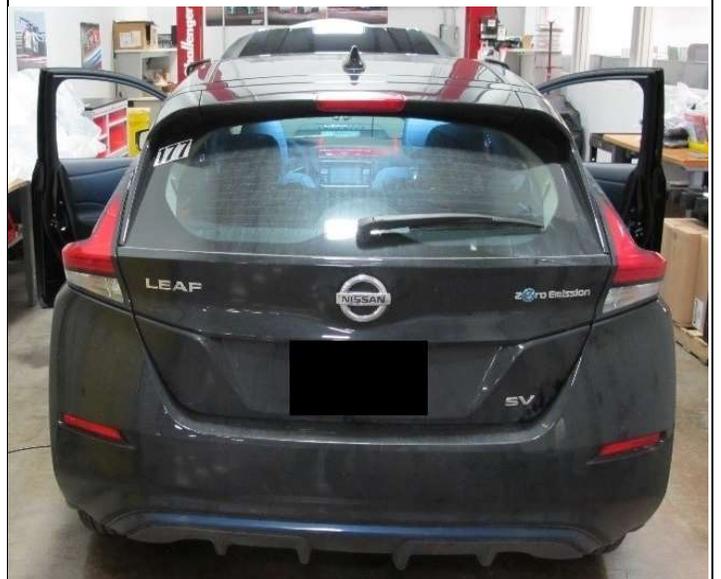
Figure 2

2. Open both front doors. (Figure 2)

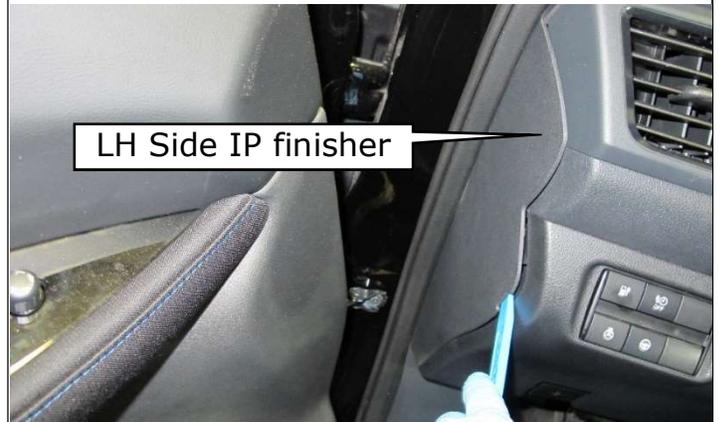
Figure 3

3. Remove the side IP finishers with a suitable tool.

- LH (Figure 3)
- RH (Figure 4)

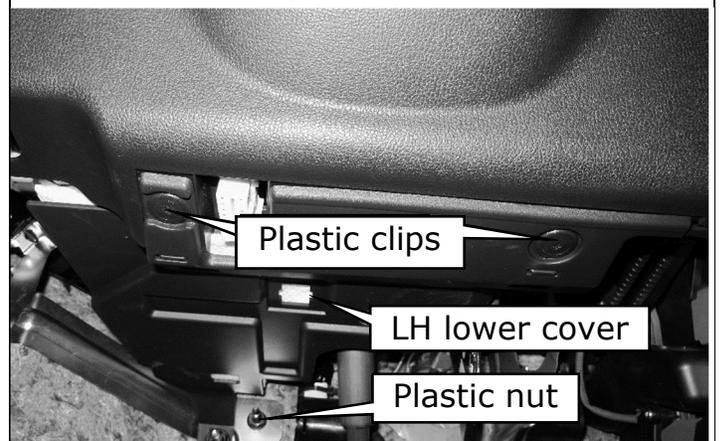
Figure 5

4. Remove the LH lower cover. (Figure 5)

- Remove the (2) clips
- Remove the plastic nut
- Remove the LH lower cover

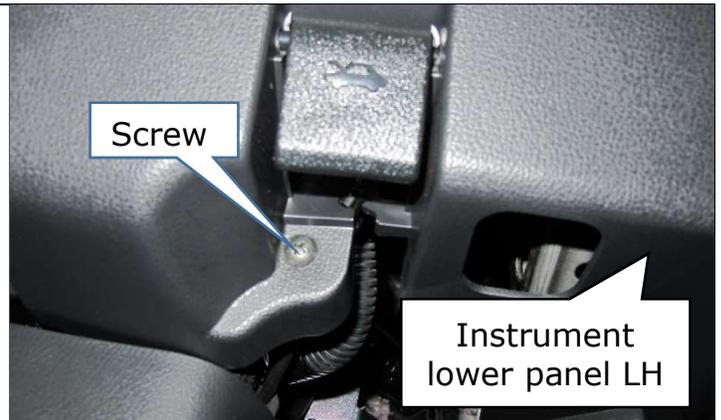
Figure 6

5. Remove the instrument lower panel LH.

- Remove the screw near the hood release lever (Figure 6)
- Using a suitable tool depress the (2) hood lock release cable tabs, rotate the cable downward and remove the cable from the hood lock release handle (Figure 7)
- Release the instrument lower panel LH using a suitable tool
- Disconnect the aspirator hose (Figure 8)
- Disconnect harness connectors (Figure 8)
- Using a suitable tool, depress the (2) connector retainers and remove the DLC from the instrument lower panel (Figure 8)
- Remove the instrument lower panel

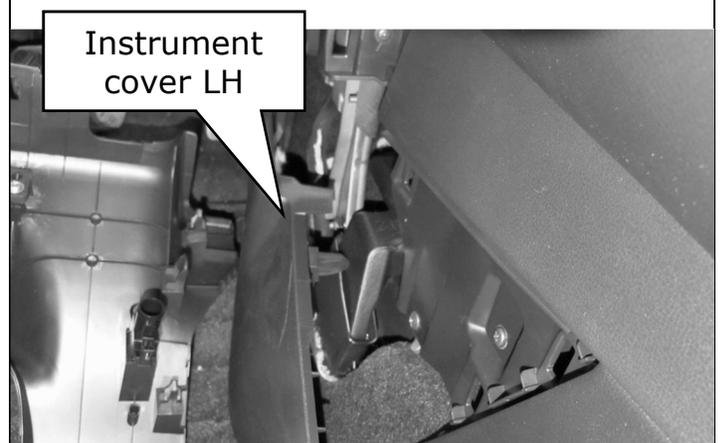
Figure 9

6. Remove both of the instrument covers LH/RH. (Figure 9)

- Using a suitable tool release the instrument lower covers
- Leave the instrument lower covers pulled away for the remainder of the repair

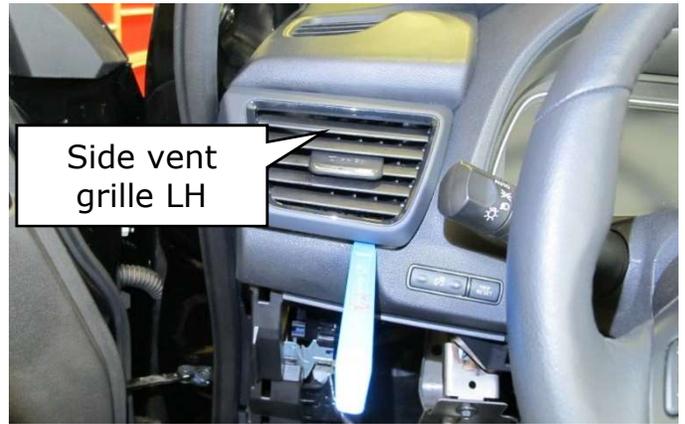
Figure 10

7. Remove side ventilator grille LH.

- Using a suitable tool remove the side ventilator grille LH. (Figure 10)

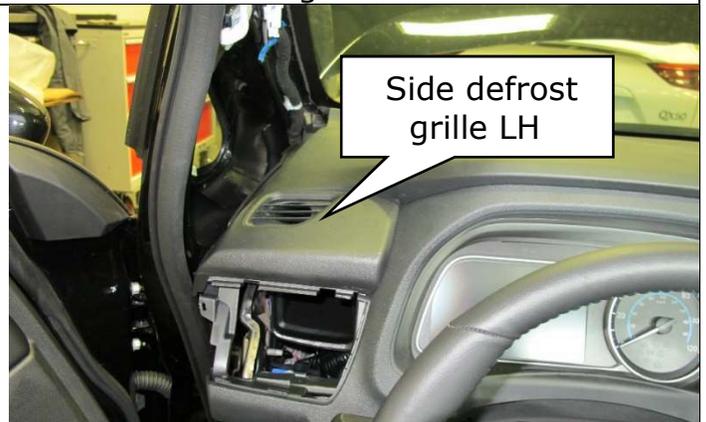
Figure 11

8. Remove the side defrost grille LH. (Figure 11)

- Using a suitable tool, remove the side defrost grille LH

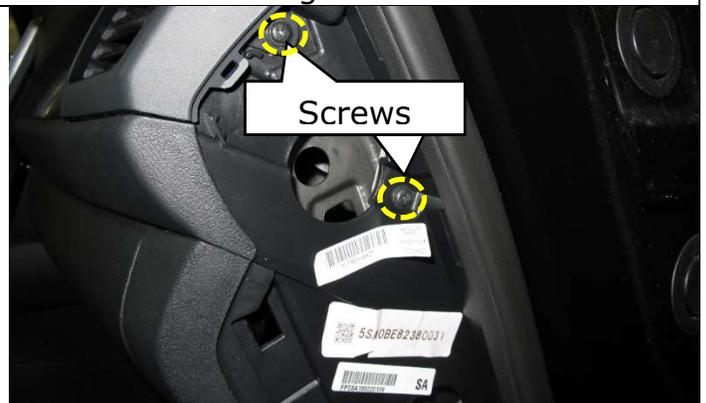
Figure 12

9. Remove the side ventilator grille RH.

- Remove the (2) screws from the RH side of the instrument panel (Figure 12)
- Using a suitable tool, release the side ventilator grille RH (Figure 13)
- Remove the side ventilator grille RH

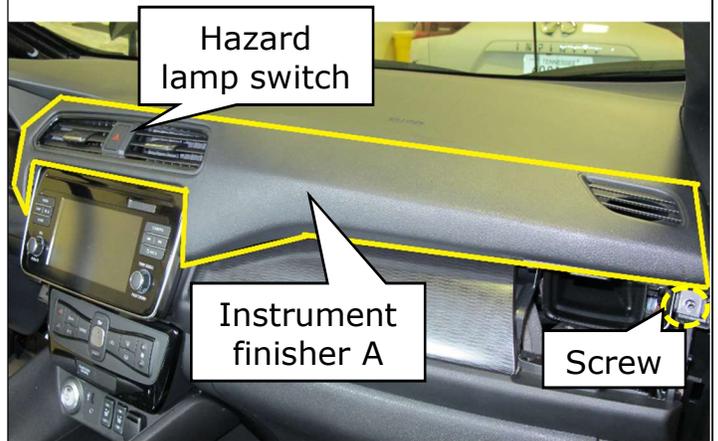
Figure 14

10. Remove instrument finisher A.

- Remove the screw located on the RH side of finisher A
- Starting on the RH side of the finisher, use a suitable tool to release the instrument finisher A (Figure 14)
- Disconnect the hazard lamp switch electrical connector
- Remove the instrument finisher A

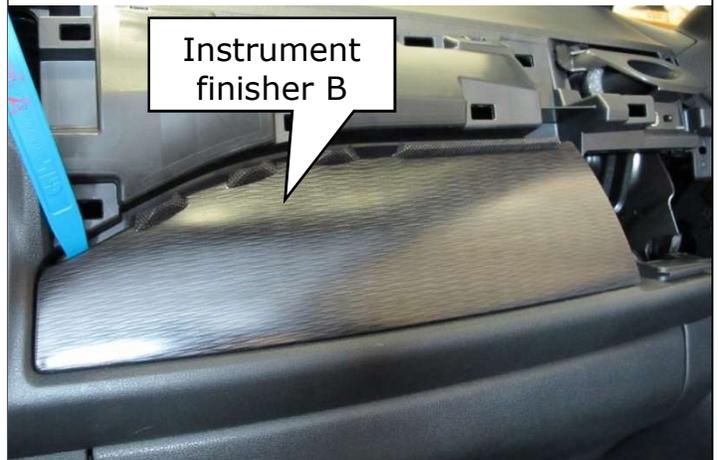
Figure 15

11. Remove instrument finisher B.

- Starting on the LH side of the finisher, use a suitable tool to release the instrument finisher B pawls (Figure 15)
- Remove the instrument finisher B

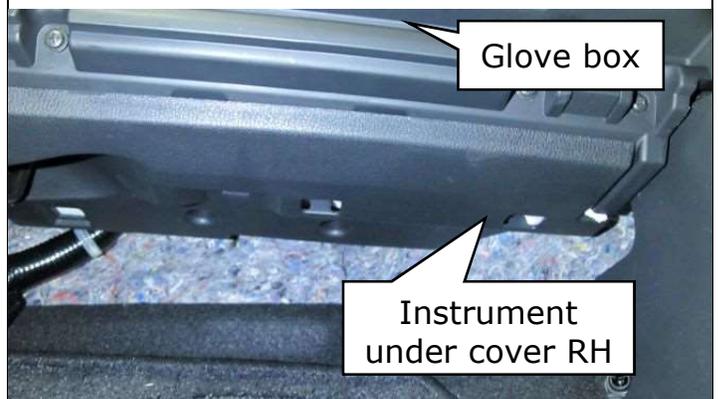
Figure 16

12. Remove instrument under cover RH. (Figure 16)

- Pull downward on the instrument under cover RH to disengage the pawls
- Remove the instrument under cover RH

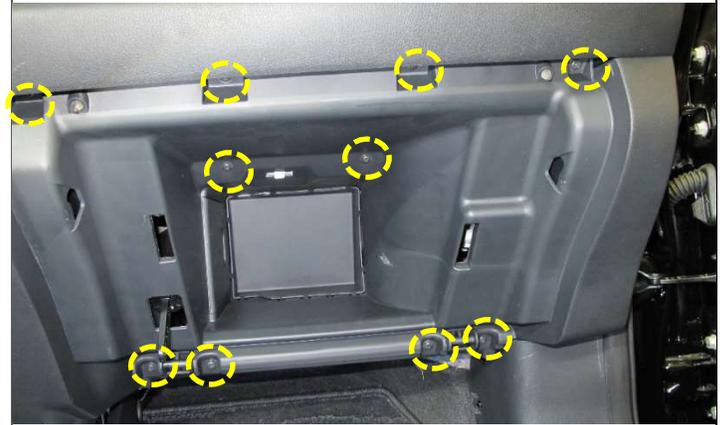
Figure 17

13. Remove the glove box cover assembly.
(Figure 17)

- Remove (10) screws from the glove box assembly
- Partially remove the glove box assembly
- Disconnect the glove box lamp connector
- Remove glove box assembly

Note: Glove box lid removed to show screw locations.

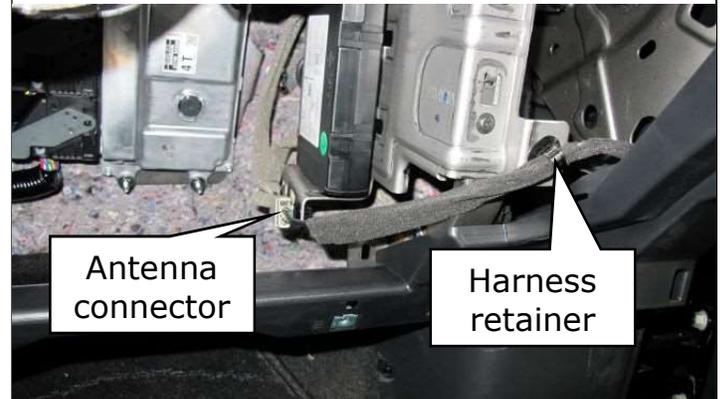
Figure 18

14. Disconnect the antenna connector.
(Figure 18)

- Using a suitable tool, separate the antenna harness retainer from the instrument panel support bar located behind glove box assembly
- Disconnect the antenna connector

Note: Antenna harness will be removed with the instrument panel.

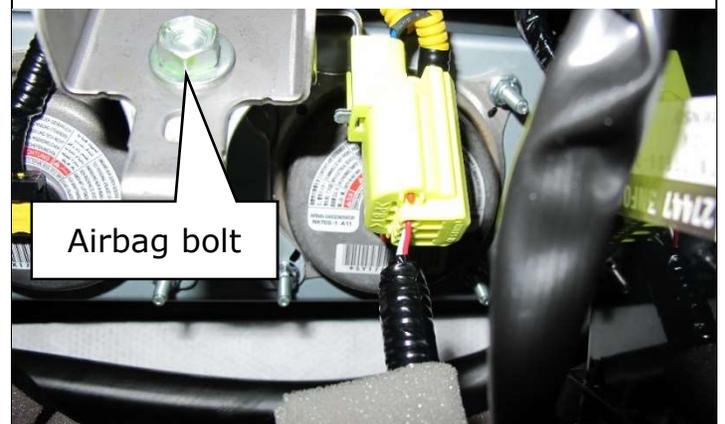
Figure 19

15. Remove the passenger airbag bolt.

- Using a suitable tool, remove the bolt for the passenger airbag (Figure 19)
- Discard bolt (One time use only)

Note: A new bolt will be used during reassembly.

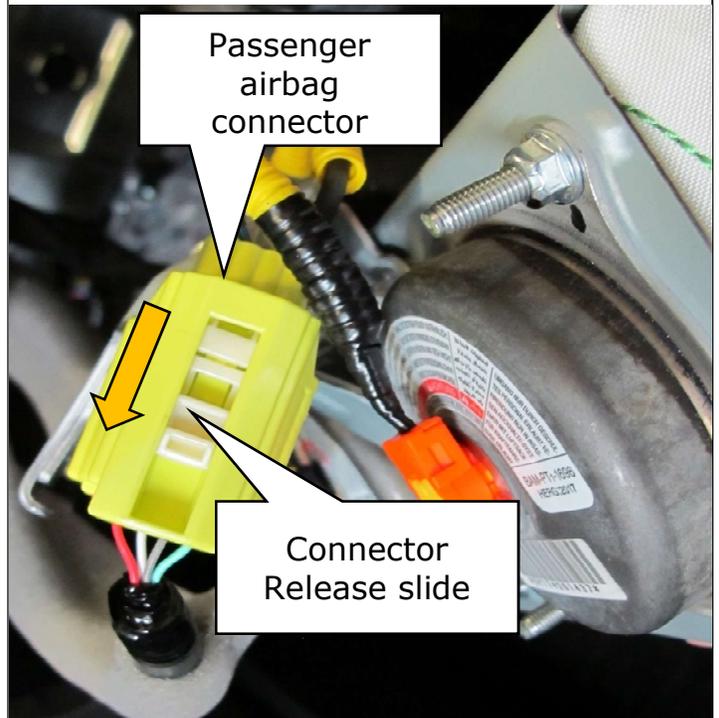
Figure 20

16. Disconnect the passenger airbag electrical connector.

- Slide the white portion of the connector release downward while providing light downward force to release the connector (Figure 20)

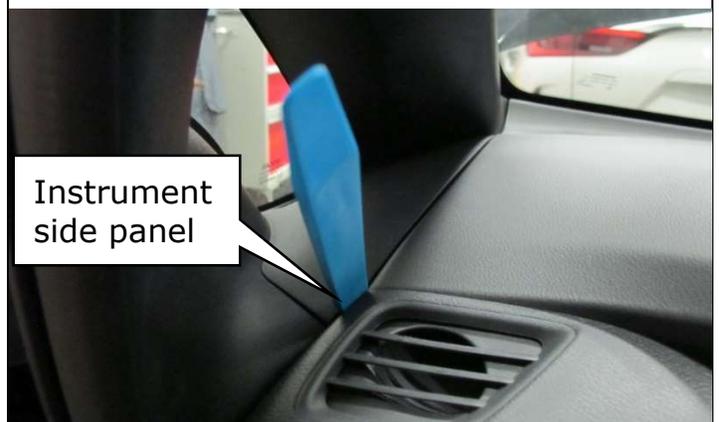
Figure 21

17. Remove both instrument side panels LH/RH. (Figure 21)

- Release the instrument side panel pawls using a suitable tool

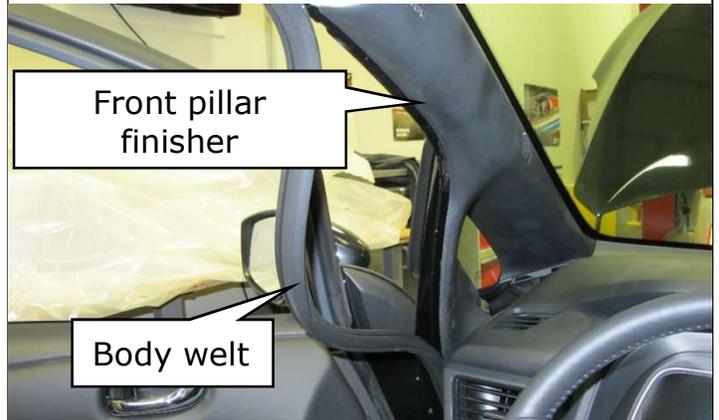
Figure 22

18. Remove both front pillar finishers LH/RH.

- Partially remove the front body side welt (Figure 22)
- Release front pillar finisher metal clip
- Cut the green anchor clip using a suitable tool (Figure 23)
- Pull the front pillar finisher toward the rear of the vehicle
- Disconnect the tweeter harness connector (if equipped) (Figure 23)
- Remove the front pillar assembly
- Using a suitable tool remove the anchor clip from the front pillars and discard

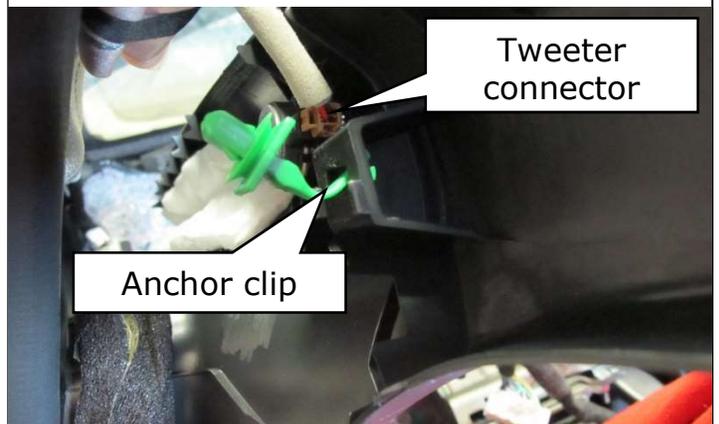
Figure 23

Note: New anchor clips will be used during reinstallation.

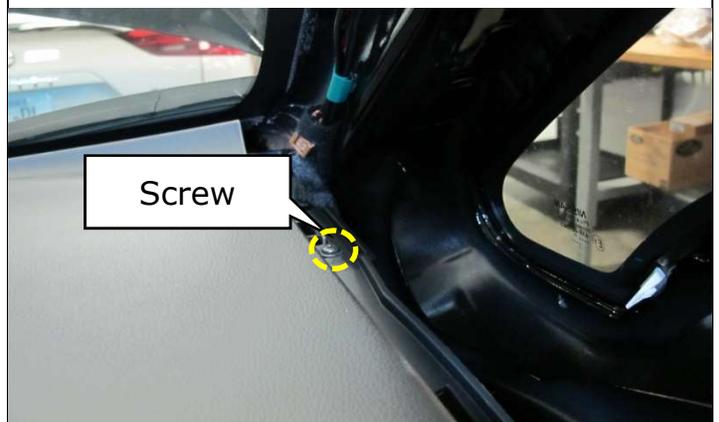
Figure 24

19. Remove screws from the instrument panel. (Figure 24)

- Using a suitable tool remove the (2) screws from the instrument panel located under front pillar finishers

Note: There is one screw on each side of the instrument panel.

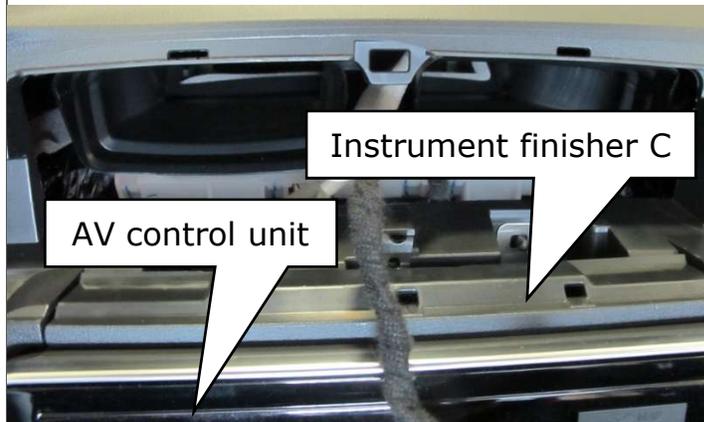
Figure 25

20. Remove instrument finisher C.
(Figure 25)

- Using a suitable tool, apply upward pressure to release pawls
- Remove instrument finisher C

Note: Instrument finisher C is located directly above the AV control unit.

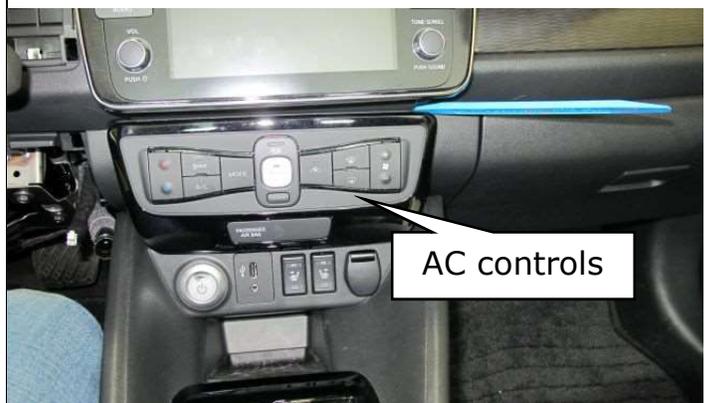
Figure 26

21. Remove AC controls. (Figure 26)

- Using a suitable tool, starting at the top RH corner apply outward force to remove the AC controls
- Disconnect the AC controls electrical connector (Figure 27)
- Disconnect the passenger airbag indicator connector (Figure 27)

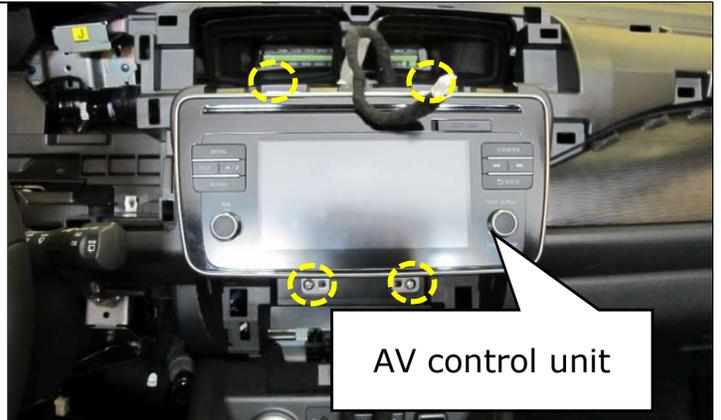
Figure 28

22. Remove the AV control unit.

- Remove the (4) screws from the AV control unit (Figure 28)
- Partially remove the AV control unit
- Disconnect all electrical connections from the AV control unit (Figure 29)
- Remove the AV control unit

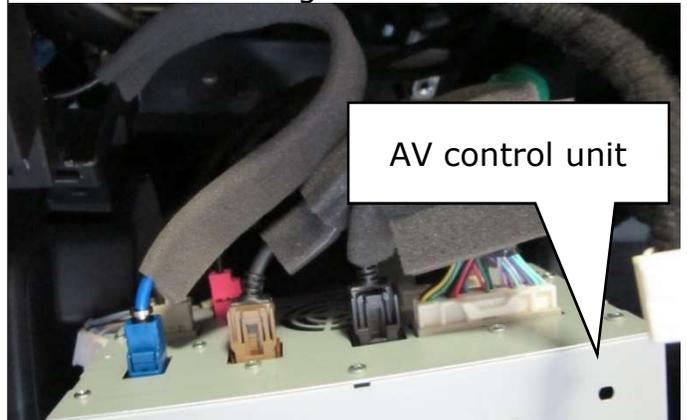
Figure 29

Note: AV control unit connections may differ from what is shown in Figure 29, depending on the vehicle trim options.

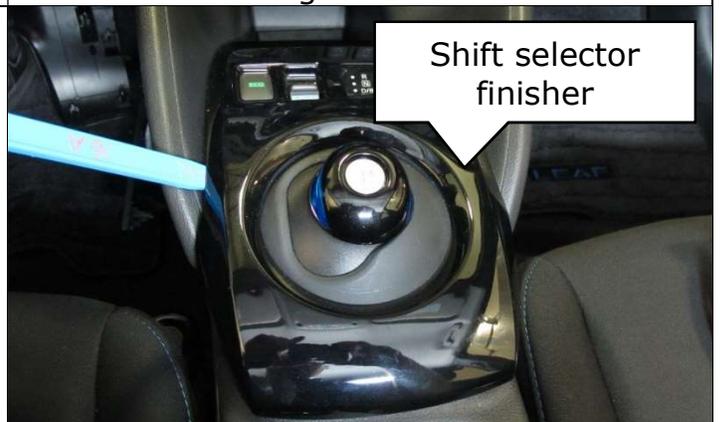
Figure 30

23. Remove the shift selector finisher. (Figure 30)

- Using a suitable tool, apply upward force to remove the shift selector finisher
- Lift the shift selector finisher up slightly to gain access to the electrical connections
- Disconnect the electrical connections (Figure 31)
- Remove the shift selector finisher

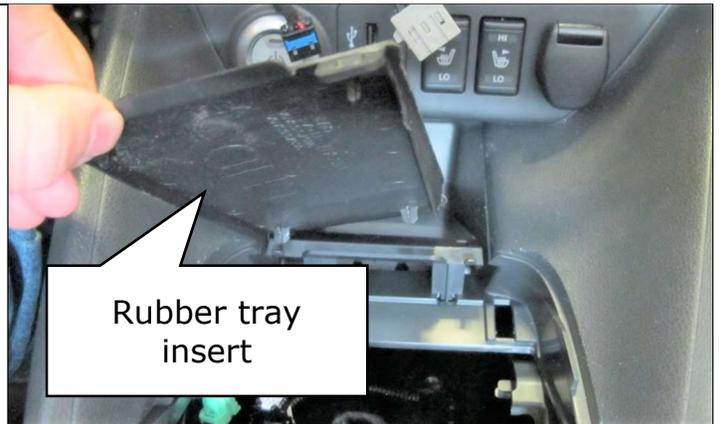
Figure 32

24. Remove the instrument lower center tray.

- Remove the rubber tray insert (Figure 32)
- Using suitable tool, lift upward to release the instrument lower center tray (Figure 33)
- Remove the instrument lower center tray

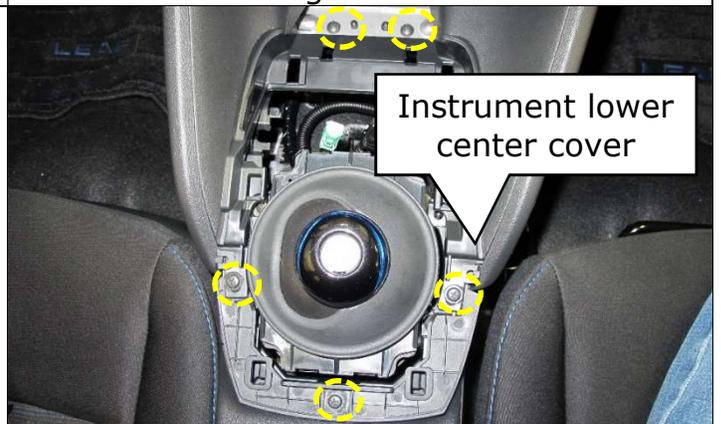
Figure 34

25. Remove instrument lower center cover.

- Remove the (5) screws (Figure 34)
- Lift the instrument lower center cover upward to release
- Disconnect all electrical connections (Figure 35)

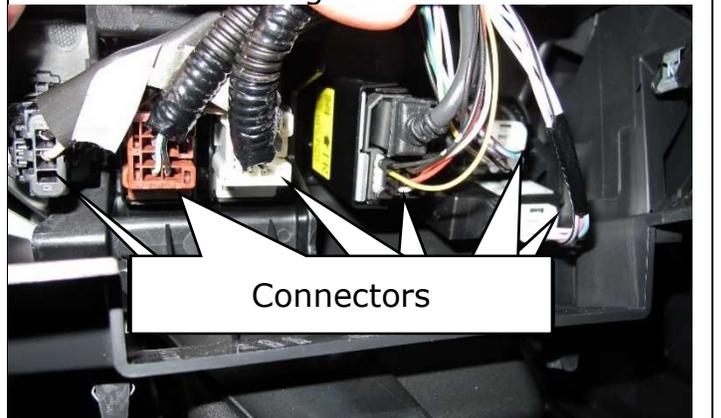
Figure 35

Note: Vehicles **NOT** equipped with heated seats, will have fewer

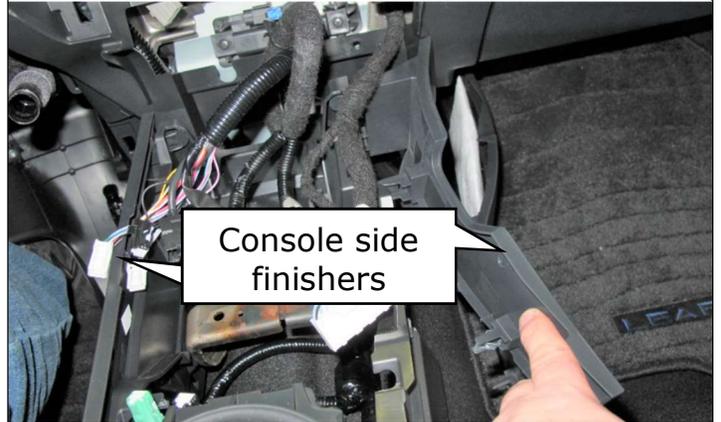
Figure 36

26. Remove console side finishers RH/LH. (Figure 36)

- Using a suitable tool, gently apply outward pressure to release finisher
- Remove the console side finishers

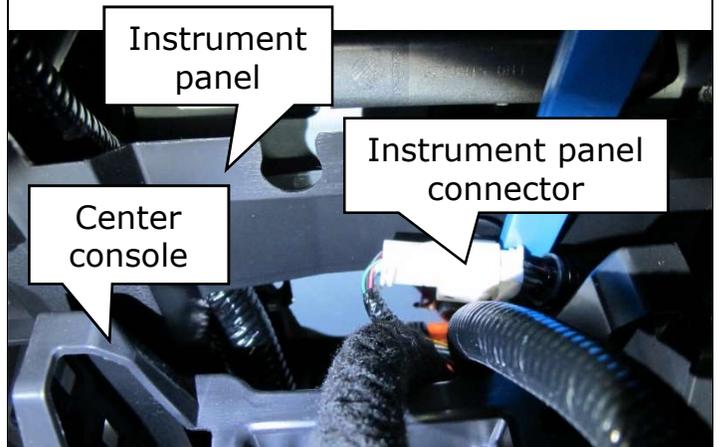
Figure 37

27. Remove harness connectors from the instrument panel. (Figure 37)

- Using suitable tool, gently remove the instrument panel harness connector from the instrument panel

Note: The instrument panel connector is located directly above the center console.

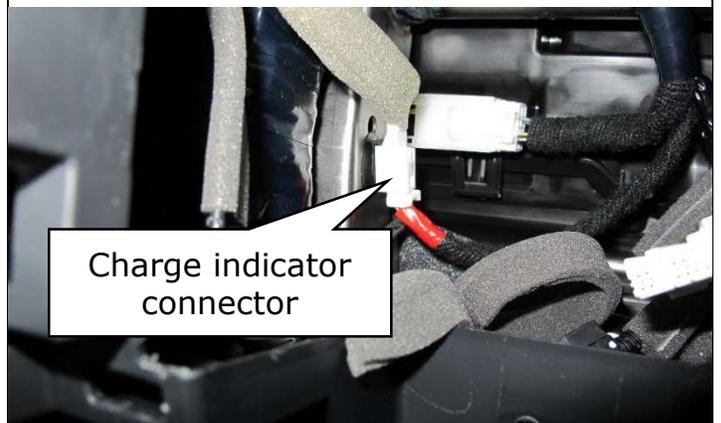
Figure 38

- Using a suitable tool, separate the charge indicator harness connector from the instrument panel support bar located behind the audio unit (Figure 38)
- Disconnect the charge indicator connector

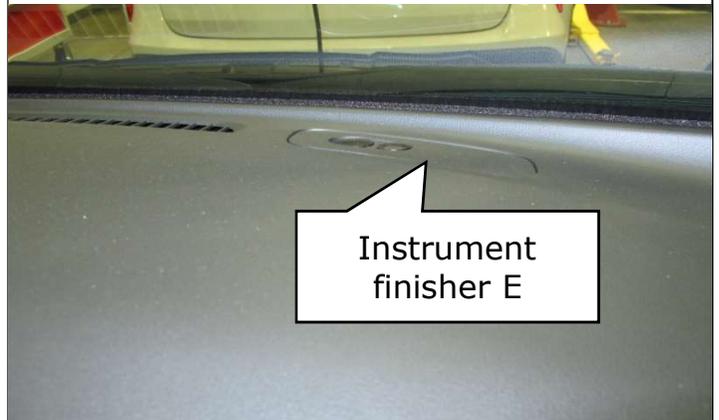
Figure 39

28. Remove instrument finisher E.
(Figure 39)

- Using a suitable tool, apply upward force on the instrument finisher E to disengage the panel
- Lift upward slightly and rotate to gain access to the electrical connector(s) (Figure 40)
- Disconnect the electrical connector(s)
- Remove the instrument finisher E

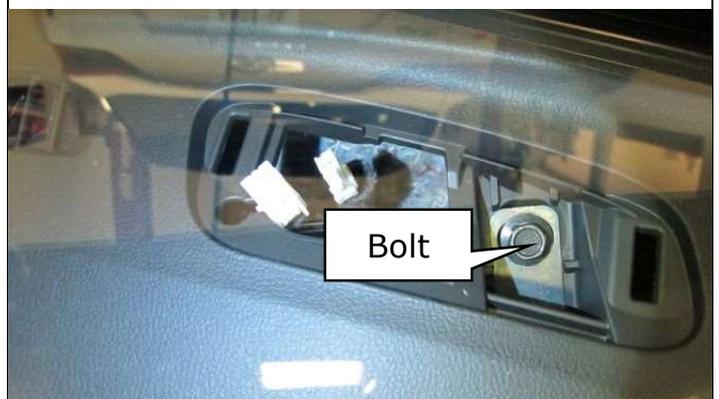
Figure 41

29. Remove the instrument panel bolt.
(Figure 41)

- Remove the bolt located under the instrument finisher E

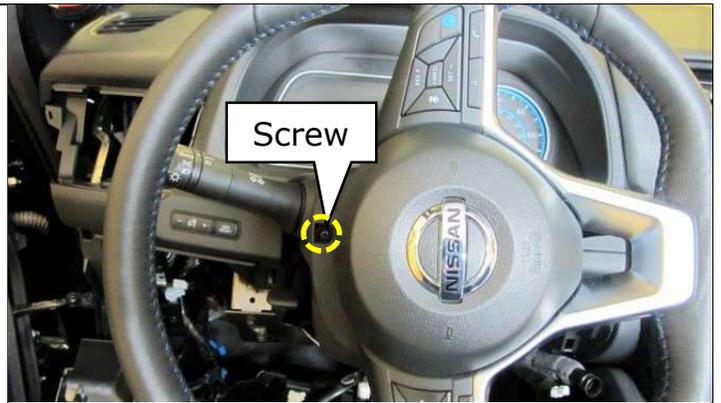
Figure 42

30. Remove the upper and lower steering column covers.

- Rotate the steering wheel 90° to the left
- Remove the screw in the steering column cover (Figure 42)
- Rotate the steering wheel 180° to the right and remove the second steering column screw
- Using a suitable tool carefully separate the upper steering column cover from the lower (Figure 43)
- Remove the upper steering column cover
- Lower the steering column tilt lever
- Carefully pull downward on the lower steering column cover to remove

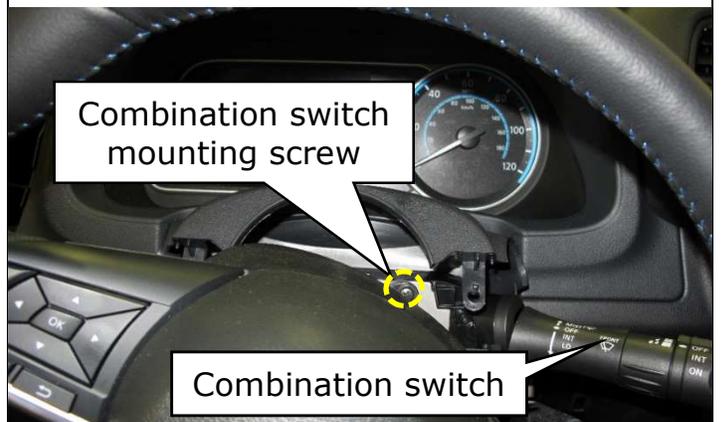
Figure 44

31. Remove the combination switch assembly.

- Rotate the steering wheel slightly to the right to access the combination switch mounting screw (Figure 44)
- Remove the mounting screw
- Rotate the steering wheel slightly to the left to access the second combination switch mounting screw
- Remove the mounting screw
- Lift upward on the combination switch
- Disconnect the electrical connector (Figure 45)
- Remove the combination switch

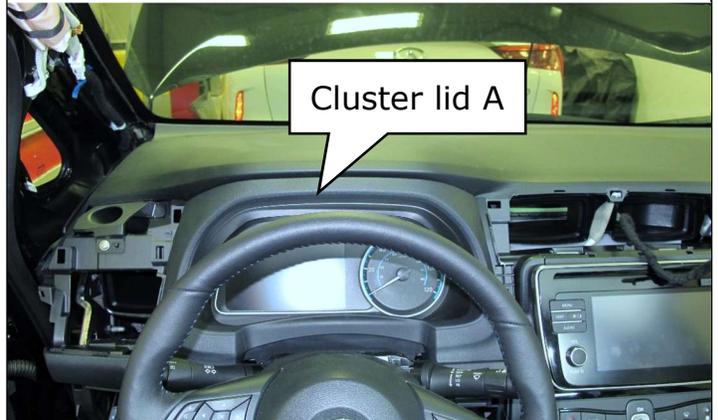
Figure 46

32. Remove cluster lid A. (Figure 46)

- Carefully pull cluster lid A toward the rear of the vehicle to disengage cluster lid A pawls
- Disconnect dimmer switch electrical connector
- Remove cluster lid A

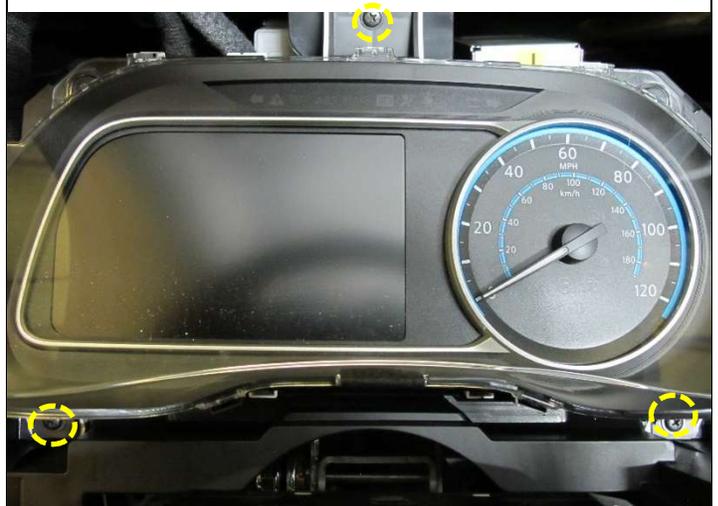
Figure 47

33. Remove the combination meter.

- Remove the (3) combination meter screws (Figure 47)
- Carefully move the combination meter back to gain access to the electrical connectors
- Disconnect the electrical connectors
- Remove the combination meter

Caution: Be careful to not scratch the lens.

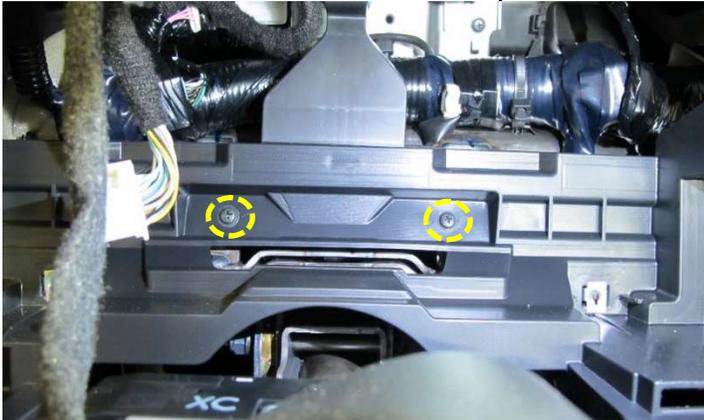
Figure 48

34. Remove the instrument panel screws.

- Remove the (2) instrument panel screws behind the combination meter (Figure 48)
- Remove the screw from the LH side of the instrument panel (Figure 49)
- Remove the instrument panel screw from behind the instrument panel lower LH (Figure 50)
- Remove the instrument panel screw to the left of the center console (Figure 51)

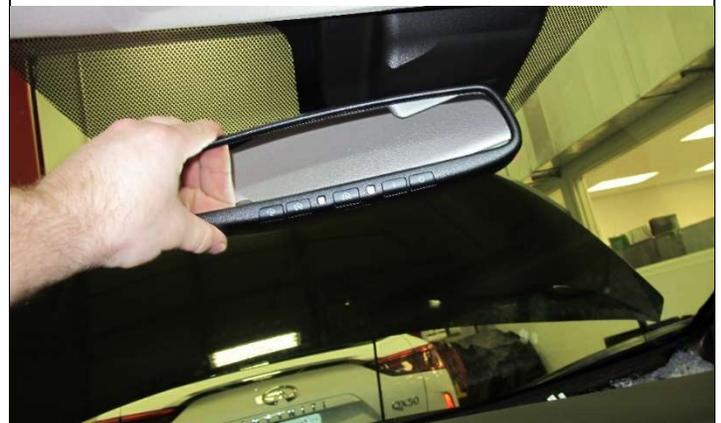
Figure 52

35. Rotate the rearview mirror upward.
(Figure 52)

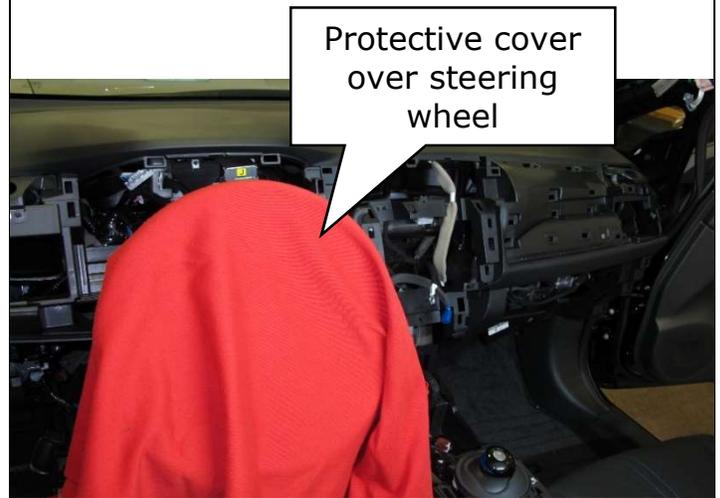
Figure 53

Caution: Place a protective covering over the steering wheel to prevent damage. (Figure 53)

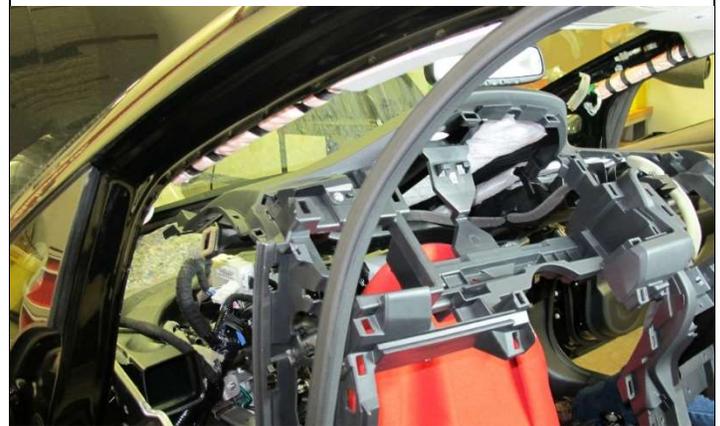
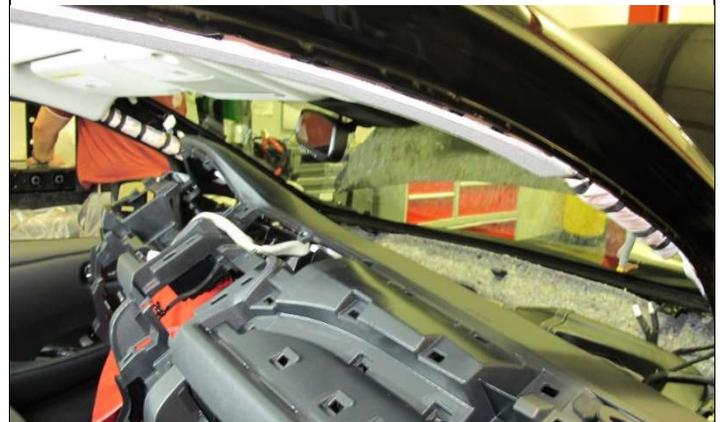
36. Remove the instrument panel.

- Lift the instrument panel upward
- Rotate the right side of the instrument panel back and move the left side over the steering wheel as shown in Figures 54 and 55.
- Remove the instrument panel from the vehicle

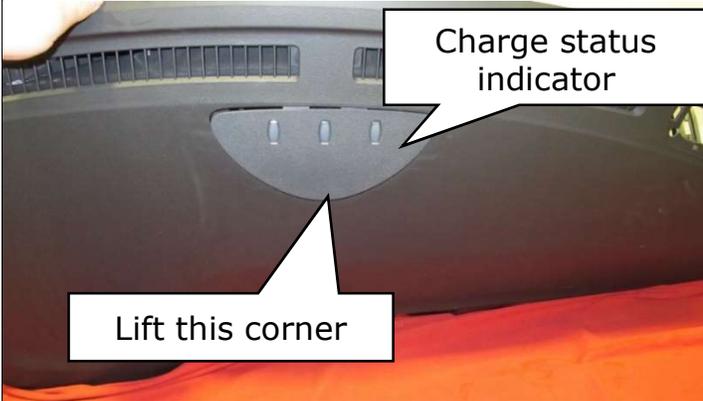
Figure 56

37. Remove the charge status indicator.

- Using a suitable tool, carefully lift upward at the corner noted in (Figure 56)
- Slide the charge indicator away from the defrost vents
- Disconnect the electrical connector for the charge status indicator (Figure 57)

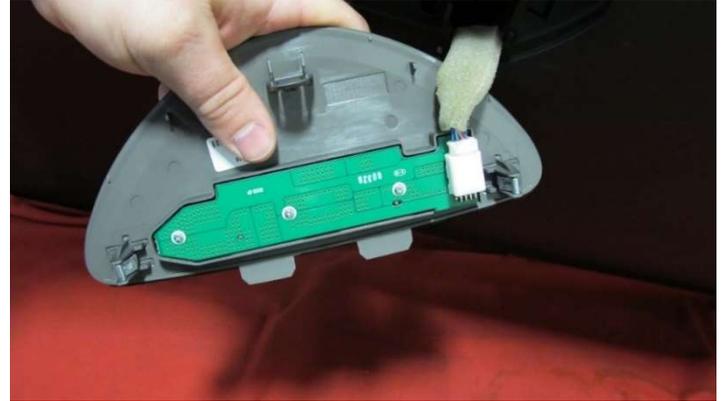
Figure 57

Note: Charge indicator sub-harness will remain on the instrument panel. A new sub-harness is provided on the new instrument panel.

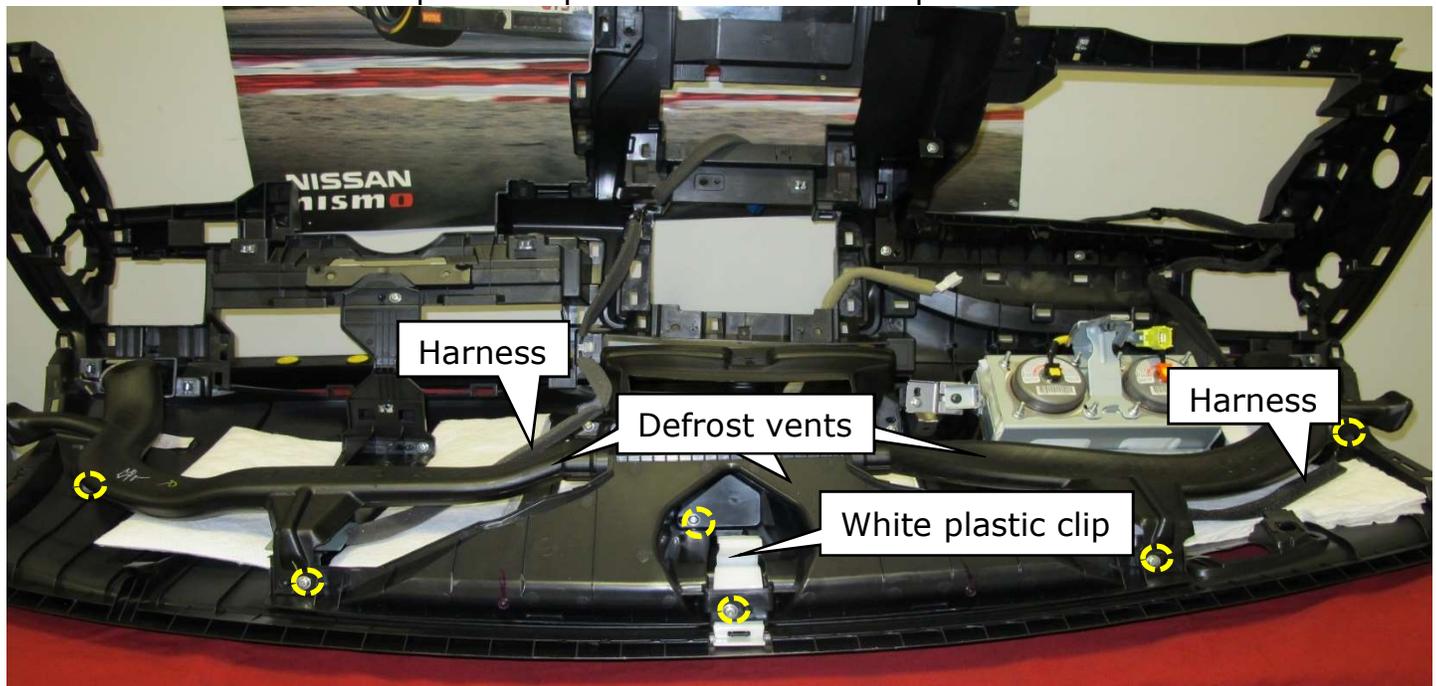
Figure 58

38. Remove the defrost vents. (Figure 58)

- Remove the (6) screws from the defrost vents
- Disconnect the antenna harnesses (if equipped) from the instrument panel
- Remove the (3) defrost vents
- Remove the white plastic clip from the instrument panel

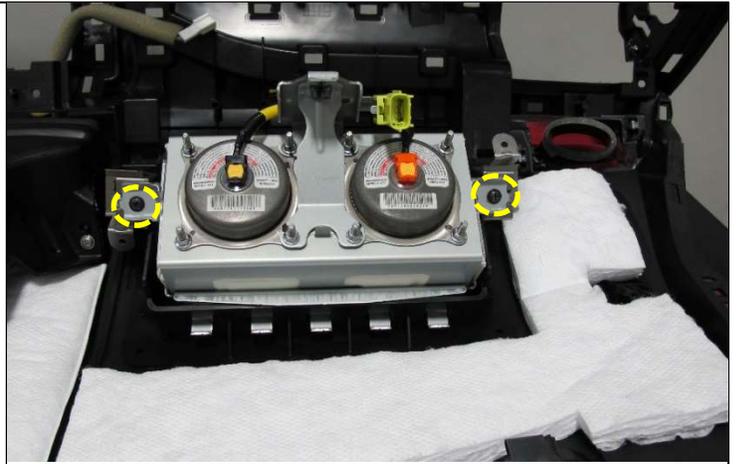
Figure 59

39. Remove the passenger airbag assembly.

- Remove the (2) screws from the passenger airbag (Figure 59)
- Push down on the airbag assembly
- Using suitable tool separate the instrument panel from the airbag assembly
- Rotate the airbag assembly toward the defrost portion of the instrument panel (Figure 60)
- Remove the airbag assembly
