Service Action

Code: 90L2

Subject	Driver Assist System Software
Release Date	April 04, 2019
Affected Vehicles	U.S.A. & CANADA: Certain 2019 MY Audi A6, A7, A8 and Audi Q8 <i>Check Campaigns/Actions screen in Elsa on the day of repair to verify that a VIN qualifies for repair under this action. Elsa is the <u>only</u> valid campaign inquiry & verification source.</i> <ul style="list-style-type: none">✓ Campaign status must show "open."✓ If Elsa shows other open action(s), inform your customer so that the work can also be completed at the same time the vehicle is in the workshop for this campaign.
Problem Description	In affected vehicles, it is possible to have the following software-related issues with adaptive cruise (driver assist system): <ul style="list-style-type: none">- Loss of target object at close range and erroneous drive-off warning in stop-and-go traffic- Occasional restrictions to comfort when driving over crests or through dips

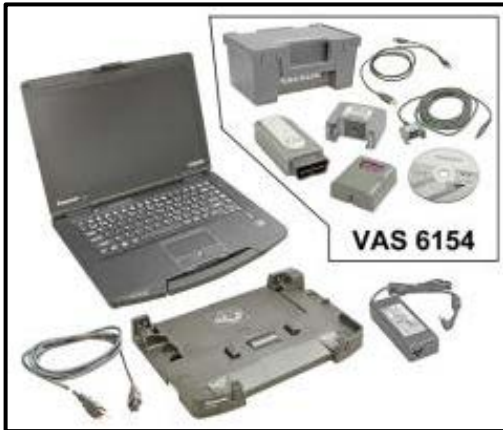
- VAS6150D - Diagnostic Tester (or equivalent)
- VAS6154 - Vehicle Communication Interface (or equivalent)

The VAS6154 or VAS5055 are the preferred diagnostic heads. Using the VAS5054 may cause a SVM failure that could result in control module failure.

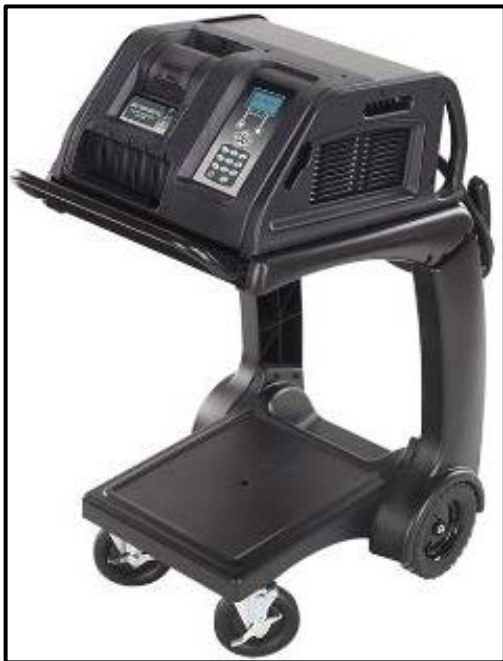
- GRX3000VAS – Battery Tester/Charger (or equivalent)

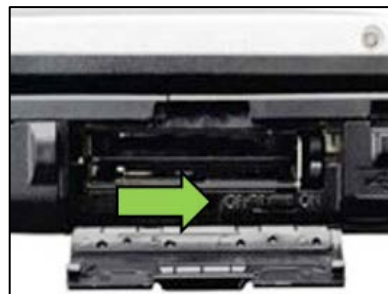
VAS 6150B
(Right side behind WIRELESS door)

- ✓ **The Bluetooth function of the scan tool is physically switched off <see pictures below>.**

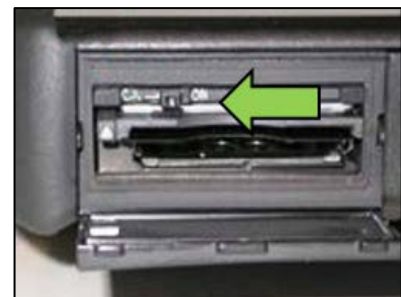
VAS 6150C
(Left side behind SC/EX door)

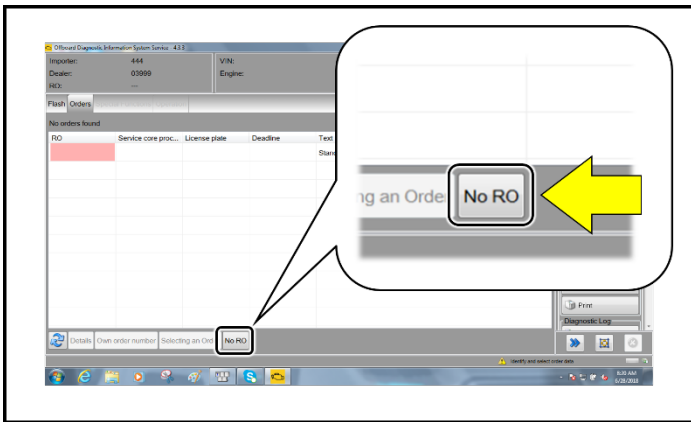
- Select “No RO”.

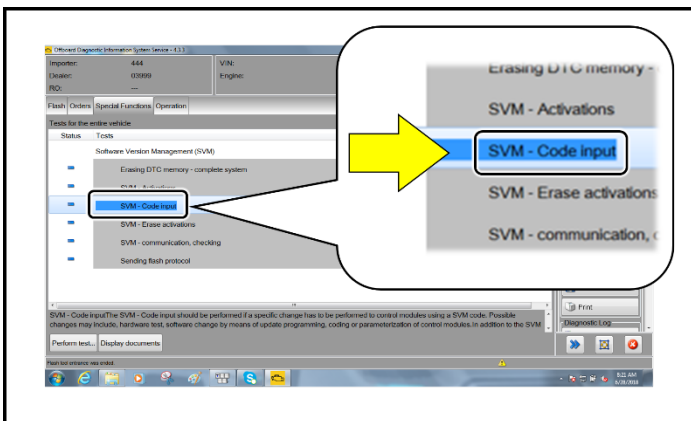
- Highlight “SVM – Code Input”.

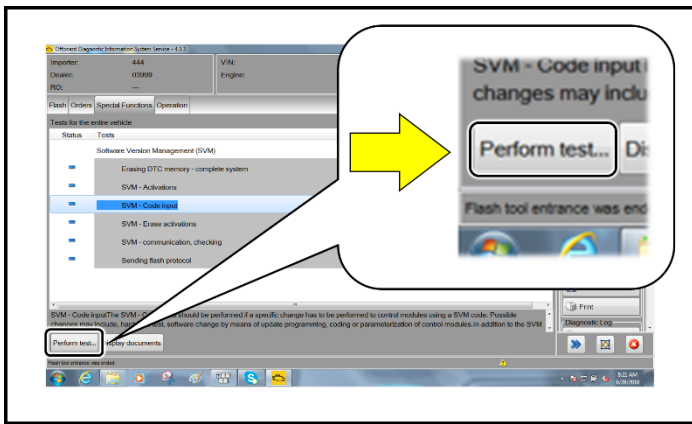
- Select “Perform test”.

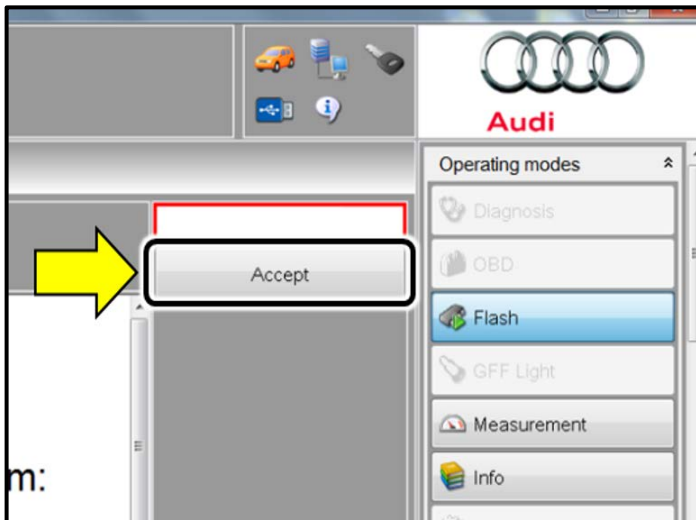
Vehicles with criteria 01:

- Update with SVM **90L2A216**.

- Update with SVM **90L2A216** on a stand-alone Flash session.
- Start a new Flash session.
- Insert SD Card part # **4N0906961K** into SD card reader under center armrest (SD card is created using the SD Creator program).
- Update with SVM **90L2B432** on a second stand-alone Flash session.
- Enter the corrective action code (SVM code) as listed above.
- Select “Accept”.
- Follow the on-screen prompts.

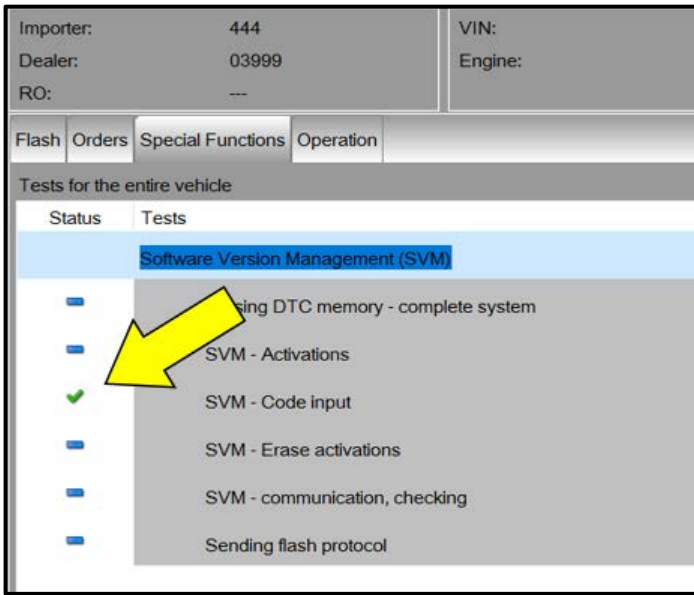
This extra ignition cycle step must be followed, otherwise faults stored during the update may not be cleared upon exiting the Flash program.

- After receiving confirmation that the update completed successfully (green check mark) <arrow>, the ignition must be turned off for 60 seconds and then turned back on.
