# Service Action

## Code: 90L2

Subject	Driver Assist System Software
Release Date	April 05, 2019
REVISION SUMMARY	<b>Removed claiming and work instructions for vehicles with <u>both</u> Criteria 01 &amp; 02</b> <b>Updated claiming and work instructions for vehicles with only Criteria 02.</b>
Affected Vehicles	<b>U.S.A. &amp; CANADA:</b> Certain 2019 MY Audi A6, A7, A8 and Audi Q8 <i>Check Campaigns/Actions screen in Elsa on the day of repair to verify that a VIN qualifies for repair under this action. Elsa is the <u>only</u> valid campaign inquiry &amp; verification source.</i> <ul style="list-style-type: none"><li>✓ Campaign status must show "open."</li><li>✓ If Elsa shows other open action(s), inform your customer so that the work can also be completed at the same time the vehicle is in the workshop for this campaign.</li></ul>
Problem Description	In affected vehicles, it is possible to have the following software-related issues with adaptive cruise (driver assist system): <ul style="list-style-type: none"><li>- Loss of target object at close range and erroneous drive-off warning in stop-and-go traffic</li><li>- Occasional restrictions to comfort when driving over crests or thr

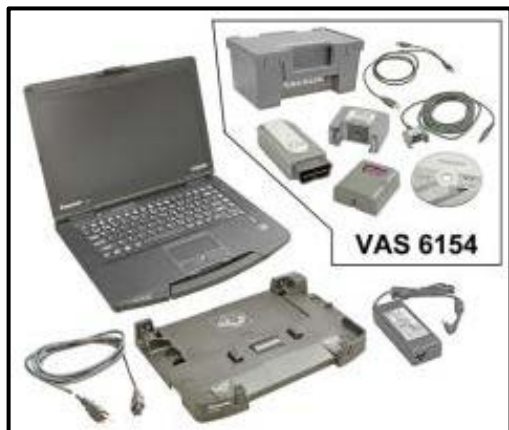
- VAS6150D - Diagnostic Tester (or equivalent)
- VAS6154 - Vehicle Communication Interface (or equivalent)

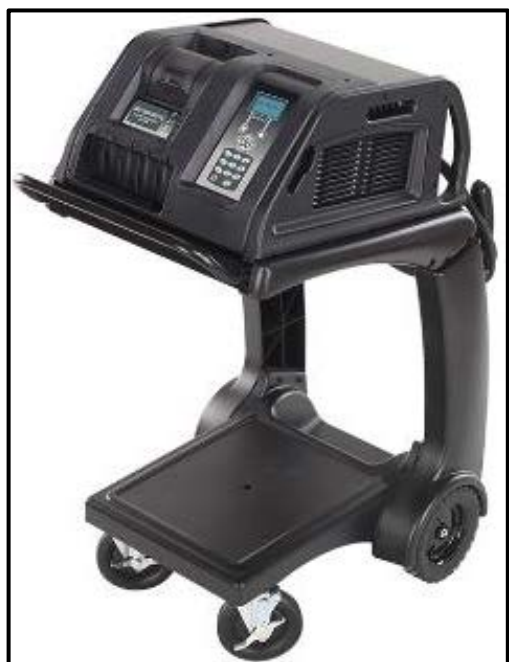
- GRX3000VAS – Battery Tester/Charger (or equivalent)

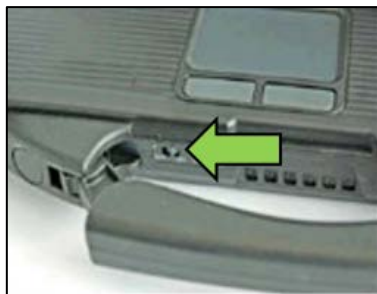
**VAS 6150 & VAS 6150A**  
(Front panel behind handle)

- ✓ **The Bluetooth function of the scan tool is physically switched off <see pictures below>.**

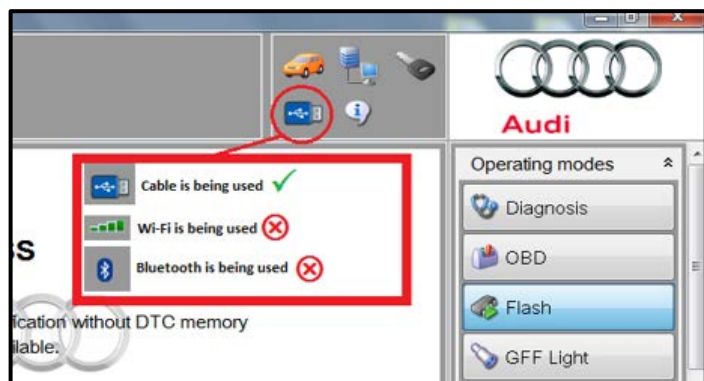
- Confirm that scan tool is communicating with the diagnostic head by USB cable.
  - If the Bluetooth or WiFi symbol is shown, then disconnect the diagnostic head from the vehicle and reconnect the USB cable to the diagnostic head and then reattach to the vehicle.

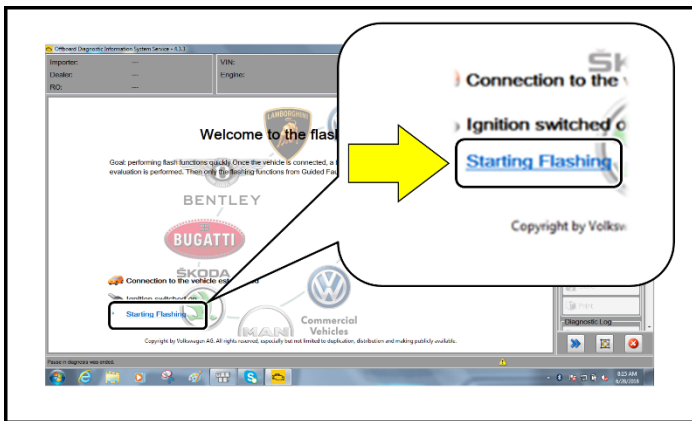
- Select “Starting Flashing” and follow the on-screen prompts.

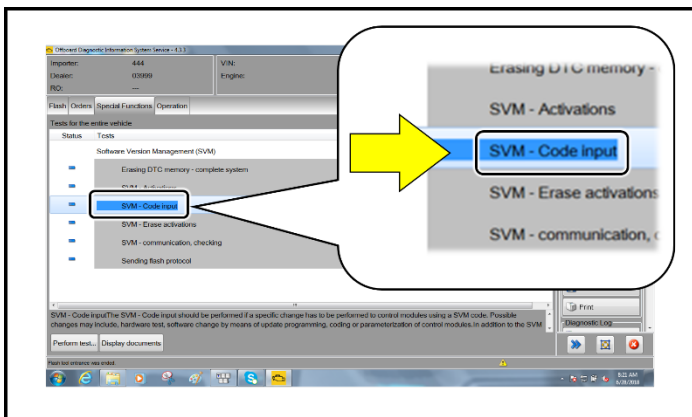
- Highlight “SVM – Code Input”.

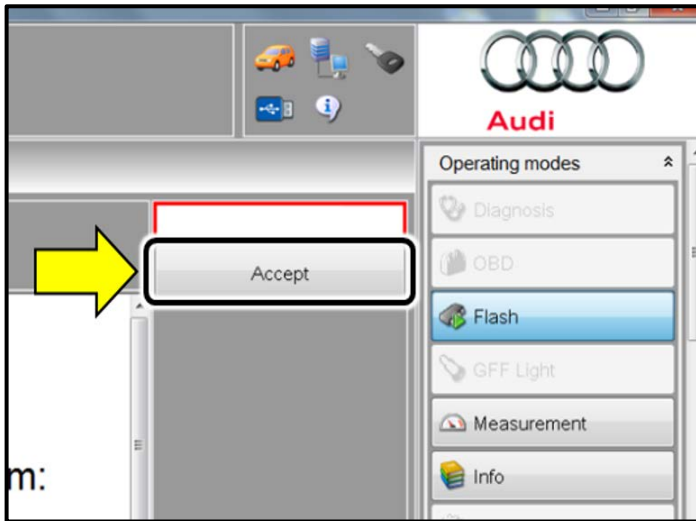
- Insert SD Card part # **4N0906961K** into SD card reader under center armrest (SD card is created using the SD Creator program).
- Enter the corrective action code (SVM code) as listed below.
- Update with SVM **90L2B432**.
- Select "Accept".
- Follow the on-screen prompts.

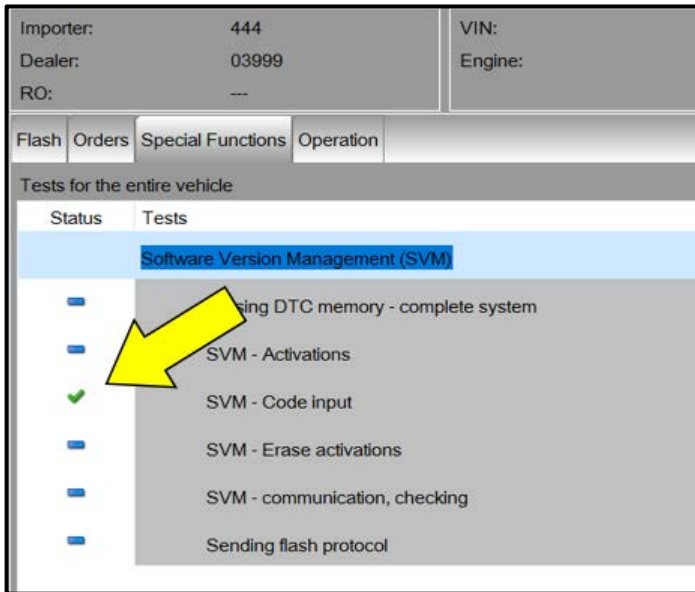
This extra ignition cycle step must be followed, otherwise faults stored during the update may not be cleared upon exiting the Flash program.

- After receiving confirmation that the update completed successfully (green check mark) <arrow>, the ignition must be turned off for 60 seconds and then turned back on.

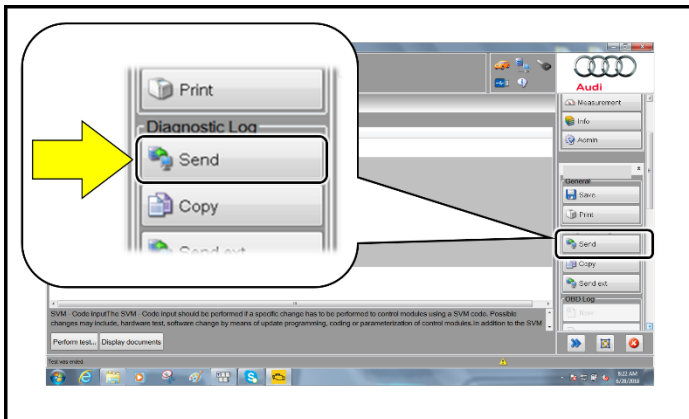
- Select "Send" to send the diagnostic protocol online.
- Follow the on-screen prompts.

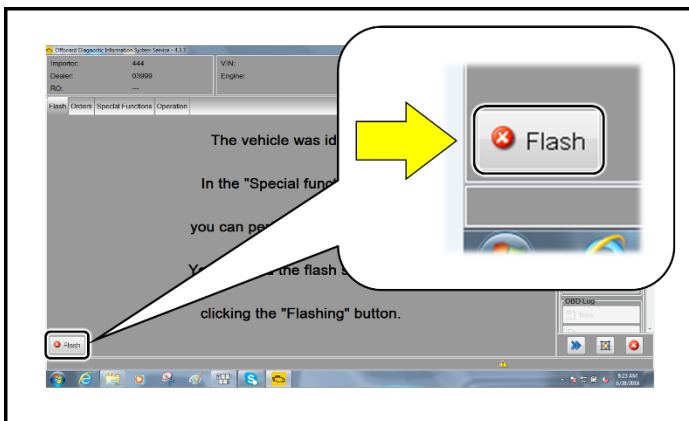
- Click "Flash" to exit the flash session.
- Remove the SD card from the SD card reader (vehicles with Criteria 02).
- **Proceed to Section C.**
