Service Action

Code: 90L2

Subject	Driver Assist System Software
Release Date	April 09, 2019
REVISION SUMMARY	Updated work and claiming instructions to reflect the following: <ul style="list-style-type: none">• Criteria 01 vehicles – required work: software update via SVM• Criteria 02 vehicles – required work: software update via SVM <u>and</u> via SD card+SVM
Affected Vehicles	U.S.A. & CANADA: Certain 2019 MY Audi A6, A7, A8 and Audi Q8 <i>Check Campaigns/Actions screen in Elsa on the day of repair to verify that a VIN qualifies for repair under this action. Elsa is the <u>only</u> valid campaign inquiry & verification source.</i> <ul style="list-style-type: none">✓ Campaign status must show “open.”✓ If Elsa shows other open action(s), inform your customer so that the work can also be completed at the same time the vehicle is in the workshop for this campaign.
Problem Description	In affected vehicles, it is possible to have the following software-related issues with adaptive cruise (driver assist system): <ul style="list-style-type: none">- Loss of target object at close range and erroneous drive-off warning in stop-and-go traffic- Occasional restrictions to comfort when driving

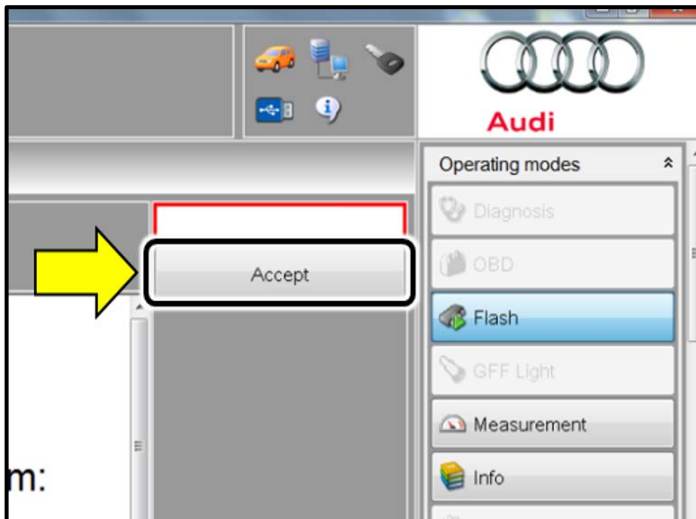
- Update with SVM **90L2A216** on a stand-alone Flash session.
- Select “Accept”.
- Follow the on-screen prompts.
- Start a new Flash session.
- Insert SD Card part # **4N0906961K** into SD card reader under center armrest (SD card is created using the SD Creator program).
- Update with SVM **90L2B432** on a second stand-alone Flash session.
- Select “Accept”.
- Follow the on-screen prompts.
