# Service Action

## Code: 90L2

<b>Subject</b>	<b>Driver Assist System Software</b>
<b>Release Date</b>	April 12, 2019
<b>REVISION SUMMARY</b>	<b>Updated work instructions to reflect the following:</b> <ul style="list-style-type: none"><li>• <b>Criteria 02 vehicles – the “Automatic online map update” must be deactivated before starting SVM code 90L2B432</b></li></ul>
<b>Affected Vehicles</b>	<b>U.S.A. &amp; CANADA: Certain 2019 MY Audi A6, A7, A8 and Audi Q8</b> <p><i>Check Campaigns/Actions screen in Elsa on the day of repair to verify that a VIN qualifies for repair under this action. Elsa is the <u>only</u> valid campaign inquiry &amp; verification source.</i></p> <ul style="list-style-type: none"><li>✓ Campaign status must show “open.”</li><li>✓ If Elsa shows other open action(s), inform your customer so that the work can also be completed at the same time the vehicle is in the workshop for this campaign.</li></ul>
<b>Problem Description</b>	In affected vehicles, it is possible to have the following software-related issues with adaptive cruise (driver assist system): <ul style="list-style-type: none"><li>- Loss of target object at close range and erroneous drive-off warning in

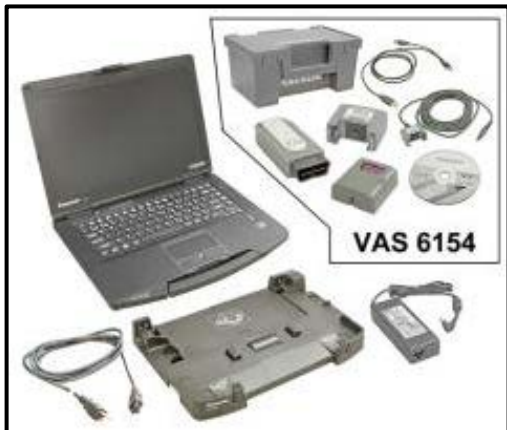
- VAS6150D - Diagnostic Tester (or equivalent)
- VAS6154 - Vehicle Communication Interface (or equivalent)

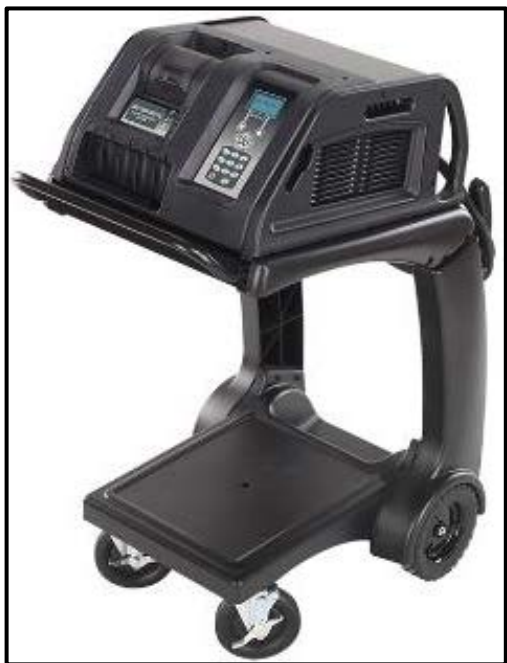
- GRX3000VAS – Battery Tester/Charger (or equivalent)

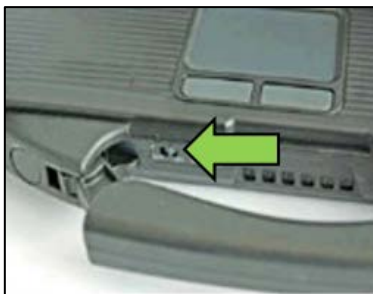
**VAS 6150 & VAS 6150A**  
(Front panel behind handle)

- ✓ **The Bluetooth function of the scan tool is physically switched off <see pictures below>.**

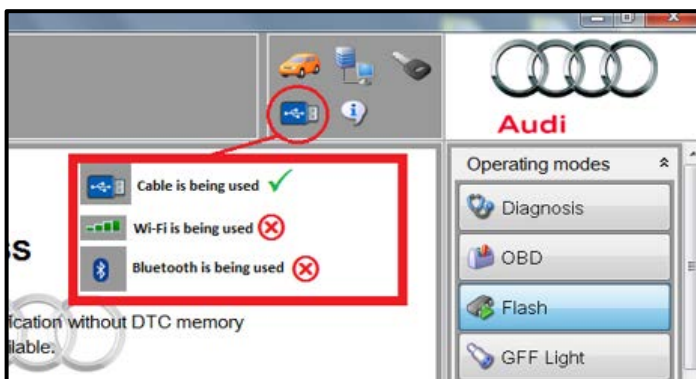
- Confirm that scan tool is communicating with the diagnostic head by USB cable.
  - If the Bluetooth or WiFi symbol is shown, then disconnect the diagnostic head from the vehicle and reconnect the USB cable to the diagnostic head and then reattach to the vehicle.

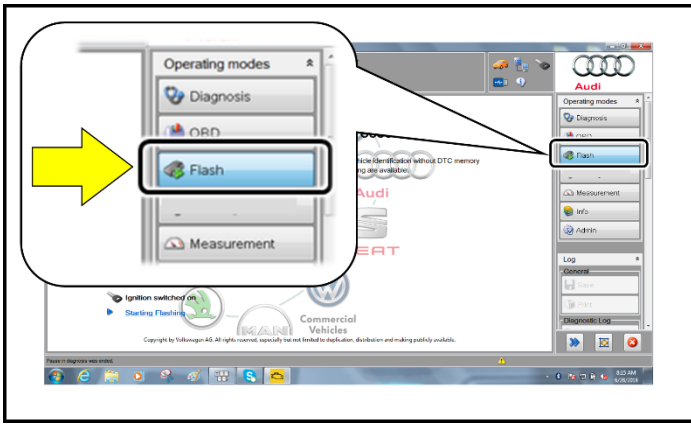
- From the home screen of the scan tool highlight “Flash” <1>.
- Follow the on-screen prompts.

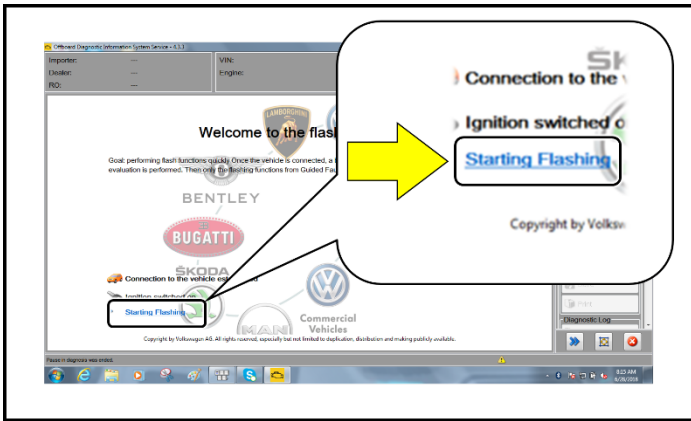
- Select “Starting Flashing” and follow the on-screen prompts.

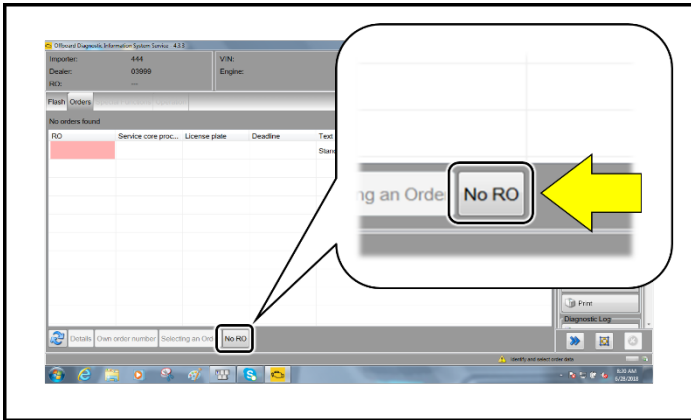
- Select “No RO”.

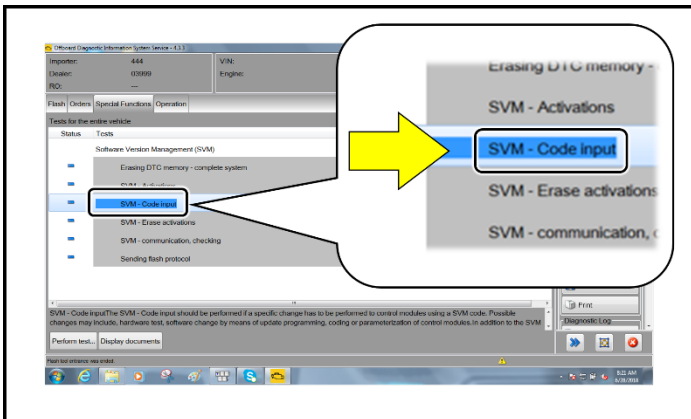
- Highlight “SVM – Code Input”.

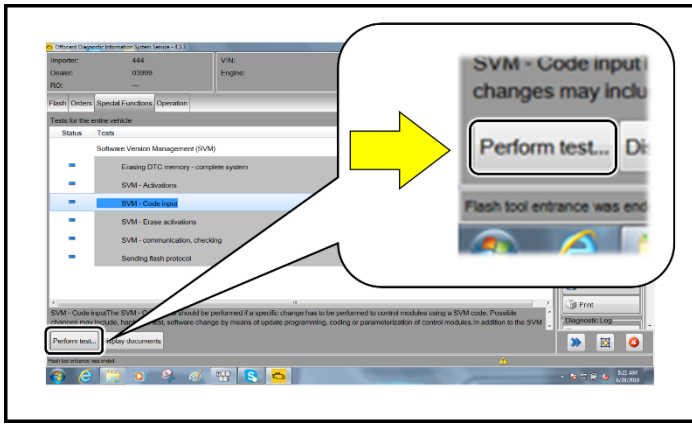
- Select “Perform test”.

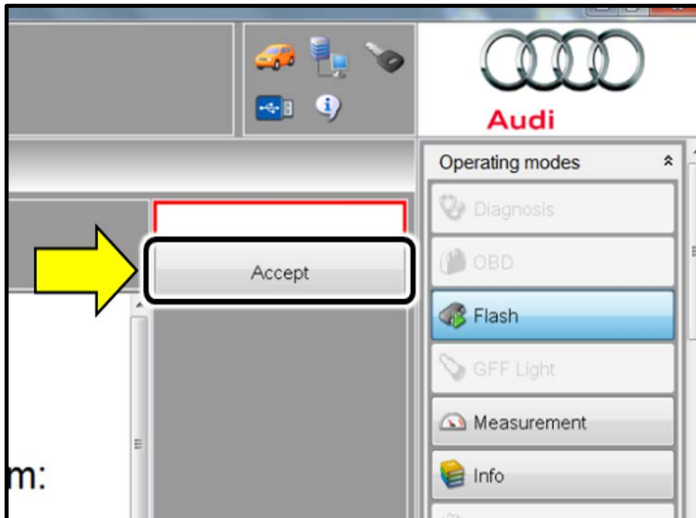
**Vehicles with criteria 01:**

- Enter the corrective action code (SVM code) as listed below.
- Update with SVM **90L2A216**.
- Select “Accept”.
- Follow the on-screen prompts.

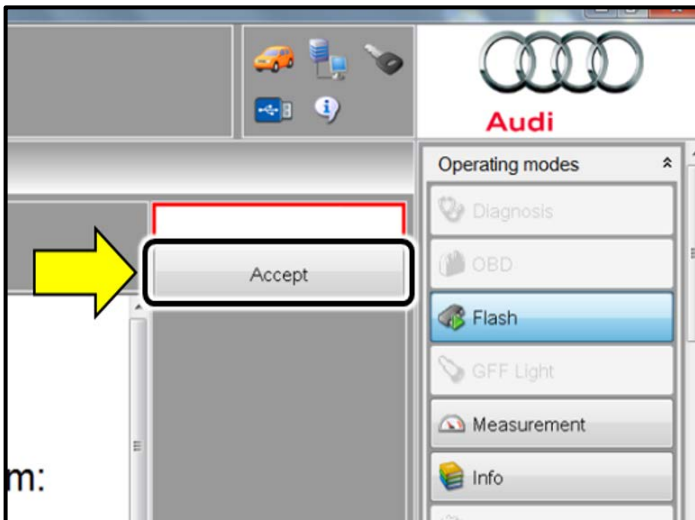
- Update with SVM **90L2A216** on a stand-alone Flash session.
- Select "Accept".
- Follow the on-screen prompts.
- Follow the rest of the steps in this work instruction (including the extra ignition cycle step).
- Start a new Flash session.

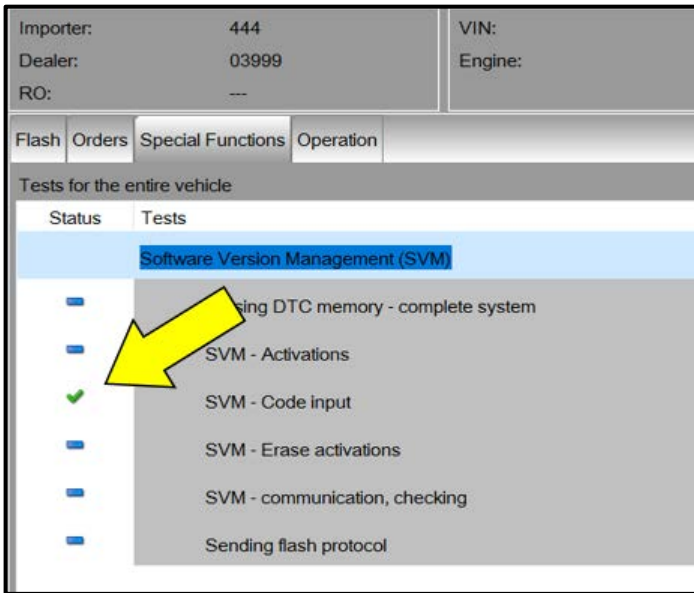
This extra ignition cycle step must be followed, otherwise faults stored during the update may not be cleared upon exiting the Flash program.

- After receiving confirmation that the update completed successfully (green check mark) <arrow>, the ignition must be turned off for 60 seconds and then turned back on.

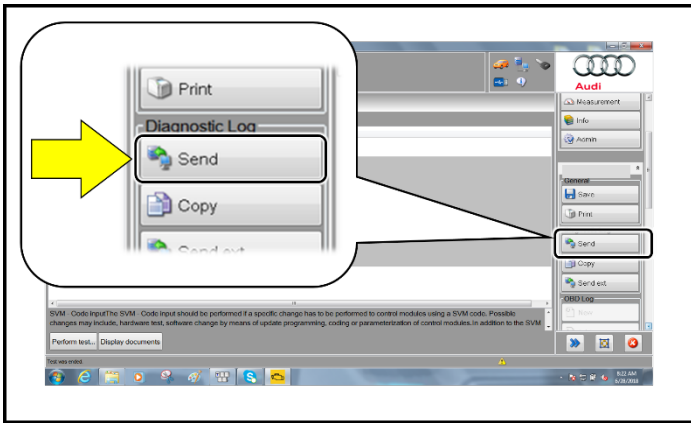
- Select "Send" to send the diagnostic protocol online.
- Follow the on-screen prompts.

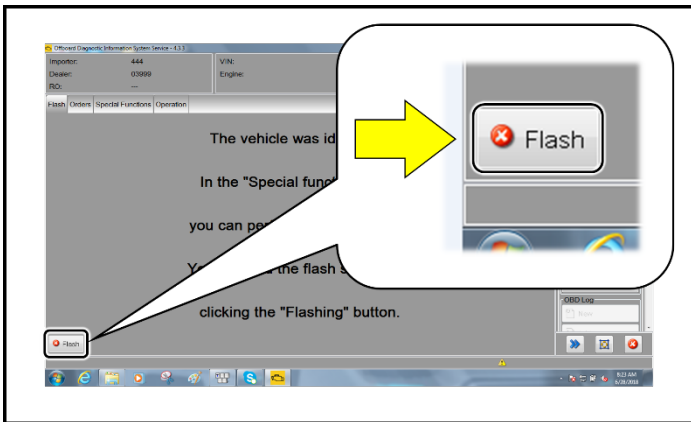
- Click "Flash" to exit the flash session.
- Remove the SD card from the SD card reader (vehicles with both criteria 01 and 02).
- **Proceed to Section C.**
