# Technical Service Bulletin

SUBJECT: <b>QUICK CHARGING WITH ABB QUICK CHARGER STOPS DUE TO ISOLATION ERROR - REVISED</b>			No: <b>TSB-19-54-001REV</b>
			DATE: <b>March 2019</b>
			MODEL: <b>2016-2017 i-MiEV, 2018-2019 Outlander PHEV</b>
<b>CIRCULATE TO:</b>	<input type="checkbox"/> GENERAL MANAGER	<input checked="" type="checkbox"/> PARTS MANAGER	<input checked="" type="checkbox"/> TECHNICIAN
<input checked="" type="checkbox"/> SERVICE ADVISOR	<input checked="" type="checkbox"/> SERVICE MANAGER	<input checked="" type="checkbox"/> WARRANTY PROCESSOR	<input type="checkbox"/> SALES MANAGER

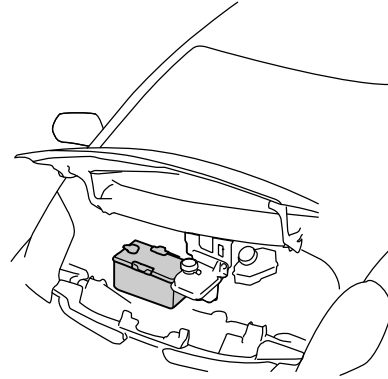
### 12V Starter Battery Location: i-MiEV

To ensure that the vehicle battery maintains 12V during the procedure, hook-up a battery charger to the 12V starter battery during the procedure.

Under Hood

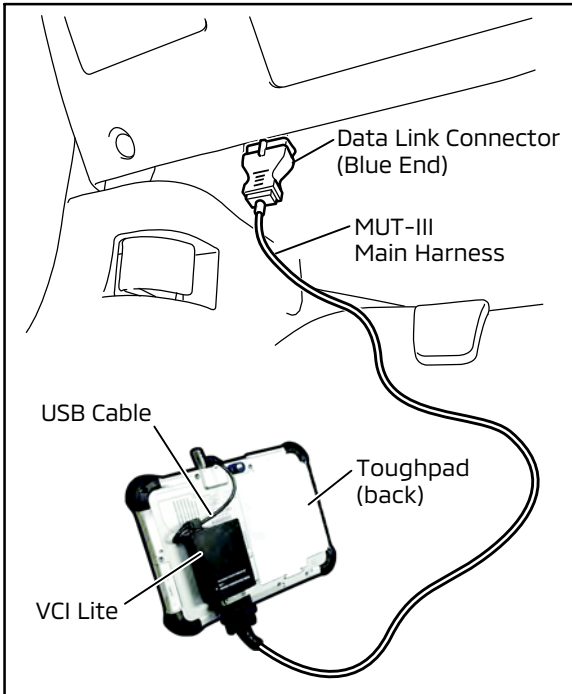
1. Connect the equipment as follows:

**NOTE: VCI Lite and MEDIC 4.0 Toughpad shown for illustration purposes only.**

- Turn the MEDIC PC/tablet on. If the battery indicator in the lower right hand corner of the screen does not show a full charge, it is recommended that either the battery be charged prior to beginning, or be used with the A/C power adaptor connected.
- Connect the USB cable to the VCI/VCI Lite.
- When the laptop/tablet displays the MUT-III main screen, connect the USB cable to the device.
- Connect the MUT-III main harness with the blue DLC connection to the VCI/VCI Lite.
- Connect the blue connection of the MUT-III main harness to the vehicle's data link connector.
- For VCI only (p/n MB991824): Turn the VCI power switch ON. Verify that the indicator lamp in the upper right corner of the screen is green.

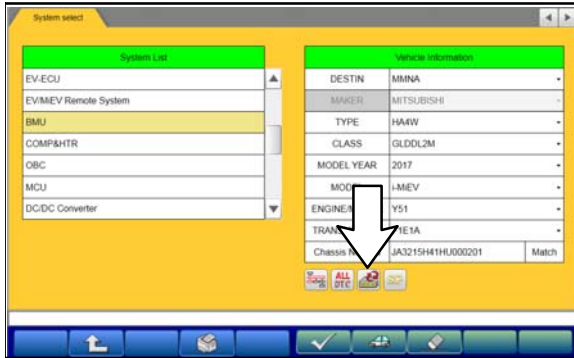
a. On the System Select screen click on the Reprogram button.

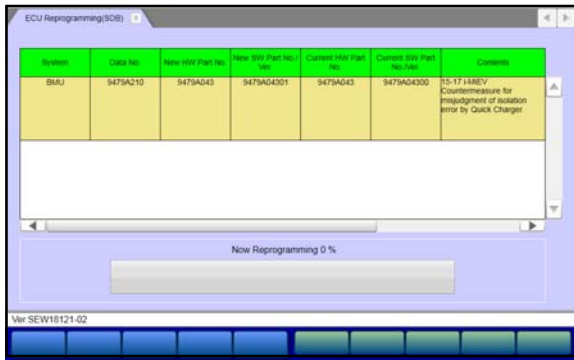
g. Once the reprogramming is initiated, the screen shown will indicate the reprogramming progress.

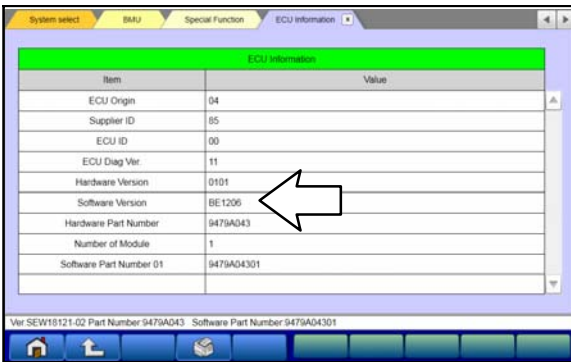
Item	Value
ECU Origin	04
Supplier ID	85
ECU ID	00
ECU Diag Ver.	11
Hardware Version	0101
Software Version	BE1206
Hardware Part Number	9479AD43
Number of Module	1
Software Part Number 01	9479AD4301

Confirm "Software Version" now matches the NEW one shown in the "**BMU/Sub-BMU Reprogramming Chart**" in this TSB.

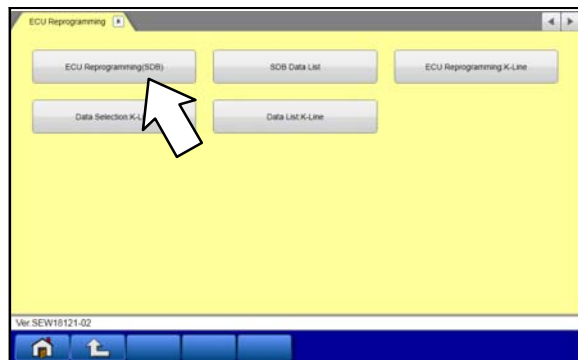
b. Select "ECU Reprogramming (SDB)."
