GROUP <b>Product Improvement</b>	MODEL <b>See Model List on Page 1</b>
	NUMBER <b>PI1802W/X (Rev 4, 04/03/2019)</b>	DATE <b>October 2018</b>
<b>PRODUCT IMPROVEMENT CAMPAIGN</b>		
SUBJECT: <b>ENGINE REPLACEMENT INSTRUCTIONS FOR DTC P1326 (PI1802W/X)</b>

This bulletin provides information related to the Technical Service Bulletin previously published in July 2018 ([PI1802](#), Rev 6, 01/31/2019) titled “Knock Sensor Detection System - ECU Logic Improvement”. Specifically, this bulletin provides instructions on which procedures to follow if, after installation of the KSDS, any one of the subject vehicles below returns to the dealer with Diagnostic Trouble Code (“DTC”), P1326.

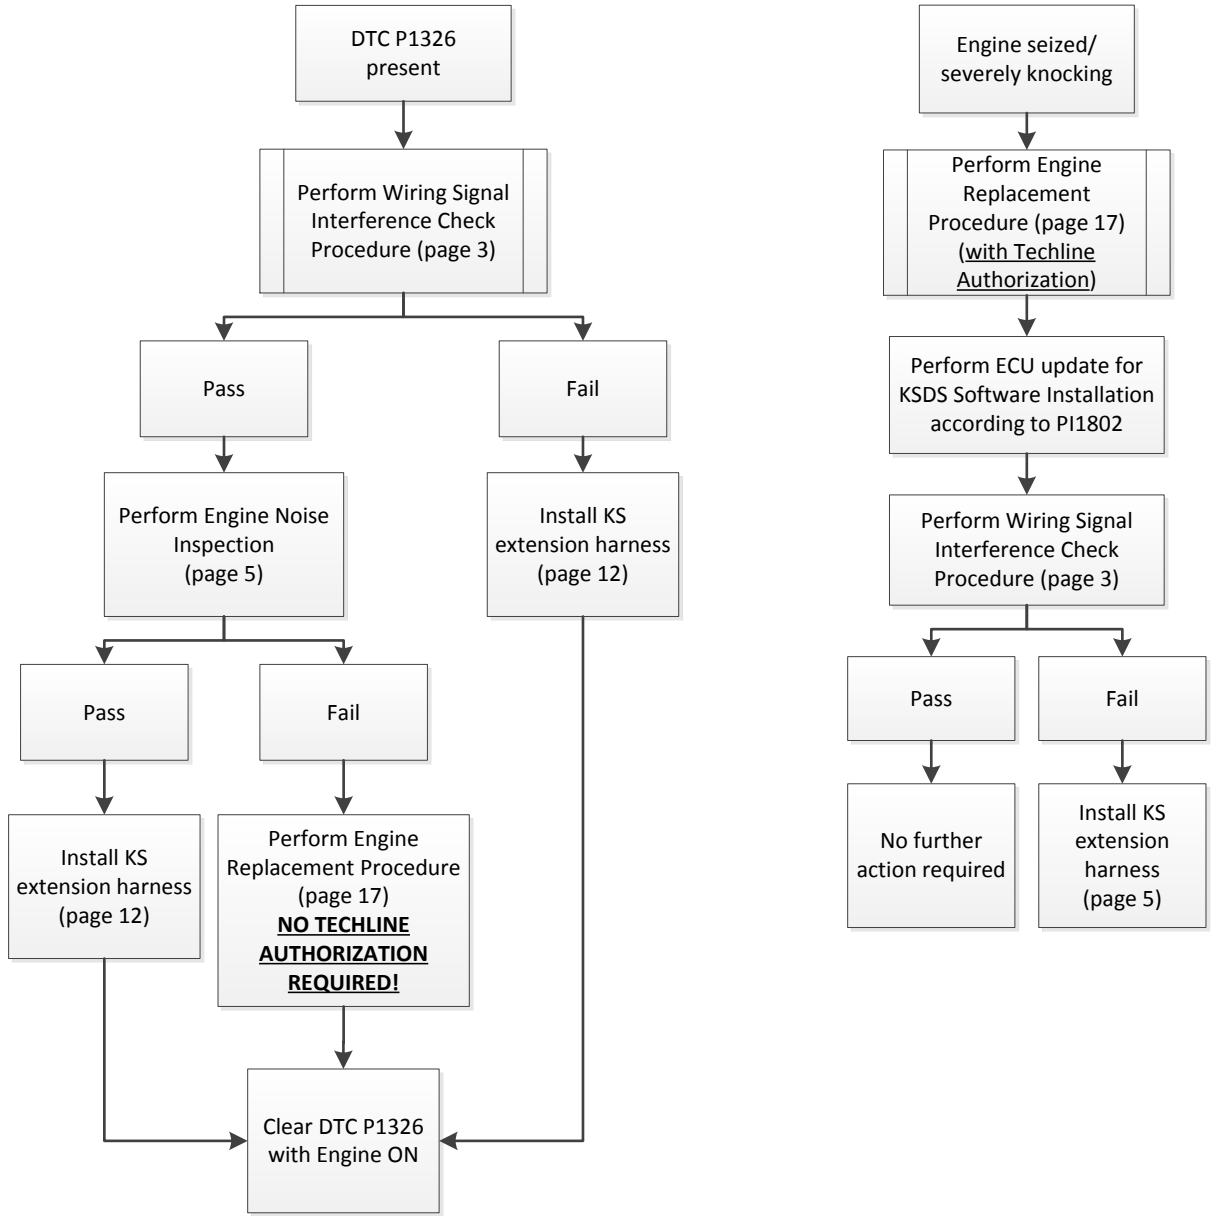
**Flow Chart:**

**Note:** If any concerns arise after completing the flow chart, open a Techline case online.

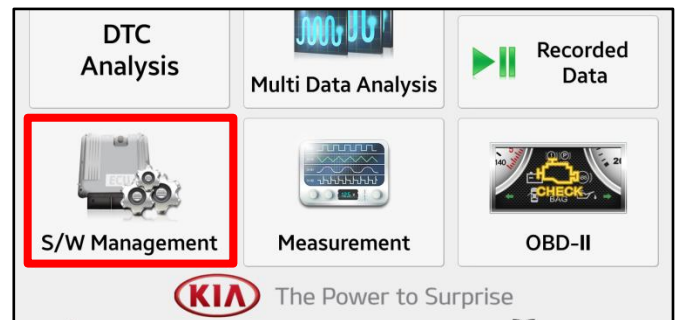
- From the KDS Home Screen, select S/W Management.

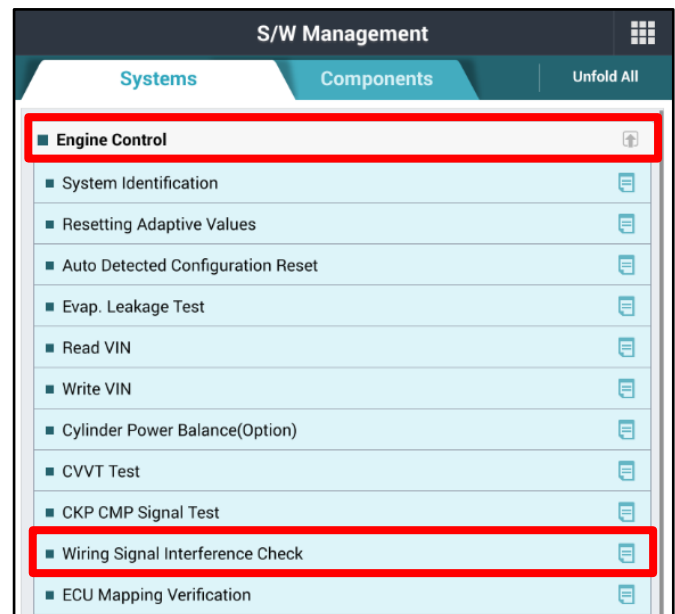
- Select Engine Control → Wiring Signal Interference Check.

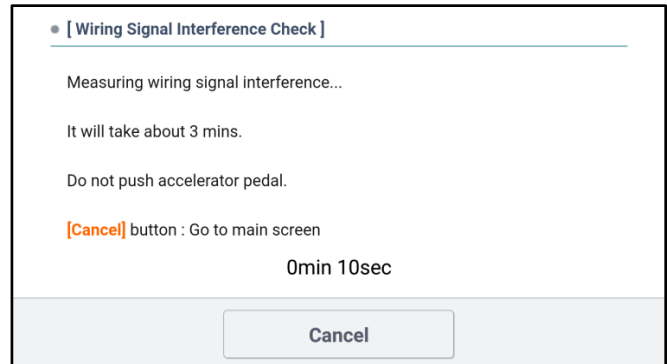
7. Wiring Signal Interference Check test will begin and take about three (3) minutes to complete. **NOTE:** Do not push on the accelerator pedal.

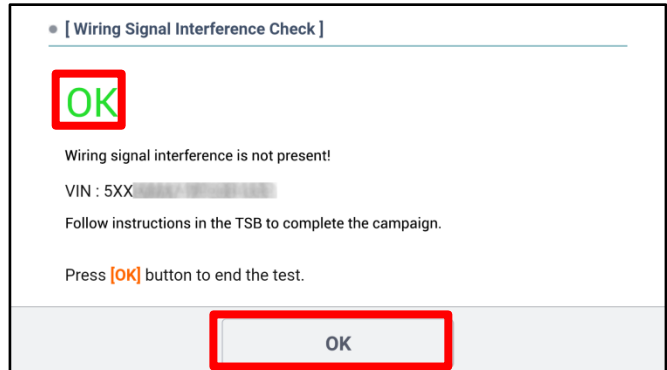
- If the result is “OK”, proceed to the Engine Noise Inspection procedure on page 5.

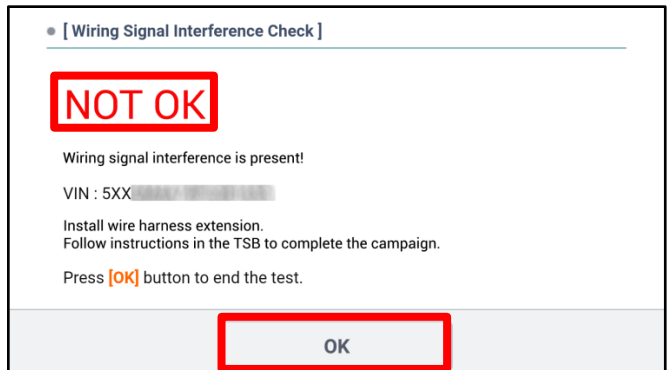
- If the result is “NOT OK”, turn the engine off and proceed to **step 2** of the Knock Sensor (KS) Extension Harness Installation procedure on page 12.

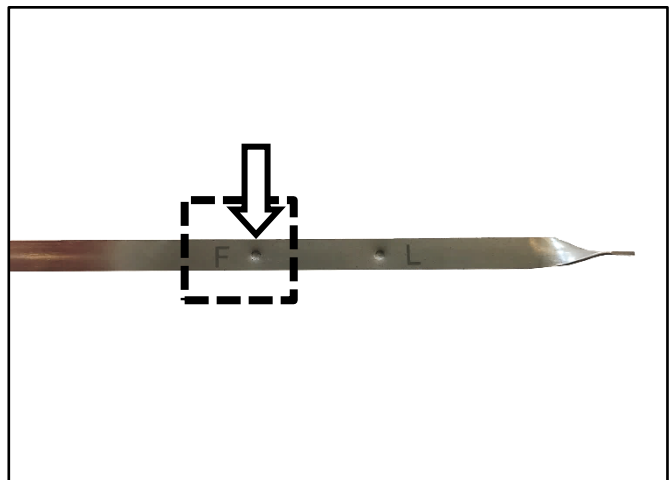
1. Prior to inspection, ensure the KDS is fully charged and is connected to the internet every day to ensure the latest update is received and installed.
  - Engine oil level should be at the “FULL” mark. Top off with 5W-30 if required.
  - Test requires the engine to be in satisfactory running condition and able to idle normally.
  - Engine coolant temperature should be above minimum test temperature: 185°F (85°C).

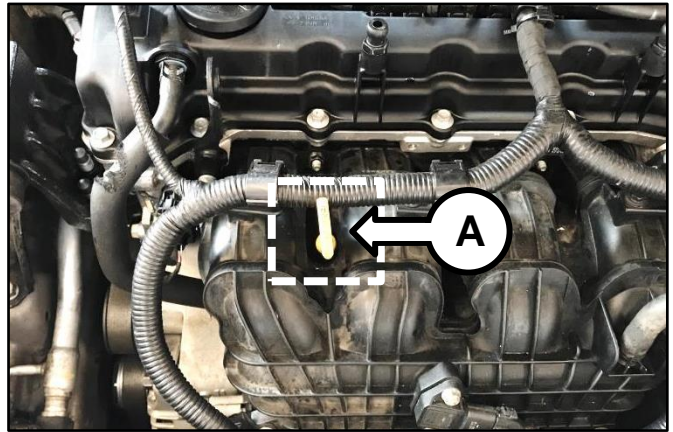
2. With the engine off, remove the dipstick (A).

Engine cover removed in images for demonstration-only purposes.

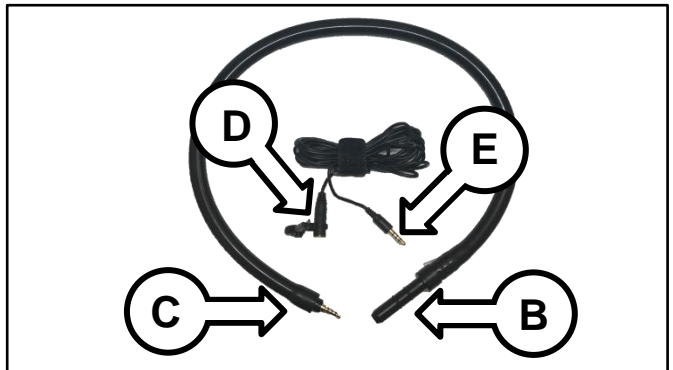
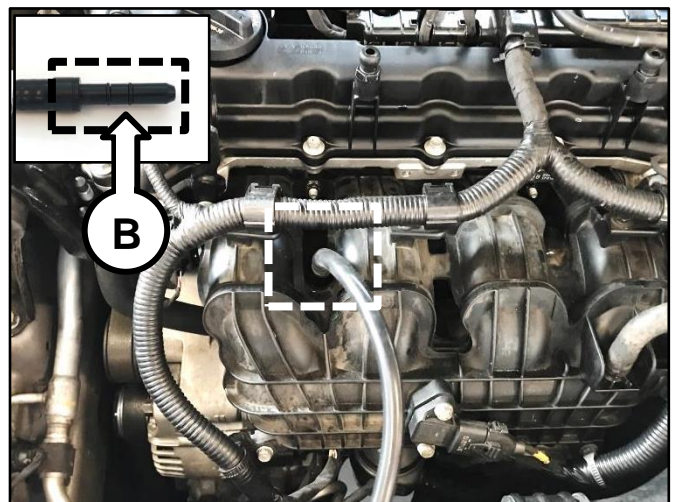
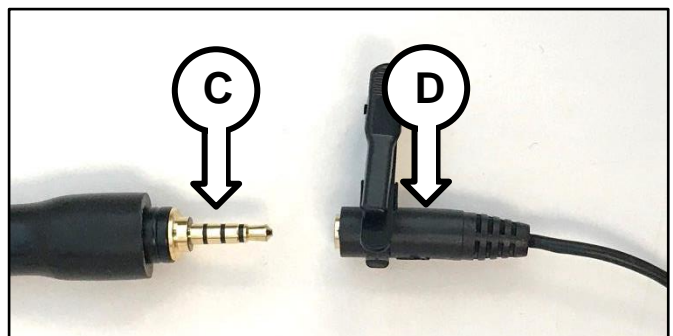
3. Insert the engine noise tester SST adapter (B) into the dipstick tube then start and idle the engine.

4. Connect the 3.5 mm male end of the engine noise tester SST (C) to the 3.5 mm female end of the extension cable (D).

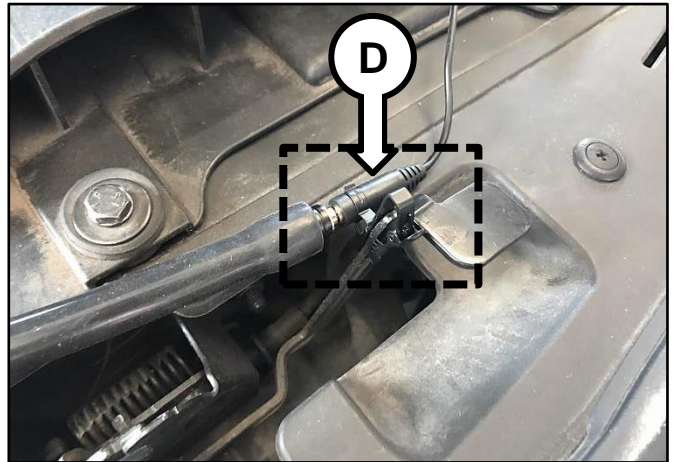
5. Attach the SST clip of the extension cable (D) to the hood latch.

Make sure to route the extension cable away from moving parts (pulleys, fan, and belts and be careful not to get it pinched between door and body or window, etc.).

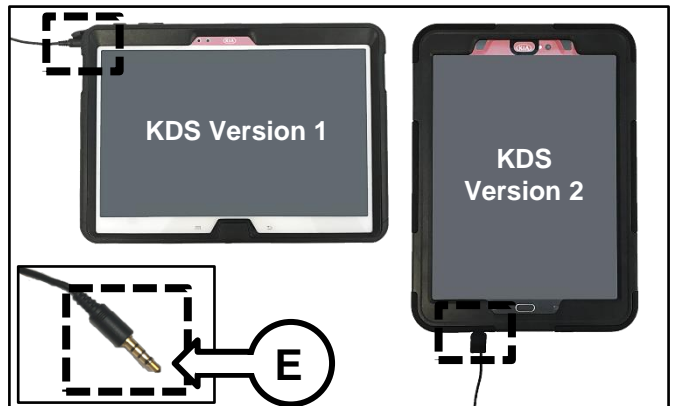
6. Connect the 3.5 mm male end (E) of the extension cable to the headphone port located at the upper left corner (KDS version 1.0) or at the bottom of the tablet (KDS version 2.0).

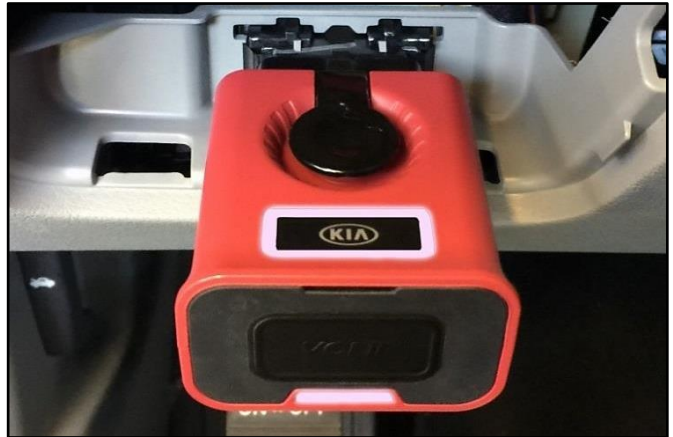
7. Connect the VCI-II to the OBD-II connector and launch the KDS application from the KDS tablet home page.

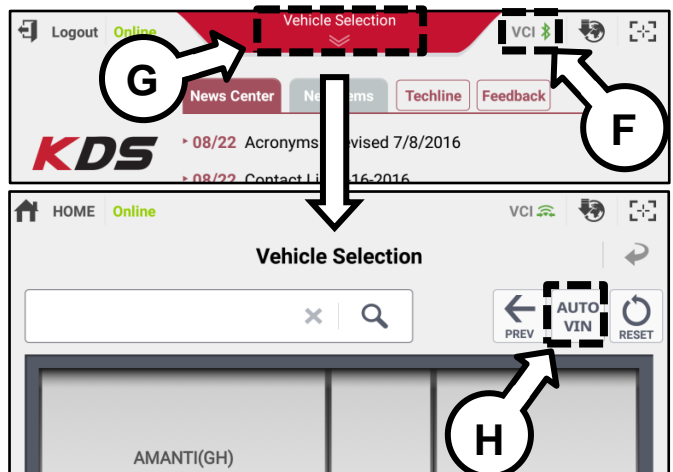
8. Confirm communication with VCI (F) and then configure the vehicle (G) using the **AUTO VIN** (H) feature.

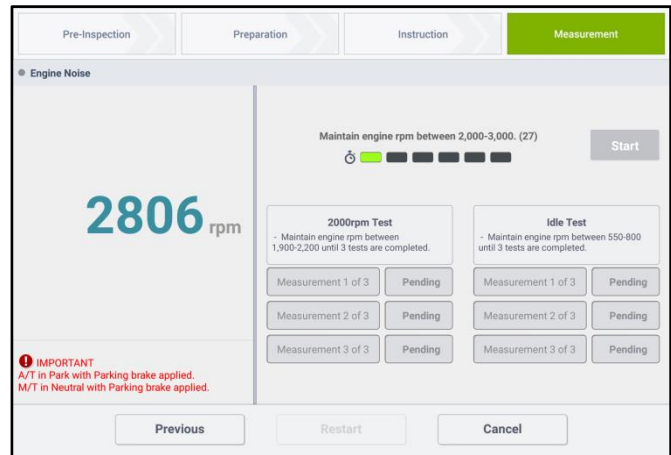
Once the RPM is in the specified range, the time count (green bars) will be initialized.

- With the vehicle in Park (A/T) / Neutral (M/T), begin the “2000rpm Test” by increasing and maintaining engine speed between 1,900-2,100 (2.4L) or 1,900-2,200 (2.0T) RPM until all three (3) measurements are complete.

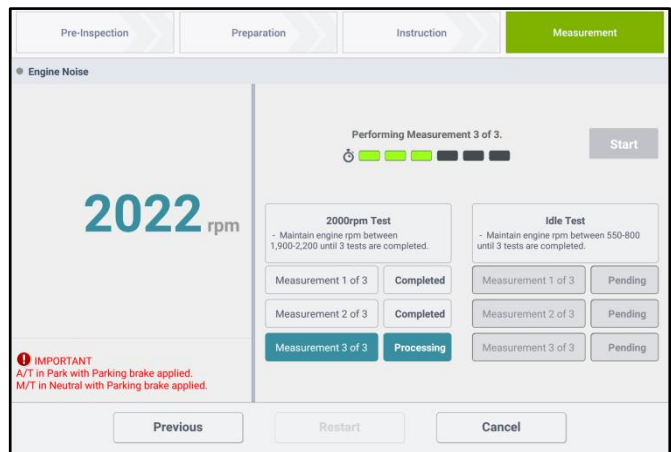
- When the “2000rpm Test” is complete, release the accelerator pedal so that engine maintains idle state for the “Idle Test”.

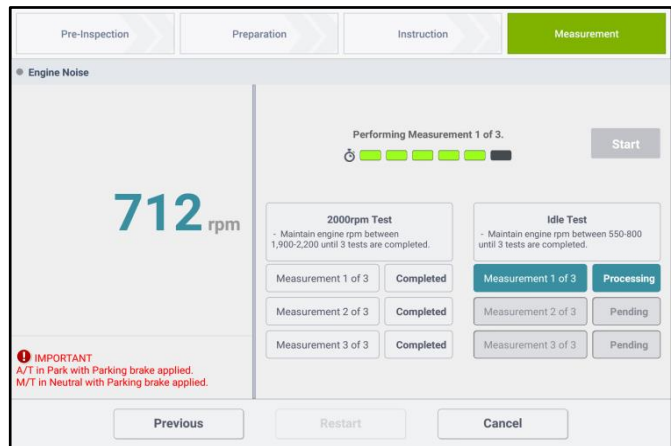
- The “Idle Test” will automatically begin. Keep the engine at idle and wait until all three (3) measurements are complete.

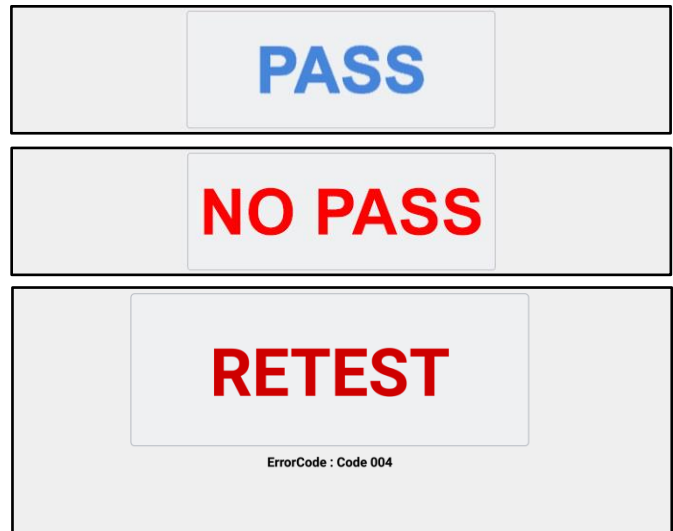
19. After the completion of the engine noise inspection, the KDS will automatically generate/display a “PASS” or “NO PASS” result.
- If the inspection result is “PASS”, proceed to the KS Extension Harness Installation procedure on page 12.
  - If the inspection result is “NO PASS,” proceed to the engine replacement procedure on page 17.
  - If the inspection result is “RETEST” with an error code, see Adapter Error Code chart in Appendix 4 on page 45 for corrective action then repeat the inspection procedure starting from step 9.

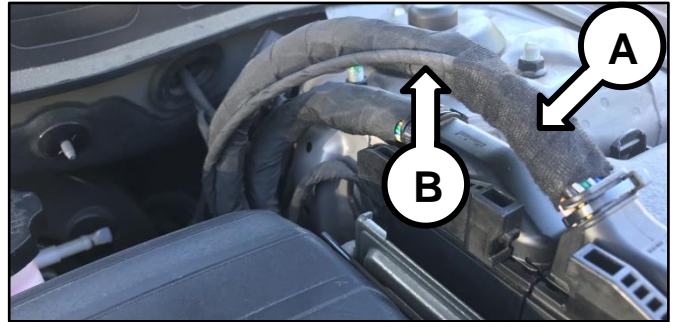
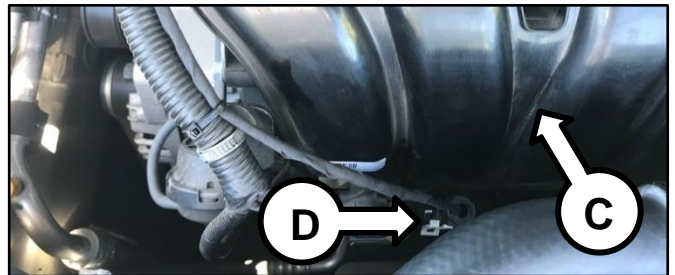
**NOTE:** To identify the extension harness (B), look for an external harness (B) which should be cable-tied to the existing wiring harness (A) leading by the intake manifold (C) to the knock sensor (D), as shown.

- If the extension harness (B) has been installed, open a Techline case online.
- If the extension harness (B) has not been installed, proceed to the next step.

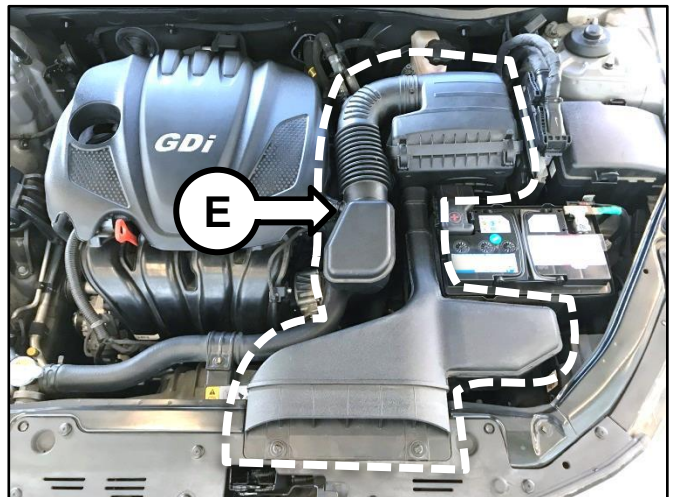
2. Remove the air cleaner and duct assembly (E).

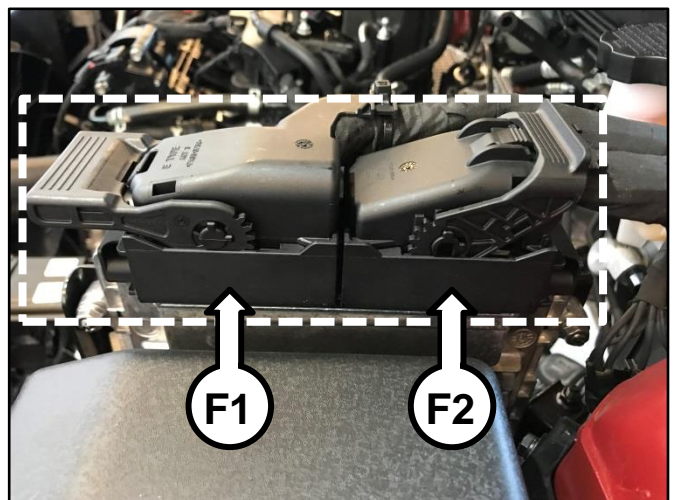
3. Disconnect the ECU connector\* (figure F1 or F2) (\*see IMPORTANT note below).

Location of the ECU connector may vary from model to model. Refer to the table on page 13 for the ECU connector number and the applicable ETM Manual on KGIS for the location of the ECU connector.

MY	Model	Engine	ECU Connector Number
2014-2015	TF	2.4	C200-B
2015	QF	2.4	C200-B
		2.0T	C100-B
2016-2018	JF/JFa	2.4	C200-A
	JFa	2.0T	C100-A
2015	XMa	2.4	C300-B
2016-2018	UMa	2.4	C100-A
		2.0T	C200-A
2014-2016	SL	2.4	CHGG-BG
		2.0T	CHTG-BG
2017-2018	QL	2.4	C100-A
		2.0T	C200-A

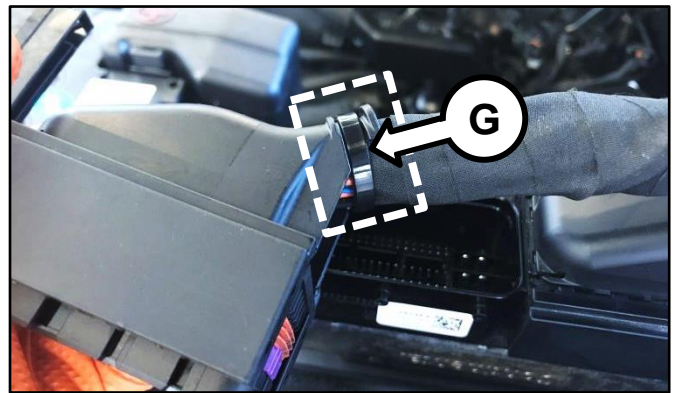
4. Cut the existing cable-tie (G) from the connector.

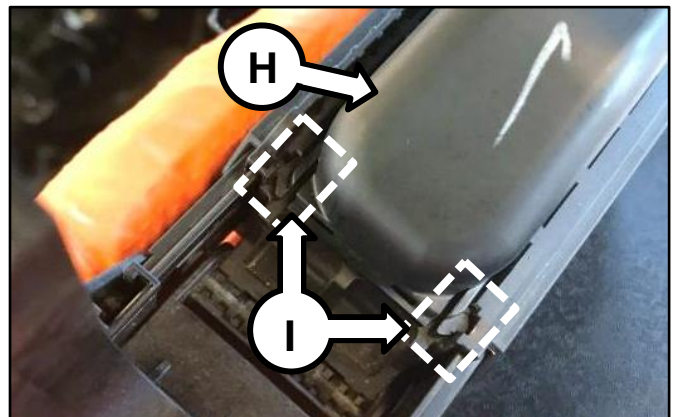
5. Remove the ECU connector cover (H) by carefully unclipping the two (2) tabs (I) and sliding the cover (H) towards the tabs (I).

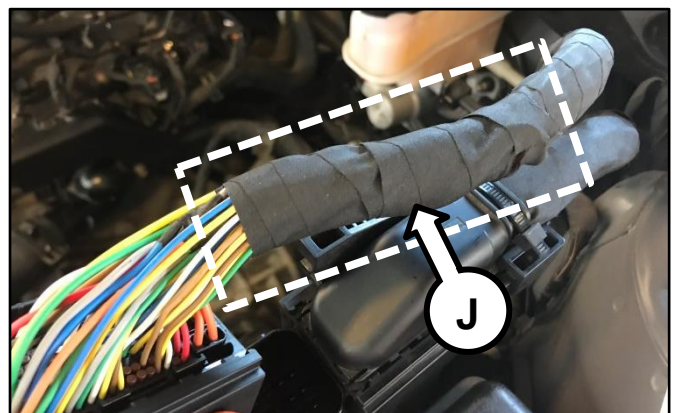
6. Carefully remove the electrical tape (J) to expose the harness wires.

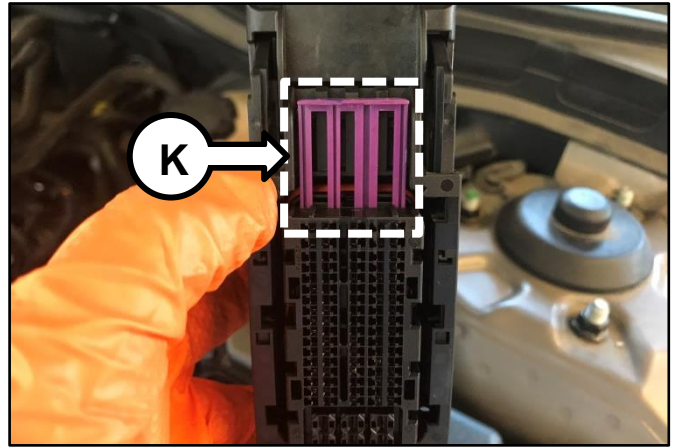
- Remove the pin retainer (K).

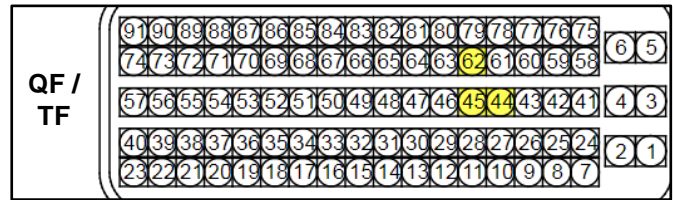
- Locate the three (3) knock sensor circuit terminals from the ECU connector. Refer to the “Schematic Diagrams → Engine Electrical System → Engine Control System → Schematic Diagrams” chapter of the applicable ETM on KGIS.

QF, TF, XMa, and SL	
Pin	Wire
44	Knock Sensor Shielded Ground
45	Knock Sensor Ground
62	Knock Sensor Interface (Signal)

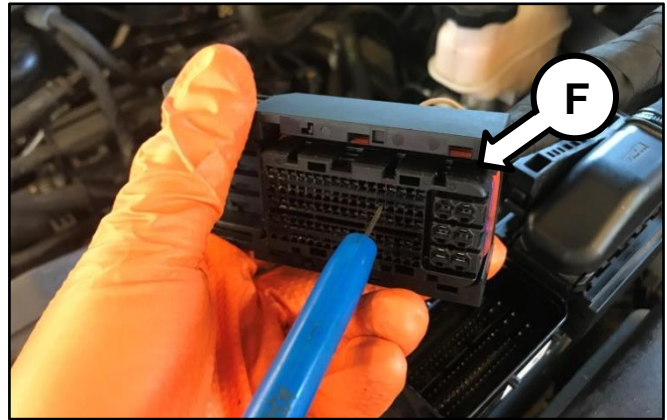
9. Remove the three (3) terminals **one at a time** and insert the new terminals of the extension harness into the ECU connector (F). Reinstall pin retainer (K) and reassemble the connector (F).

QF, TF, XMa, and SL	
Pin	Extension Wire Color
44	Blue
45	Black
62	Red
UMa, JF, JFa, and QL	
Pin	Extension Wire Color
61	Blue
62	Black
63	Red

**NOTE:** Be sure to note the rotational position of the terminals during removal. They are directional and need to be reinstalled in the same “clock” position.

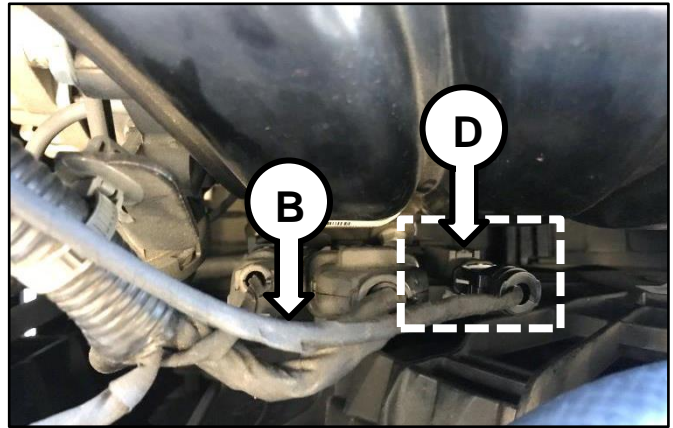
11. Connect the extension harness (B) to the knock sensor (D).

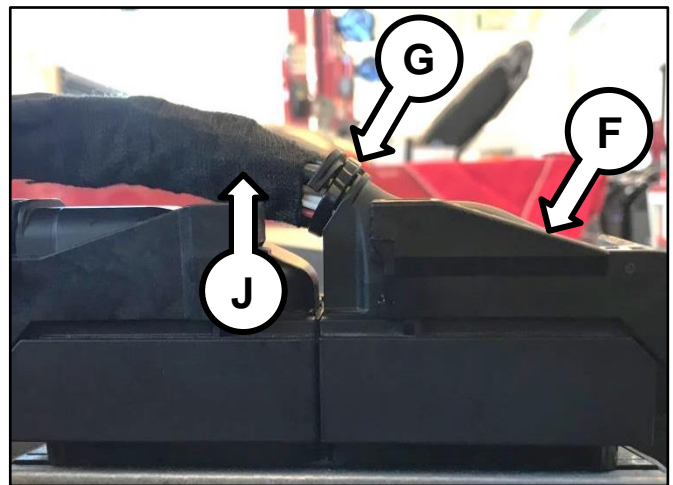
12. Cut off and discard the three (3) old knock sensor circuit terminals and the old knock sensor connector and secure the remaining wires to the new extension harness using the supplied electrical tape. **NOTE:** Complete removal of the old knock sensor wires is not necessary. Only remove the old terminals and connector.

13. Secure the extension harness at the connector (F) by replacing the cable-tie (G) removed in step 4 with a new supplied cable-tie and the electrical tape (J) removed in step 6 with new supplied electrical tape.

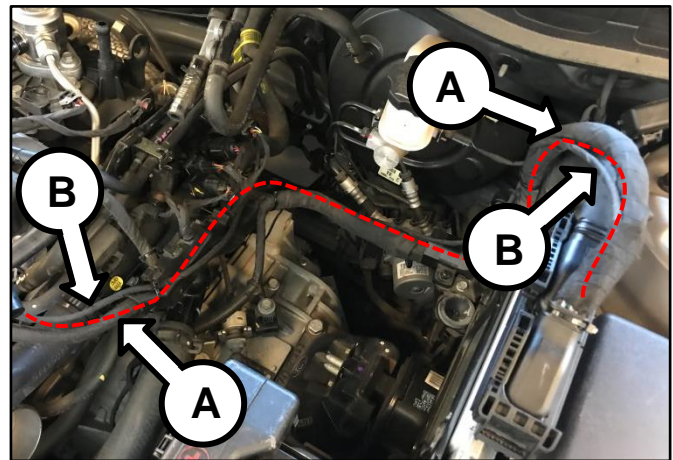
14. Secure the extension harness (B) to the existing harness (A) using the supplied cable-ties. Tuck and secure any excess wiring of the extension harness near the ECU with cable-tie.

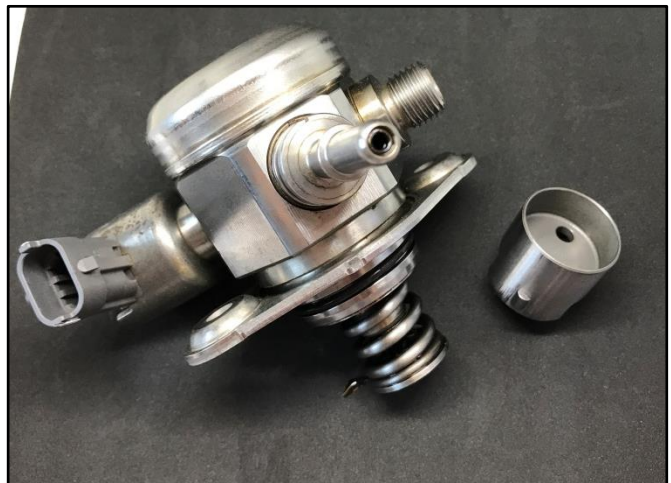
**Tightening torques of pipe flare nut:**

**19.5 – 23.9 lb.ft (26.5 – 32.4 N.m,  
2.7 – 3.3 kgf.m)**

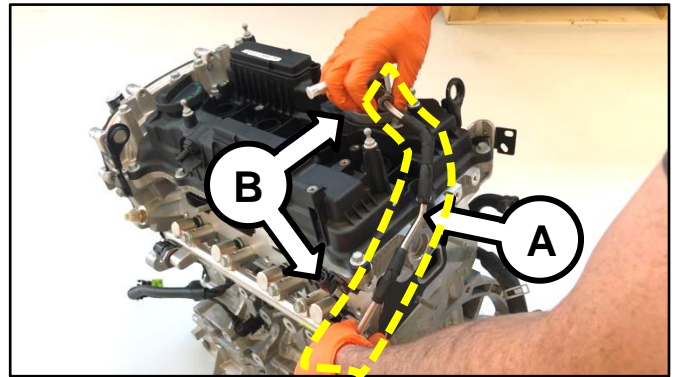
1. Properly position the new fuel pipe (A) and then hand-tighten both flare nuts (B).

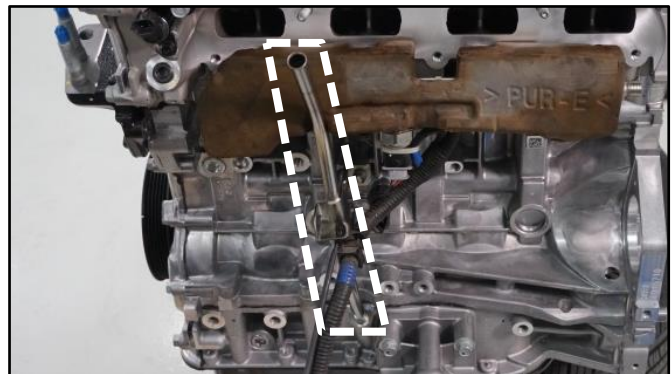
**Tightening torque of bolt:**

**5.8 – 8.7 lb.ft (7.8 – 11.8 N.m,  
0.8 - 1.2 kgf.m)**

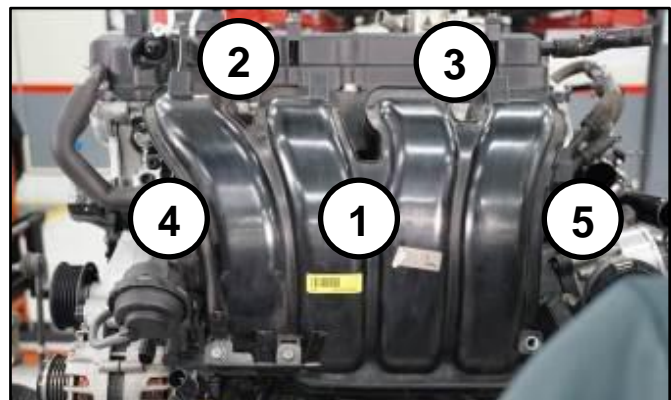
## Intake Manifold:

- Prior to installation, replace the intake manifold gaskets.
- Torque bolts in the sequence shown.

**Tightening torque of bolts:**

**13.7 – 17.4 lb.ft (18.6 – 23.5 N.m,  
1.9 – 2.4 kgf.m)**

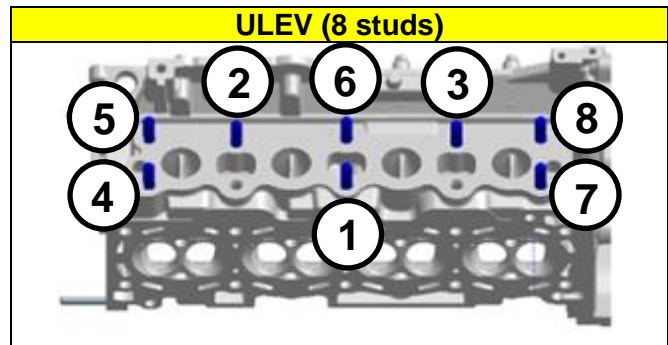
- All engines supplied under this Product Improvement Campaign have the exhaust manifold studs configured for SULEV engines.
- Using the pictures to the right, check the exhaust manifold stud location and quantity. Relocate as required for ULEV engines and obtain one (1) extra from the removed engine.
- Prior to installation, replace the exhaust manifold gasket and front muffler gasket.
- Torque nuts in the sequence shown.

**Tightening torque of nuts:**  
**36.2 – 39.7 lb.ft (49.0 – 53.9 N.m,**  
**5.0 – 5.5 kgf.m)**

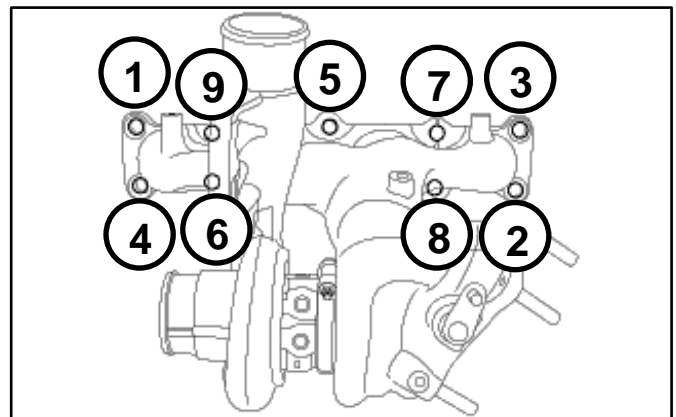
- On Turbo engines, replace the turbocharger oil feed line and gaskets.

- Torque exhaust manifold nuts in the sequence shown.

**Tightening torque of nuts:**  
**36.2 – 39.7 lb.ft (49.0 – 53.9 N.m,**  
**5.0 – 5.5 kgf.m)**

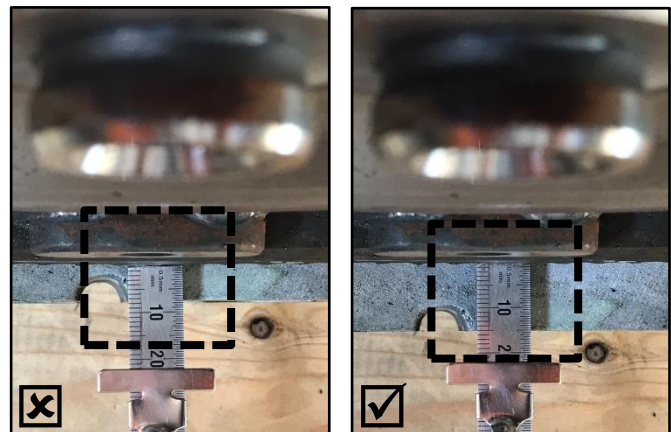
- If the torque converter has moved from the fully inserted position, carefully push inward while rotating the torque converter until it is recessed approximately 9/16 – 5/8" (14 – 16mm) (☑) into the transaxle case when reinstalling the automatic transaxle.

Not Fully Inserted

Fully Inserted

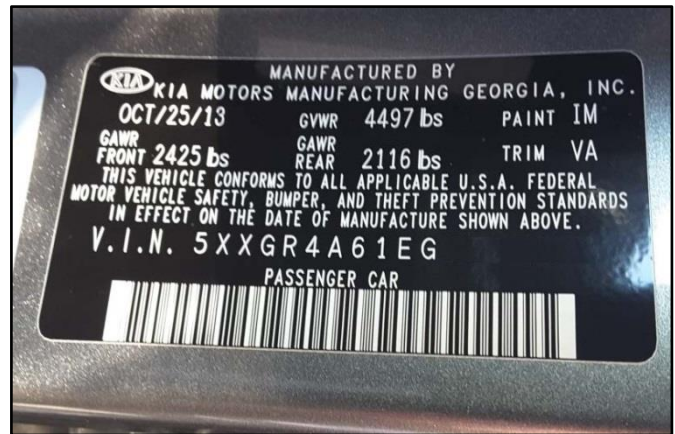
- Start by recording the VIN. Ensure sun glare is not reflecting off windows or other objects.

Without stopping the recording, capture the area of the vehicle displaying the issue. i.e.;

- Engine Noise – record the engine.
- Hole In Block – record the side of the engine with the damage.
- Seized Engine – record a technician trying to turn the engine over with a breaker bar.
