GROUP	MODEL
ENG	2019MY Rio (SC)
NUMBER	DATE
202	April 2019

TECHNICAL SERVICE BULLETIN

SERVICE ACTION: ECU LOGIC

IMPROVEMENT FOR DTC P0128 (SA374)

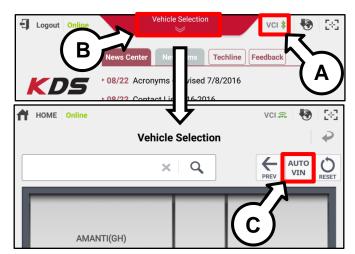
3. Confirm communication with VCI (A) and then configure the vehicle (B) using the **AUTO VIN** (C) feature.
