GROUP ENG	MODEL 2019MY Forte (BDm)
	NUMBER 204	DATE April 2019
TECHNICAL SERVICE BULLETIN		
SUBJECT: SERVICE ACTION: ECU LOGIC IMPROVEMENT FOR P030X, P219X (SA378)

This bulletin provides the procedure to improve the logic of the Engine Control Unit (ECU) on some 2019MY Forte (BDm) vehicles, equipped with a NU 2.0MPI Atkinson engine and produced from July 9, 2018 through March 11, 2019, which may experience a malfunction indicator lamp (MIL) ON with DTC P030X and/or P219X. To correct this concern, apply the improved logic to the ECU using the KDS ECU Upgrade function as described in this bulletin. For confirmation that the latest reflash has been applied to a vehicle you are working on, verify the ROM ID using the table on page 2 of this bulletin. Before conducting the procedure, verify that the vehicle is included in the list of affected VINs.

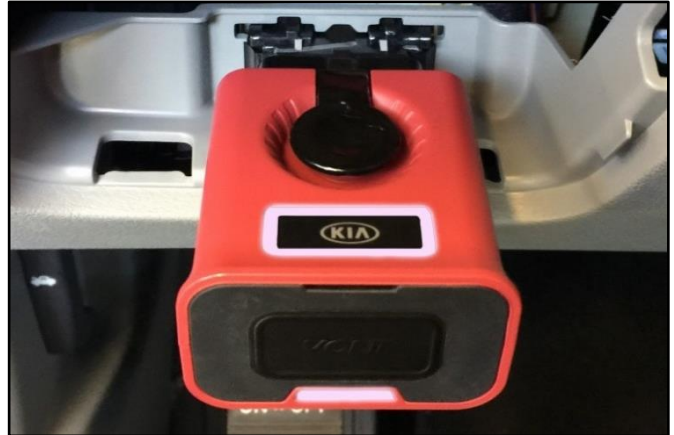
1. Connect the VCI-II to the OBD-II connector, located under the driver's side of the instrument panel.

The ECU upgrade function on KDS operates wirelessly. It is not necessary to perform the upgrade via USB cable.

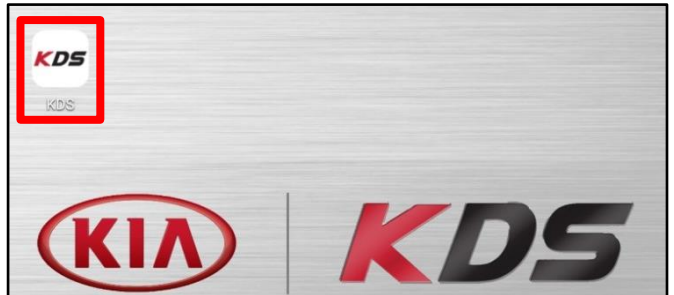
2. With the ignition ON, turn ON the KDS tablet. Select **KDS** from the home screen.

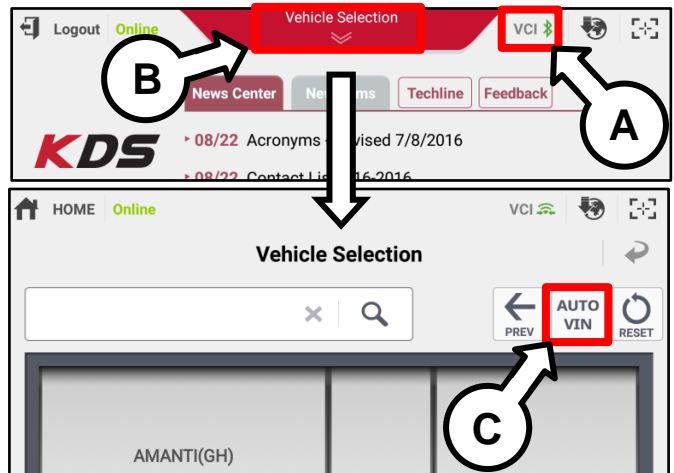
3. Confirm communication with VCI (A) and then configure the vehicle (B) using the **AUTO VIN** (C) feature.

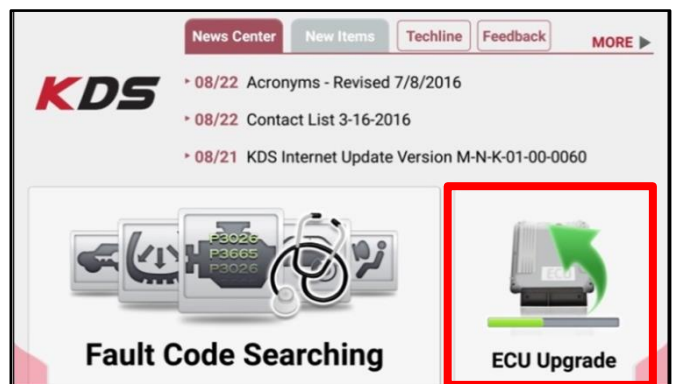
4. Select **ECU Upgrade**.

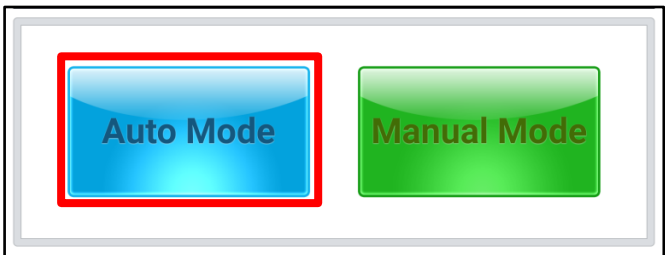
- Select **Auto Mode**.

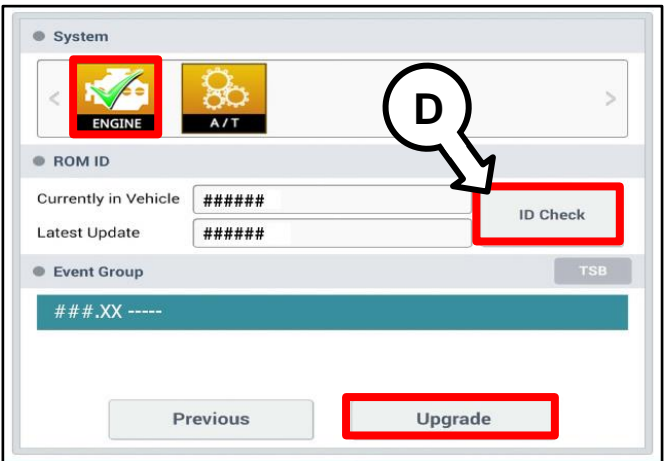
- Select the **Engine** system under the System selection menu.

Touch **ID Check (D)** and confirm that the latest update is available.

Select **Upgrade Event #406** and select **Upgrade** to continue.

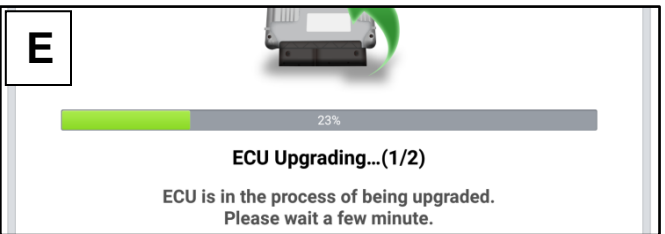
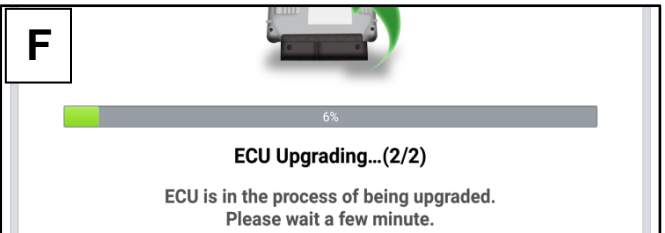
- The ECU upgrade will begin and the progress of the upgrade will appear on the bar graph. Upgrade part (1/2) (E) will download the upgrade event to the VCI-II. Upgrade part (2/2) (F) will upgrade the ECU.

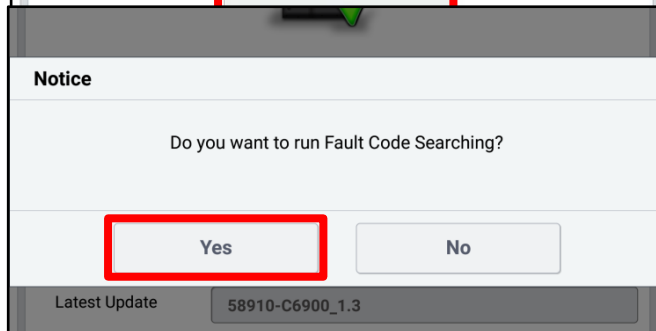
12. When prompted, select **YES** to check for Diagnostic Trouble Codes (DTC) and erase any DTCs stored such as EPS, ESC, and TPMS that may have been set during the upgrade.
