TECHNICAL SERVICE BULLETIN

SERVICE ACTION: WIRING SIGNAL INTERFERENCE CHECK & ENGINE NOISE INSPECTION (\$A379)

This bulletin provides information related to an expanded diagnostic test that is now required on a number of vehicles previously diagnosed with Diagnostic Trouble Code ("DTC") P1326. Using the procedures published in TSB PI1802W/X and PI1803W/X, the subject vehicles were diagnosed and determined to require an engine replacement and are currently being held at dealers pending repair.

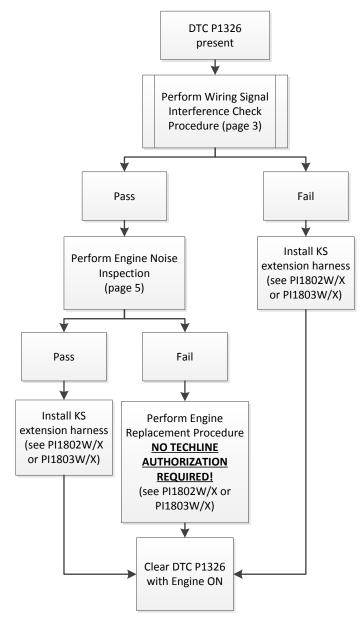
Flow Chart:

Note: If any concerns arise after completing the flow chart, open a Techline case online.

PI1802W/X: Wiring Harness Install – page 12; Engine Replacement – page 17 PI1803W/X: Wiring Harness Install – page 12; Engine Replacement – page 16

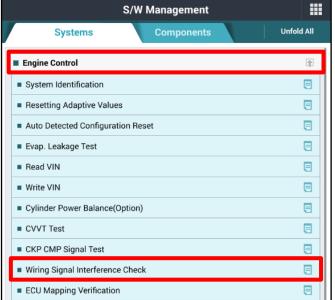
4. Select Engine Control → Wiring Signal Interference Check.

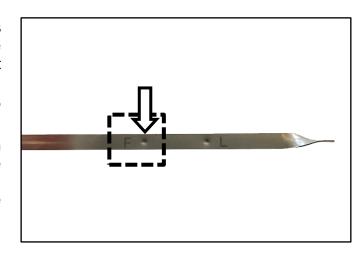
- Prior to inspection, ensure the KDS is fully charged and is connected to the internet <u>every day</u> to ensure the latest update is received and installed.
 - Engine oil level should be at the "FULL" mark. Top off with 5W-30 if required.
 - Test requires the engine to be in satisfactory running condition and able to idle normally.
 - Engine coolant temperature should be above minimum test temperature: 185°F (85°C).

If the engine's running condition is poor due to issues unrelated to a connecting rod knocking noise (faulty sensors, intake/exhaust manifold leak, catalytic converter, etc.), diagnose and repair prior to performing this inspection procedure. If the engine cannot be tested or has other major concerns, see Warranty Claim Authorization information on PI1802W/X (page 40) or PI1803W/X (page 30).

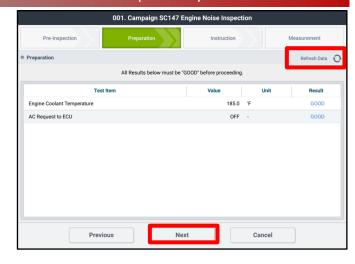
- 12. The program will automatically check the engine sensors' data. Select the "Next" button if all the conditions are satisfied.
 - Engine Coolant Temperature: 185°F or higher
 - A/C Request to ECU: OFF

Note: If the test item result is "NOT GOOD", correct the condition then select "Refresh Data".

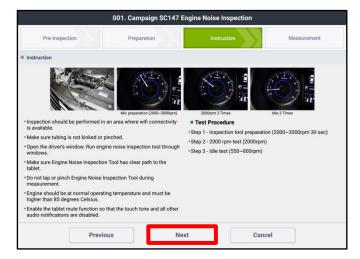
13. Follow the instructions on the screen then select "Next".

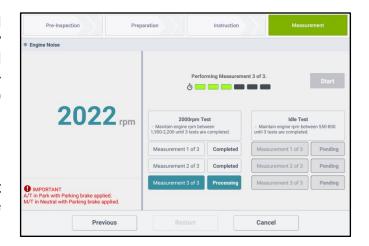
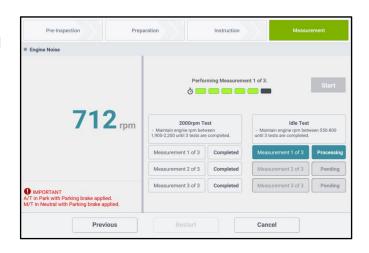
- 16. With the vehicle in Park (A/T) / Neutral (M/T), begin the "2000rpm Test" by increasing and maintaining engine speed between 1,900-2,100 (2.4L) or 1,900-2,200 (2.0T) RPM until all three (3) measurements are complete.
- When the "2000rpm Test" is complete, release the accelerator pedal so that engine maintains idle state for the "Idle Test".
- 18. The "Idle Test" will automatically begin. Keep the engine at idle and wait until all three (3) measurements are complete.

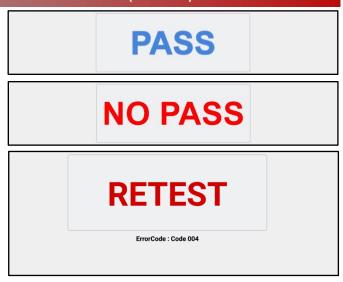
- After the completion of the engine noise inspection, the KDS will automatically generate/display a "PASS" or "NO PASS" result.
 - If the inspection result is "PASS", proceed to the KS Extension Harness Installation procedure in PI1802W/X (page 12) or PI1803 (page 12).
 - If the inspection result is "NO PASS," proceed to the Engine Replacement Procedure in PI1802W/X (page 17) or PI1803W/X (page 16)
 - If the inspection result is "RETEST" with an error code, see Adapter Error Code chart in Appendix 1 on page 13 for corrective action then repeat the inspection procedure starting from step 9.
- 20. Select "Finish" to complete the engine noise inspection. Ensure the KDS is connected to the internet and the "Special Inspection" KDS application is open to automatically submit the results to the Kia Server. To save and/or print the results as PDF, select "Print".

If the KDS is not connected to the internet, up to five (5) results will stay pending in the queue until the KDS is connected to the internet with the "Special Inspection" application open.

Note: The five (5) pending results must be submitted before a sixth (6th) test can be conducted.
