NUMBER
205 (Rev 1, 04/10/2019)

TECHNICAL SERVICE BULLETIN

SUBJECT: SERVICE ACTION: WIRING SIGNAL INTERFERENCE
CHECK & ENGINE NOISE INSPECTION (SA379)

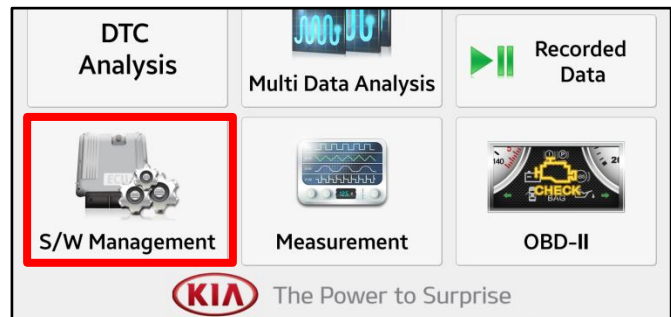
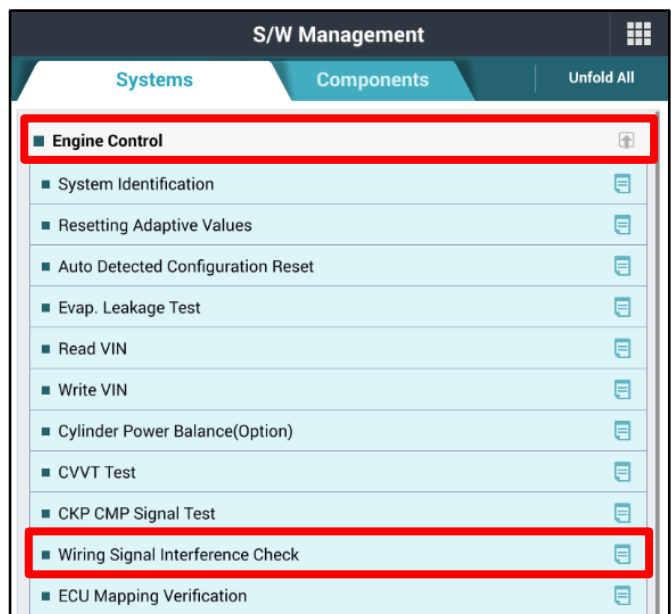
5. Ensure the engine is on and at idle and **ENGINE OIL** temperature is at 176°F degrees or higher. Select OK to proceed.

Purpose	This function is to check wiring signal interference by measuring knock sensor values.
Enable Condition	1. Engine On 2. Engine oil temp must be higher than 176°F (80°C) 3. Do not push accelerator pedal
Concerned Component	-
Concerned DTC	-
Fail Safe	-
Etc

- 5b. Select OK to proceed.

NOTE: This test should only be performed if Knock Sensor Detection System - ECU Logic Improvement (PI1803) has previously been completed.

1. Engine Status : Idle
2. Engine oil temp must be higher than 176°F (80°C)
3. Do not depress accelerator pedal

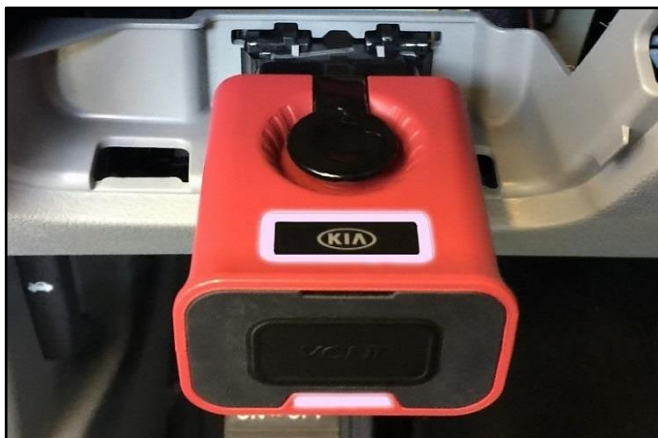
- Connect the VCI-II to the OBD-II connector and launch the KDS application from the KDS tablet home page.
