GROUP <b>TRA</b>	MODEL <b>2017-2018MY Sportage (QL) 2.4L</b>
	NUMBER <b>076</b>	DATE <b>April 2019</b>
<b>TECHNICAL SERVICE BULLETIN</b>		
<b>SUBJECT: 2.4GDI TCU LOGIC IMPROVEMENT FOR SHIFT FLARE</b>

This bulletin provides the procedure to improve the logic of the Transmission Control Unit (TCU) on some 2017-2018MY Sportage (QL) 2.4L vehicles, produced from December 10, 2015 through April 5, 2018, which may experience an intermittent shift flare concern. To correct this concern, apply the improved logic to the TCU using the KDS ECU Upgrade function as described in this bulletin. For confirmation that the latest reflash has been applied to a vehicle you are working on, verify the ROM ID using the table on page 2 of this bulletin.

415. QL THETA 2.4GDI 6AT TCU UP-SHIFT FLARE IMPROVEMENT

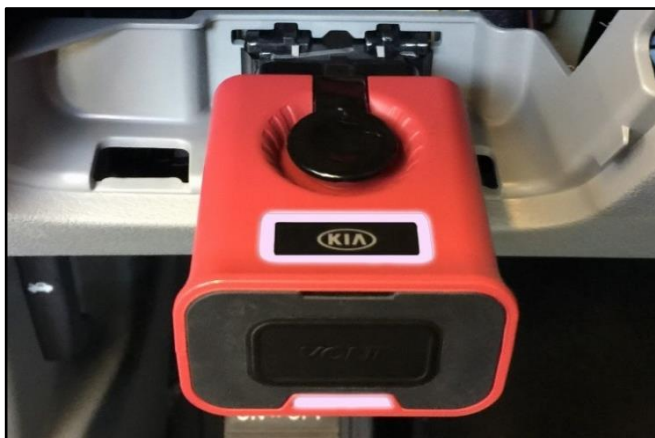
1. Connect the VCI-II to the OBD-II connector, located under the driver's side of the instrument panel.

The ECU upgrade function on KDS operates wirelessly. It is not necessary to perform the upgrade via USB cable.

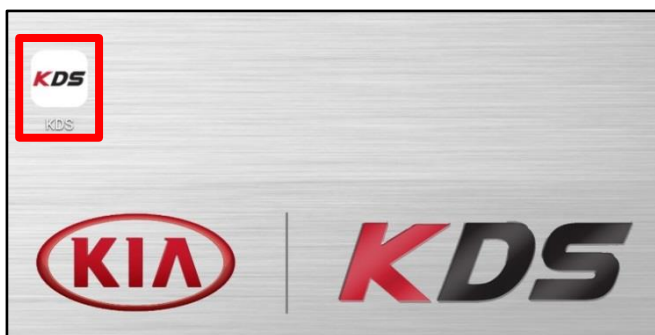
2. With the ignition ON, turn ON the KDS tablet. Select **KDS** from the home screen.

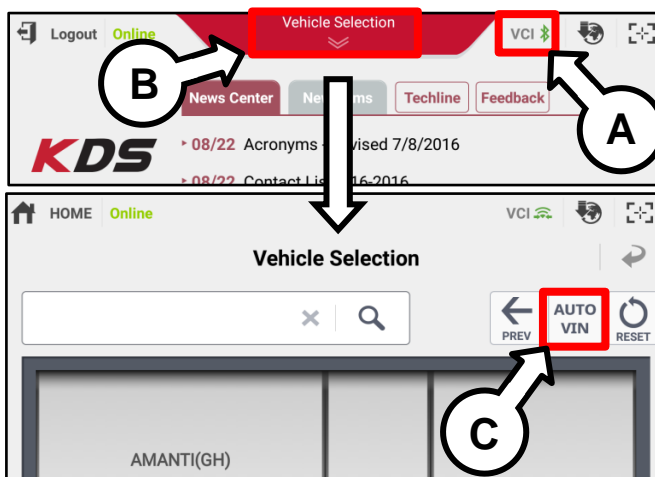
3. Confirm communication with VCI (A) and then configure the vehicle (B) using the **AUTO VIN** (C) feature.

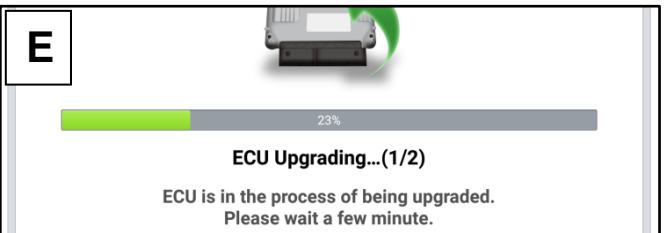
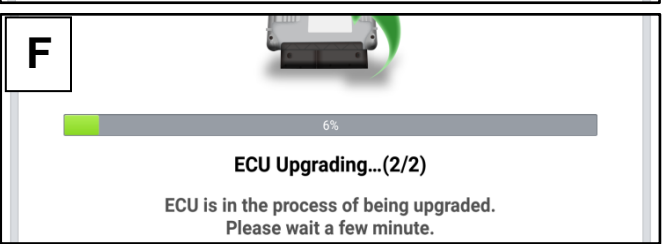
- The ECU upgrade will begin and the progress of the upgrade will appear on the bar graph. Upgrade part (1/2) (E) will download the upgrade event to the VCI-II. Upgrade part (2/2) (F) will upgrade the ECU.

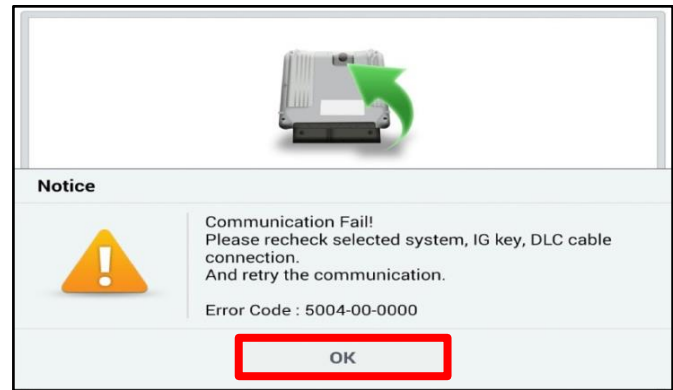
9. If a “Communication Fail” screen appears, verify that the VCI-II and KDS are communicating properly. Touch **OK** and restart the procedure from step 4.

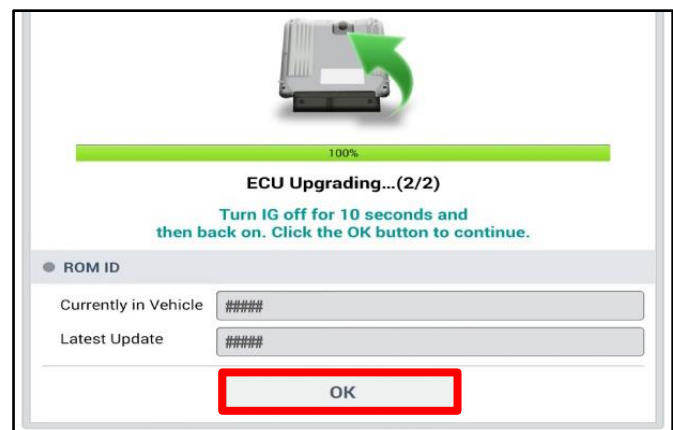
10. When instructed on the KDS, turn the ignition **OFF** for ten (10) seconds then back on. Touch **OK** to continue.

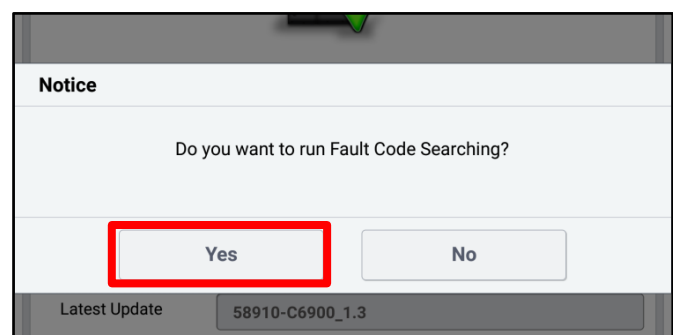
12. When prompted, select **YES** to check for Diagnostic Trouble Codes (DTC) and erase any DTCs stored such as EPS, ESC, and TPMS that may have been set during the upgrade.
