IMPORTANT UPDATE

TECHNICAL INSTRUCTIONS FOR SPECIAL SERVICE CAMPAIGN K0A ENGINE ECU SOFTWARE UPDATE CERTAIN 2018 CAMRY & 2018 SIENNA

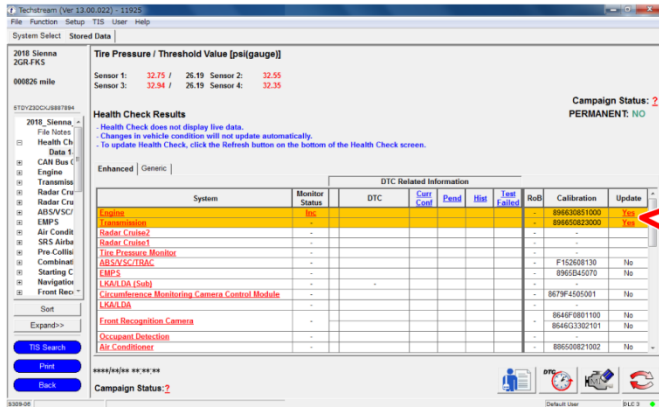
Sample Cal IDs Shown

2. CONFIRM THE ECM CALIBRATION ID

- a) Perform a Health Check.
- b) Confirm the current calibration ID in the ECM (and transmission ECU).
- c) Referencing the table below, verify if the ECM (and transmission ECU) has the updated Calibration(s).

- The current calibration ID of either is shown depending on the vehicle model and specifications.
- In SIENNA, it is necessary to check the 2 IDs of the engine ECU and the transmission ECU.

System	Calibration	Update
Engine	896630851000	Yes
Transmission	896650823000	Yes
Radial Cruise2	-	-
Radial Cruise1	-	-
Tire Pressure Monitor	-	-
ABS/VSC/TRAC	F152608130	No
EMPS	89650823000	No

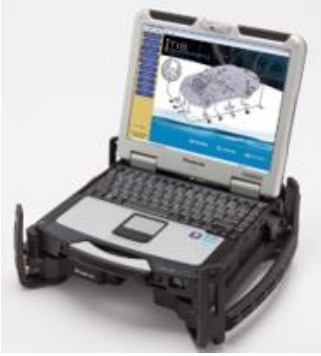
1. PERFORM VERIFICATION HEALTH CHECK

- Using a Techstream, perform a Health Check.
- Clear DTC's that may have set during the re-flash procedure.
- Re-run the Health Check to confirm that no DTC's reappear.**

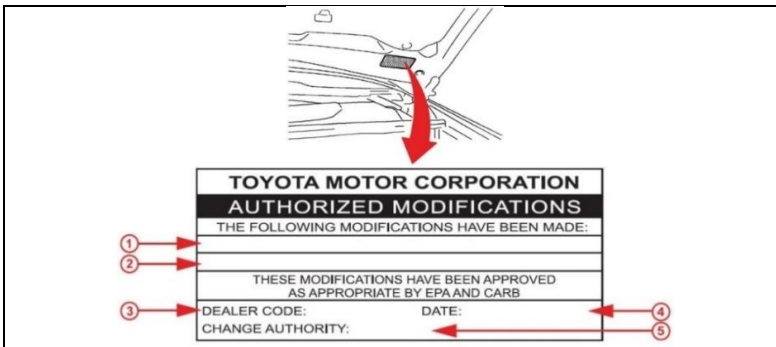
4. ATTACH THE AUTHORIZED VEHICLE MODIFICATION LABEL

- a. Fill out the label.
- b. Affix the label to the under-side of the hood.

1	ECM P/N
2	New Calibration ID
3	Dealer Code
4	Date Completed
5	Campaign Code (XXX)
