IMPORTANT UPDATE

TECHNICAL INSTRUCTIONS FOR SPECIAL SERVICE CAMPAIGN K0A ENGINE ECU SOFTWARE UPDATE

**CERTAIN:
2018 TUNDRA
2018 SEQUOIA**

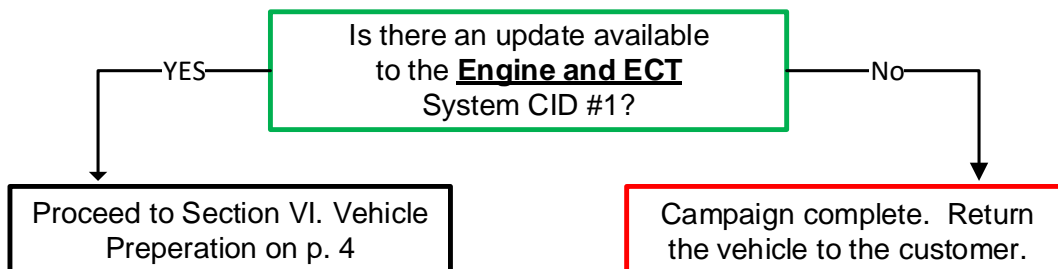
CID #1

2. CHECK CURRENT CALIBRATION

- Locate the Update column for the **Engine and ECT** System in the Stored Data tab for this vehicle.
- Determine the status of an available update for CID #1; indicated by a **Yes or No**.

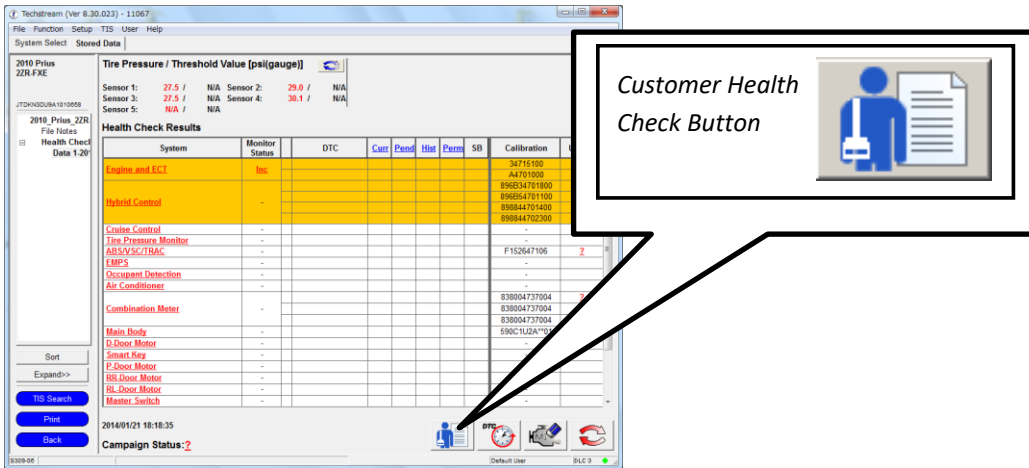
- a. From the Stored Data tab, select the Customer Health Check Report button (TIS will launch when button is pressed).

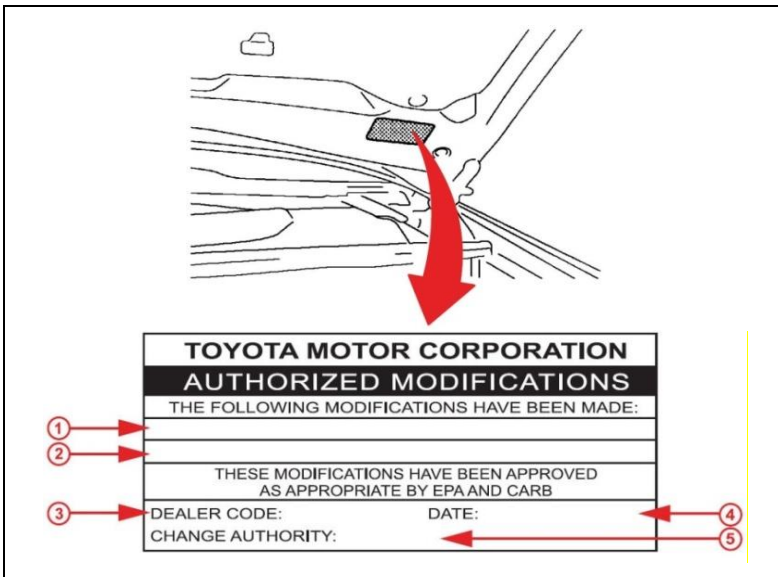
4. ATTACH THE AUTHORIZED VEHICLE MODIFICATION LABEL

- a. Fill out the label.
- b. Affix the label to the under-side of the hood.

| 1 | Engine and ECT CID's |
| 2 | (Calibration ID's) |
