**HYUNDAI**  
**Technical Service Bulletin**

GROUP <b>CAMPAIGN</b>	NUMBER <b>19-01-006H-2</b>
DATE <b>APRIL 2019</b>	MODEL(S) <b>APPLICABLE VEHICLES BELOW</b>

**SUBJECT:** THETA GDI ENGINE DTC P1326 - WIRING INSPECTION /  
 INSTALLATION AND ENGINE INSPECTION / REPLACEMENT  
 (SERVICE CAMPAIGN T3G)

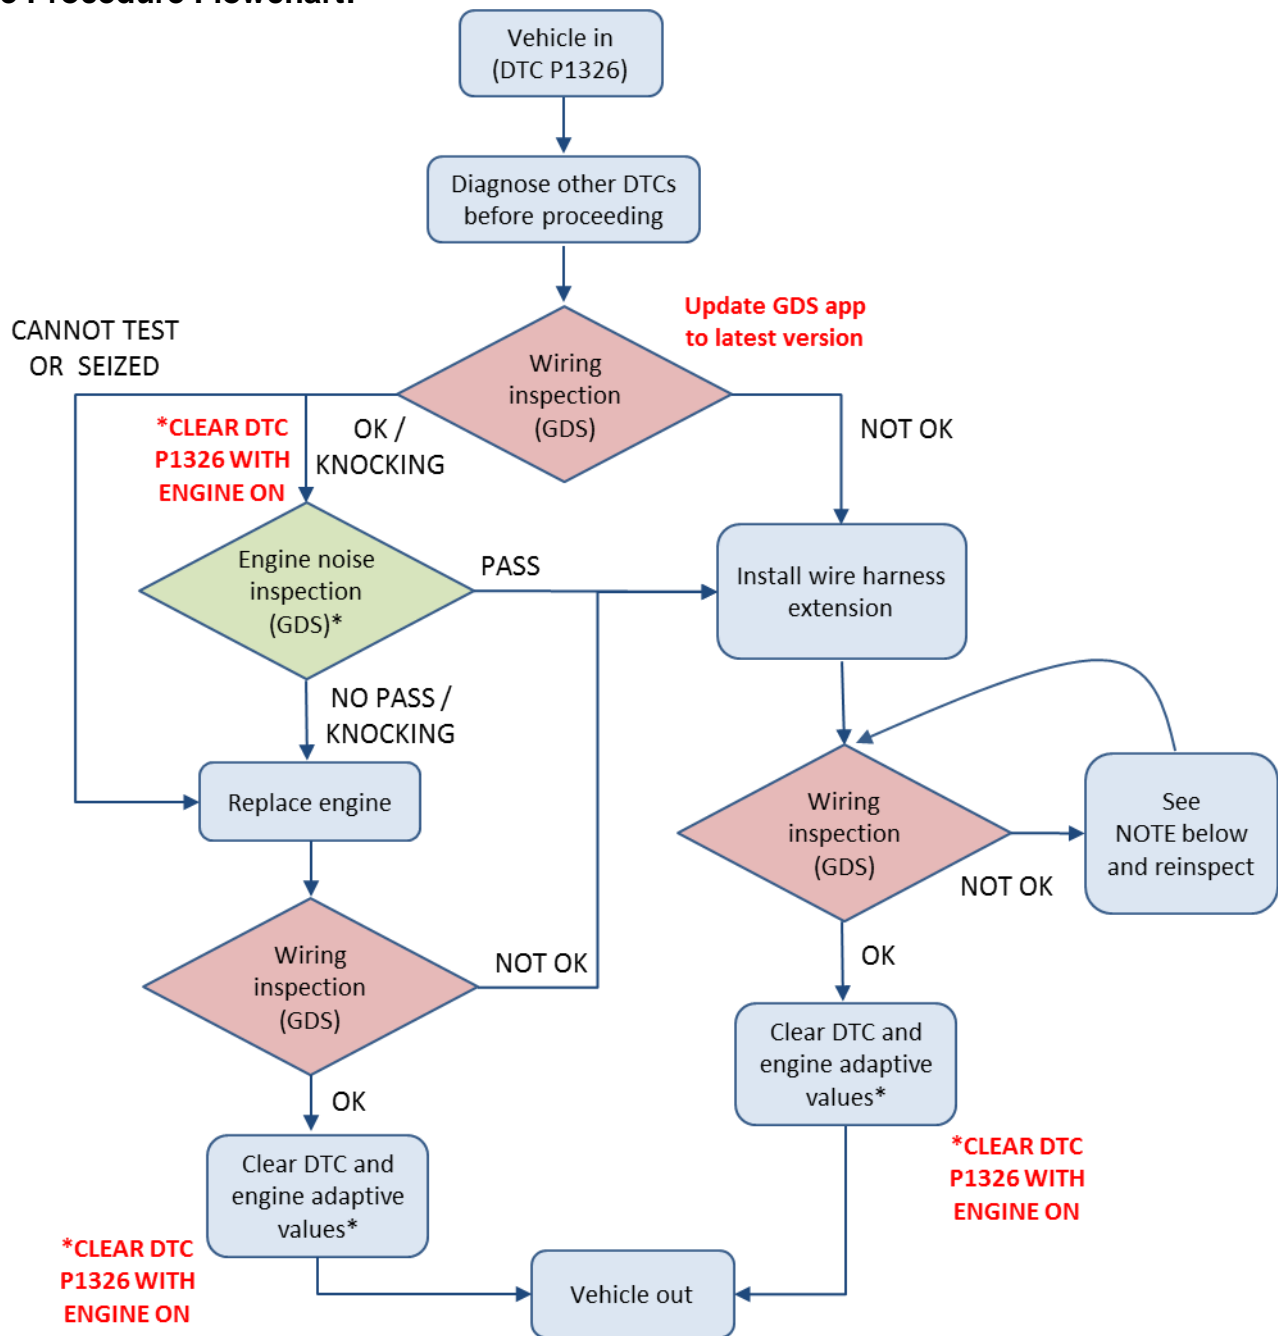
**Service Procedure Flowchart:**

**NOTE:**

If the wiring inspection is still NOT OK after installing the harness extension, proceed with the following steps until an OK test result is achieved.

- 1) Confirm pins are properly installed and secured in engine ECM connector and **reinspect**
- 2) Remove knock sensor and reinstall **with torque wrench to 15 lb-ft** and **reinspect**
- 3) Install new knock sensor **with torque wrench to 15 lb-ft** and **reinspect**

- Install the new wire harness extension kit and perform the inspection again.
- If the test result is still NOT OK after installing the extension harness, follow the Service Procedure flowchart on Page 10 until an OK test result is achieved.

- Follow the Service Procedure flowchart on Page 10 until an OK test result is achieved.

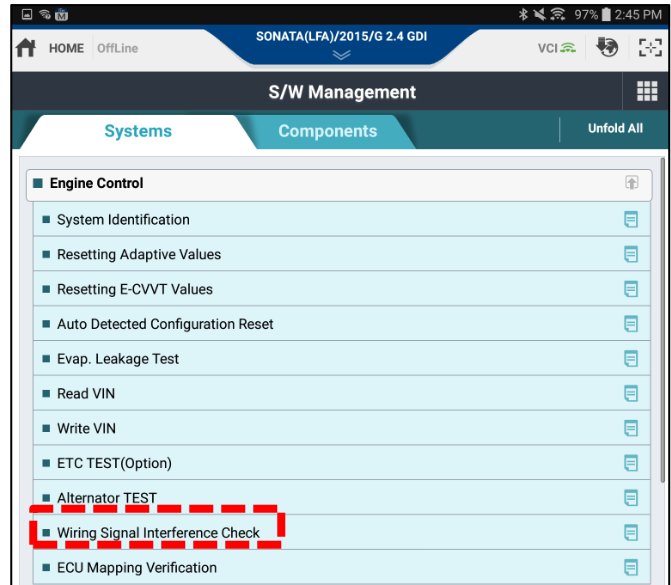
1. Check for DTCs and perform the appropriate diagnostic service. All DTCs other than P1326 should be resolved before performing the wiring inspection.
2. Warm the engine until the engine oil temperature is 176° F (80° C) or greater.
3. From the GDS main screen, navigate to **S/W Management > Engine Control** and select **Wiring Signal Interference Check**.

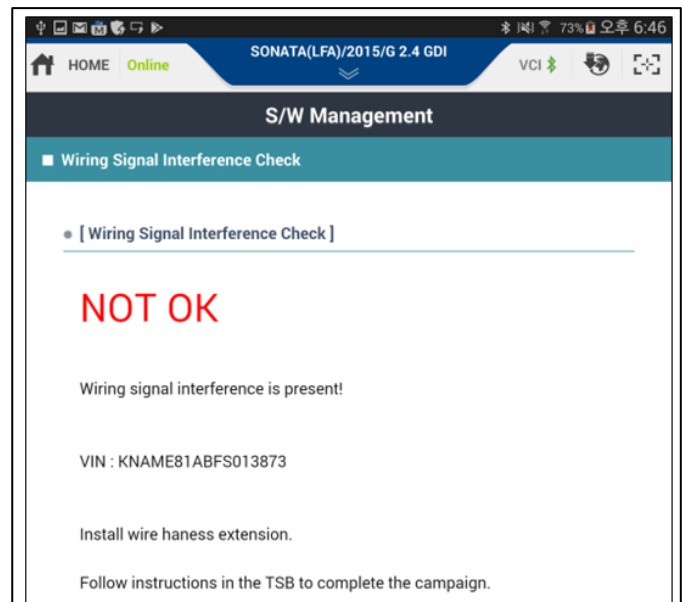
4. Follow the prompts on the GDS to complete the inspection. At the end of the inspection, take a screenshot of the results screen.

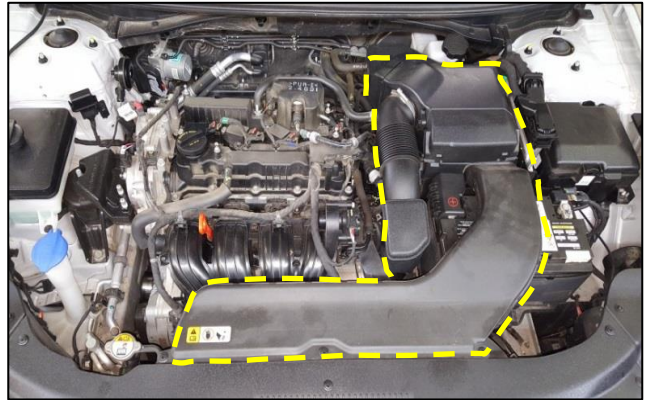
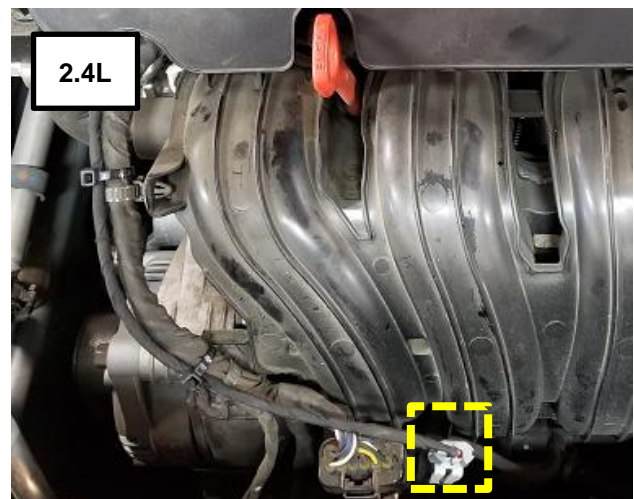
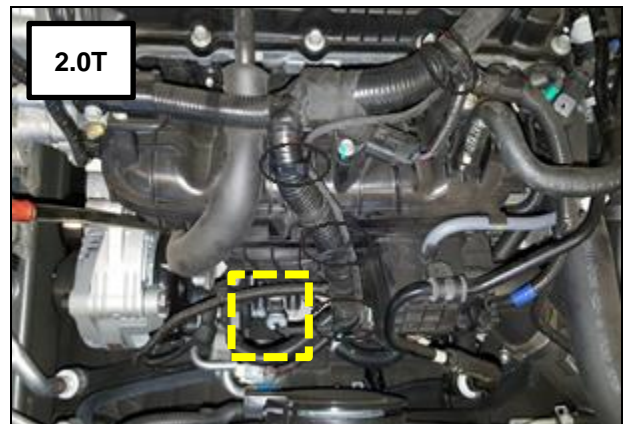
2. Disconnect the knock sensor connector and connect the connector from the new wire harness extension.

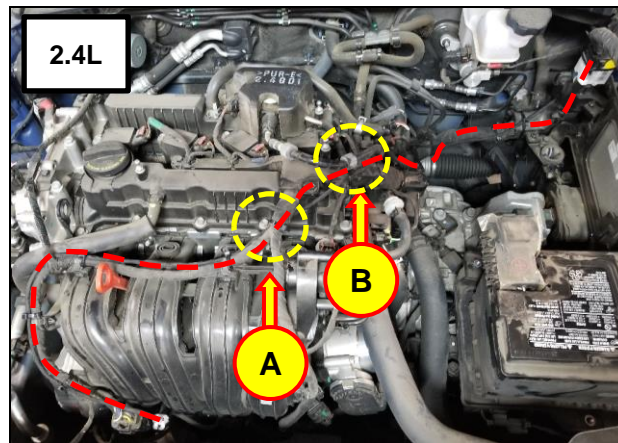
3. Route the new wire harness extension from the knock sensor connector to the engine ECM along the existing path of the engine control wire harness.

Ensure the new wire harness extension is:

- Underneath the original engine control wire harness at (A).
- On top the original engine control wire harness plastic protector at (B).

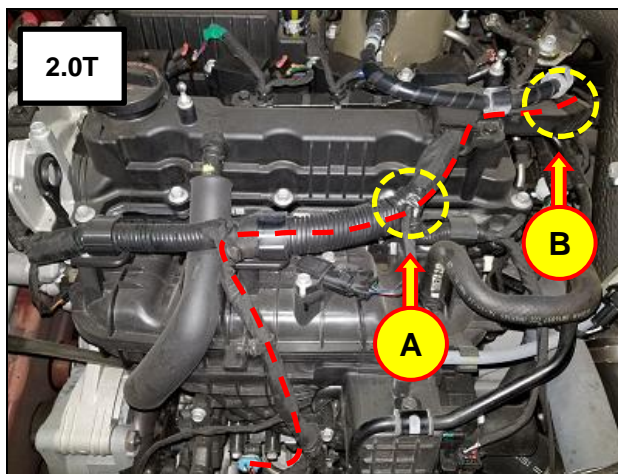
15MY Sonata (LF) vehicle is pictured for reference. Routing of the harness on other models is similar.

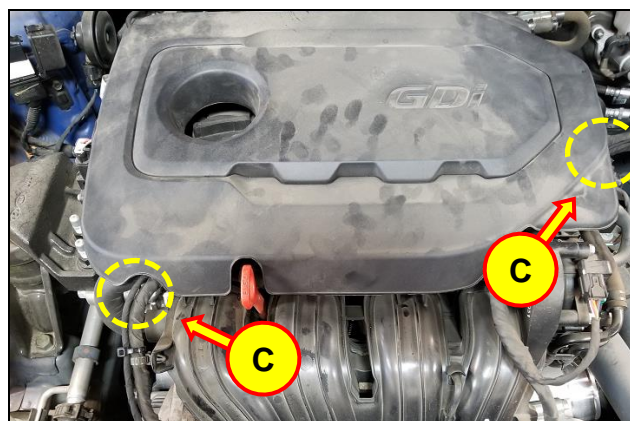
4. Secure the new wire harness extension along the existing control wire harness with zip ties and existing clips.

5. Reinstall the engine cover and ensure the new wire harness extension does not contact the engine cover at (C) and any other areas.

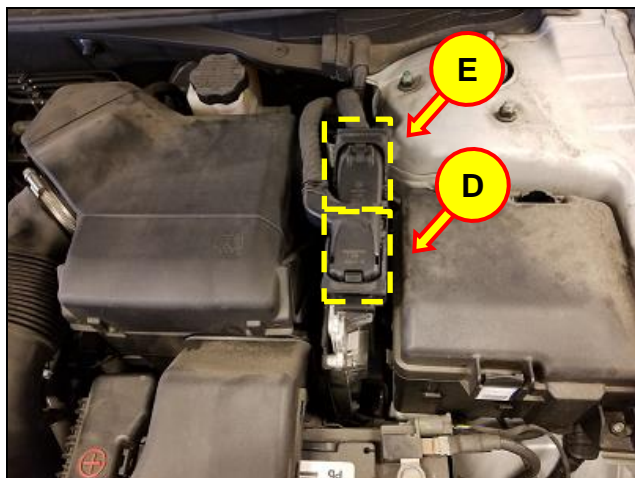
6. Identify the Engine ECM connector (D) or (E) to modify based on vehicle model and MY. Then check the connector’s manufacturer as shown (BOSCH or KET).

Model / MY	ECM Connector
11-14MY Sonata (YF) 13-16MY Santa Fe Sport (AN) 14-15MY Tucson (LM)	D
15-18MY Sonata (LF) 17-18MY Santa Fe Sport (AN) 18MY Tucson (TL)	E

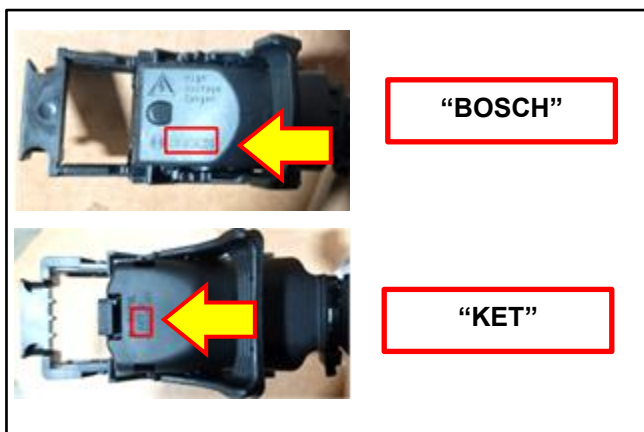
**To Remove Connector (D):**

Remove ECM connector (D) and top cover by gently prying at (F1) or pressing on (F2) based on connector type using a flat head screwdriver.

**To Remove Connector (E):**

First remove ECM connector (D) to release ECM connector (E). Then remove ECM connector (E) and top cover by gently prying at (F1) or pressing on (F2) based on connector type using a flat head screwdriver.

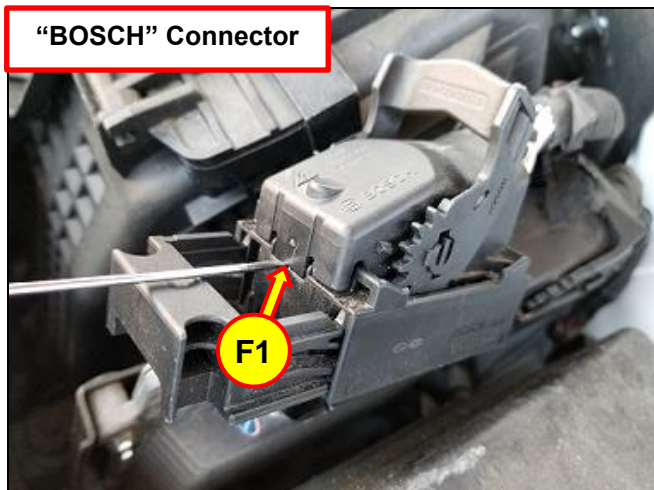
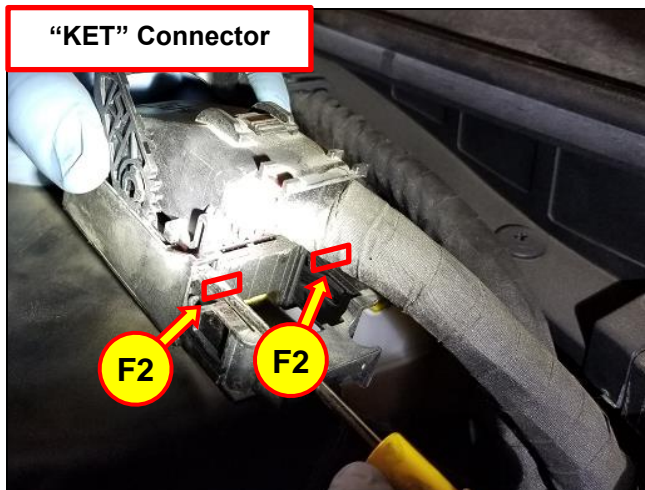
“BOSCH”

“KET”

**DO NOT use excessive force when removing the ECM connector cover. The cover comes off with minimal effort when using the release tab(s) F1 or F2.**

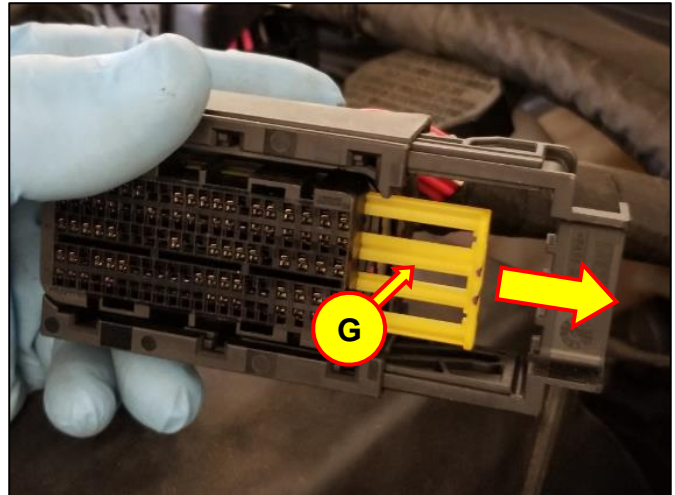
7. Fully remove the connector retaining clip from the connector by gently prying at (G) using a small flat head screwdriver.

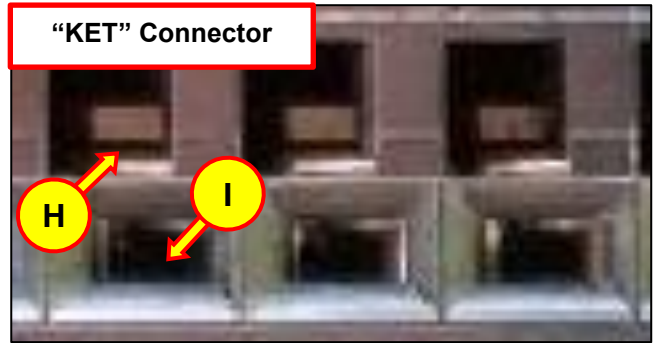
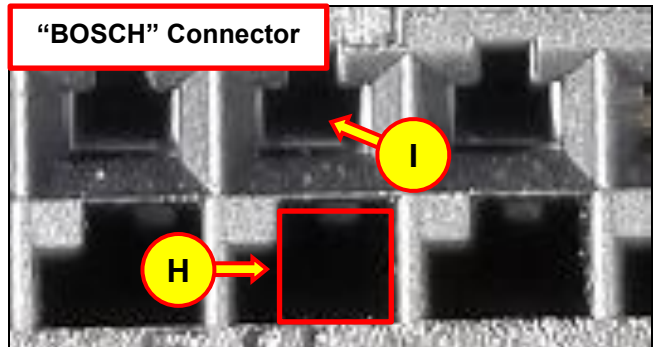
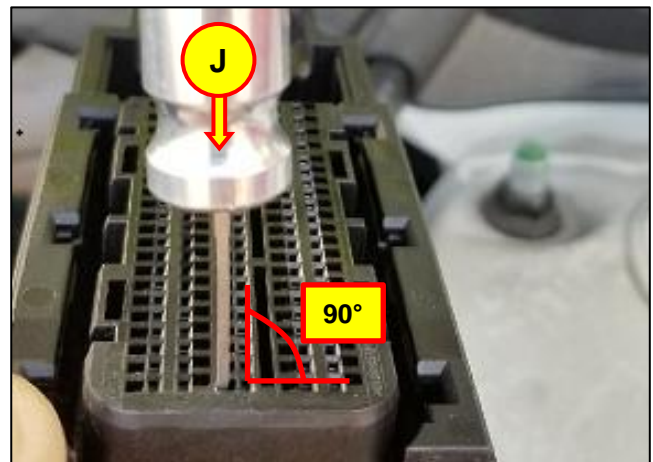
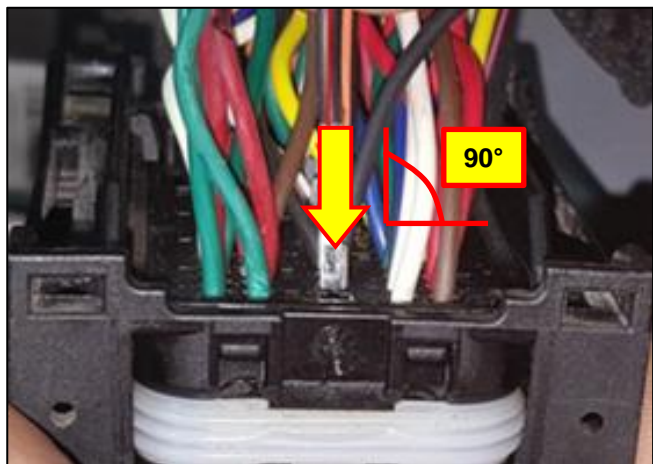
8. Locate the knock sensor pins on the ECM connector (D) or (E) based on vehicle model and MY table above.

- PIN 44 - shield ground
- PIN 45 - knock sensor ground
- PIN 62 - knock sensor interface

- PIN 63 - knock sensor interface
- PIN 62 - knock sensor ground
- PIN 61 - shield ground  
(No PIN 61 for 18MY Sonata 2.0T)

9. Carefully remove the pins for the knock sensor from the ECM connector using the SST. Insert the SST perpendicular (90°) to the surface of the connector at (H) to release each pin (I) and gently pull the wire to remove each pin from the connector.

10. Insert each of the pins from the new wire harness extension into the ECM connector until fully seated. A slight click sensation and sound indicates the terminal is fully seated.

- Red – knock sensor interface
  - Black – knock sensor ground
  - Blue – shield ground
- (Not for 18MY Sonata 2.0T)

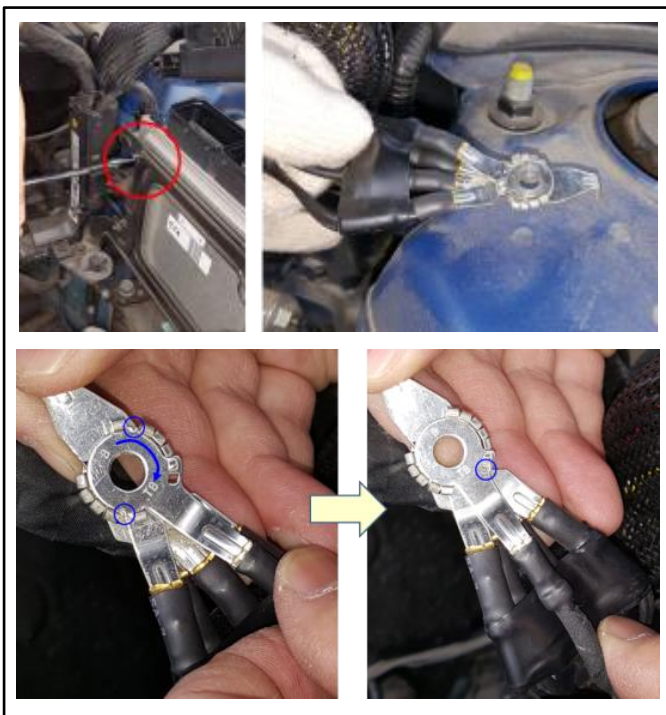
**11. For 18MY Sonata 2.0T only:**

- Loosen the ground bolt on the chassis.
- Connect the new extension wiring's ground terminal to the existing ground terminal. Rotate the new ground terminal clockwise as shown.
- Tighten the ground terminal to the chassis.

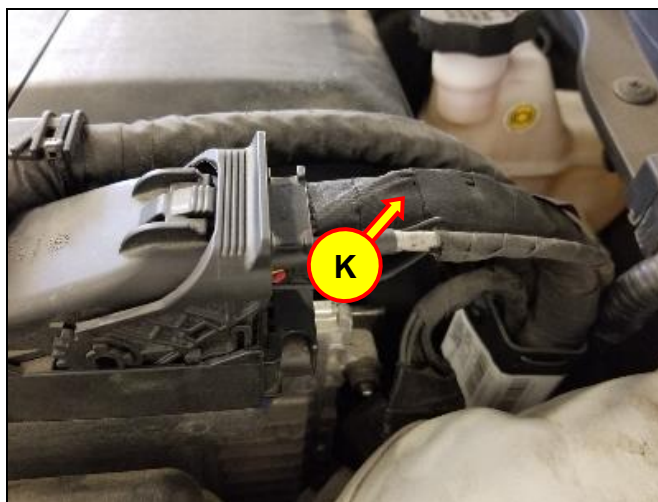
12. Cut off and discard the original terminals from the ECM connector and fold the original wires (K) back onto the original engine control wire harness and secure with tape. Secure any excess wire from the new wire harness extension onto the original engine control wire harness with tape.

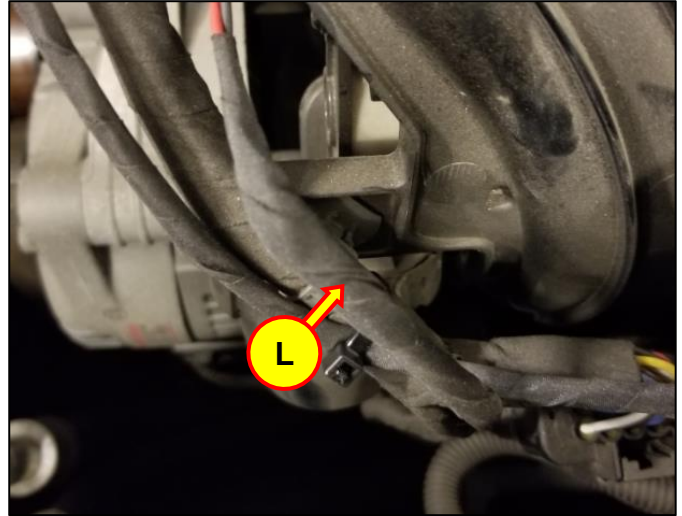
13. Cut off and discard the original knock sensor connector and fold the (2) original wires (L) from the original knock sensor connector back onto the original engine control wire harness and secure with tape.

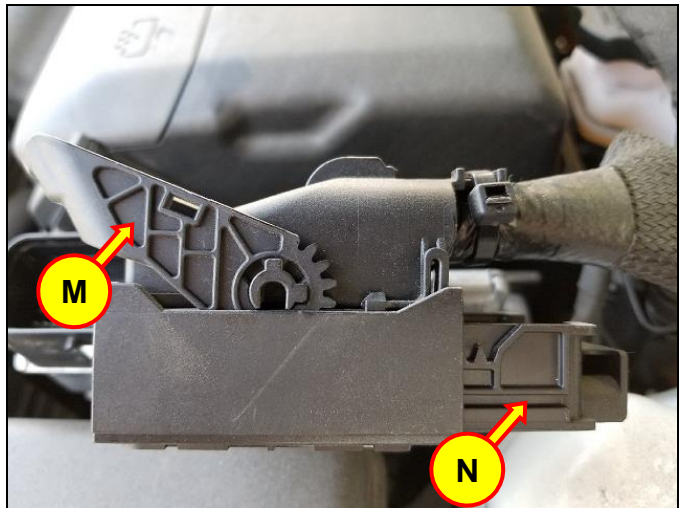
DO NOT use excessive force when reinstalling the ECM connector cover. The cover will easily snap onto the connector with minimal effort when properly aligned. Refer to original orientation of the lever (M) and slider (N) and slightly move slider (N) as necessary until the cover easily snaps onto the connector.

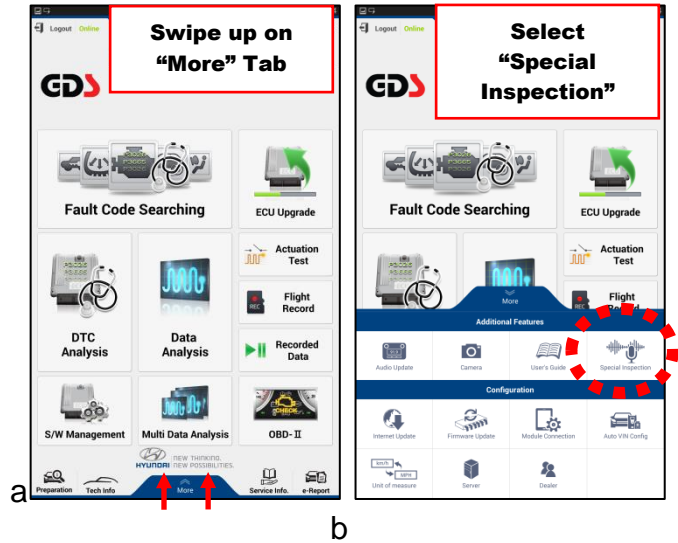
1. The inspection procedure will consist of preparing the vehicle and then performing an inspection using the “**Special Inspection**” function of the GDS Mobile application.
  - Obtain the latest GDS Mobile update daily. The GDS Mobile must be connected to the internet via WiFi daily to confirm the latest software update is installed or the application will not function.
  - Connect the GDS VCI to vehicle DLC.
  - VCI should be updated with latest version and paired with GDS Mobile.
  - Open the GDS Mobile App.
  - Swipe up on the “More” tab at the bottom of the screen.

Select the “Special Inspection” function.

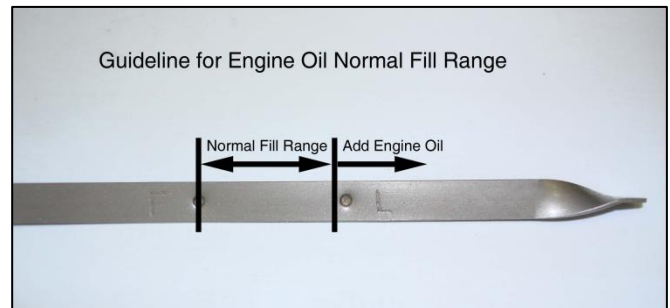
2. Prior to inspection, the engine should be in a satisfactory running condition.
  - Engine oil level should be in the normal range (shown at right).
    - Use Quaker State 5W-30 viscosity engine oil or other brand if not available (conventional type with API SM / ILSAC GF-4 or higher service grade) to adjust the oil level if necessary.
  - Engine should idle normally.
  - Clear all DTCs
  - If P1326 sets while performing the noise inspection, unplug the knock sensor and perform the test again.

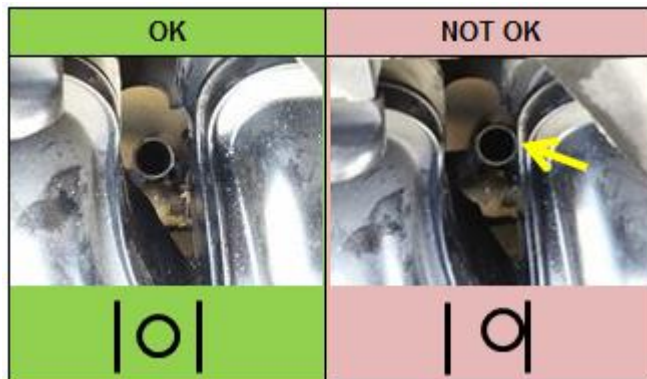
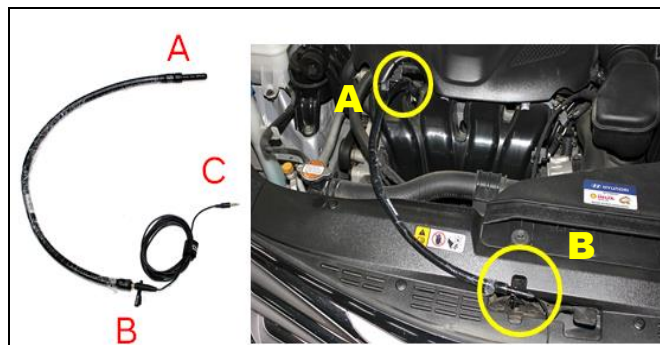
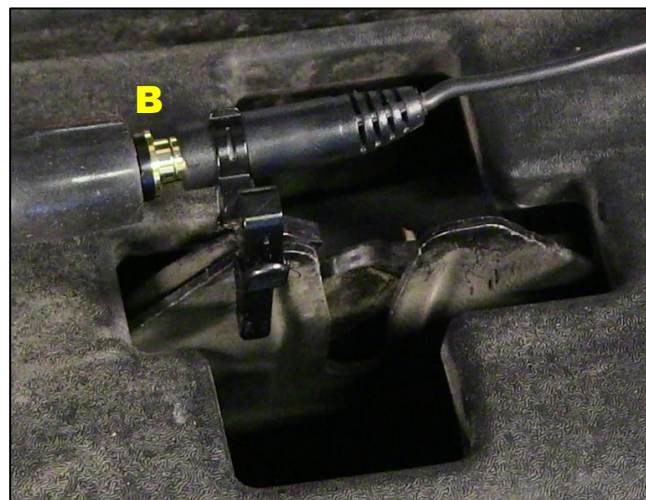
4. Prepare the vehicle and Engine Noise Inspection Tool as follows:
- Remove the oil level rod assy (engine oil dipstick).
  - Insert the adapter (A) into the oil level gauge tube (dipstick tube).
  - Check for interference between the dipstick tube and the intake manifold.

Adjust the dipstick tube to create clearance between the tube and manifold if necessary.

- Attach the clip (B) to the hood latch.
- Connect the stereo jack (C) to the GDS Mobile headphone jack.
- Feed the inspection tool through the open driver’s front window.

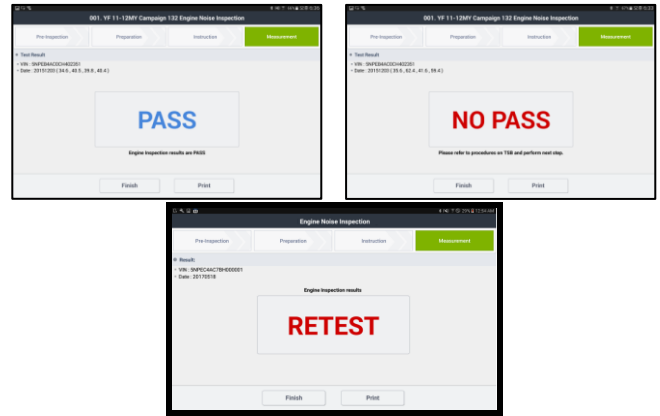
6. After the Engine Noise Inspection is complete, the application will display **PASS**, **NO PASS**, or **RETEST**.

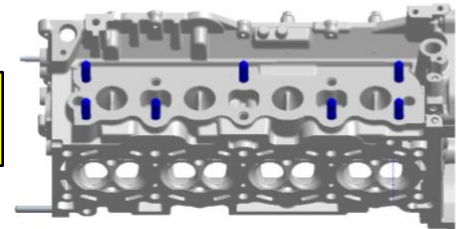
**SULEV / CAL Spec**

4. **For 2.4L with ULEV / FED emissions only**  
 2.4L replacement engines are produced with the exhaust manifold studs configured for SULEV / CAL emissions package.

Two exhaust studs must be relocated on the new engine and 1 exhaust stud must be transferred from the old engine.

**Exhaust Stud Position Relocation Information**

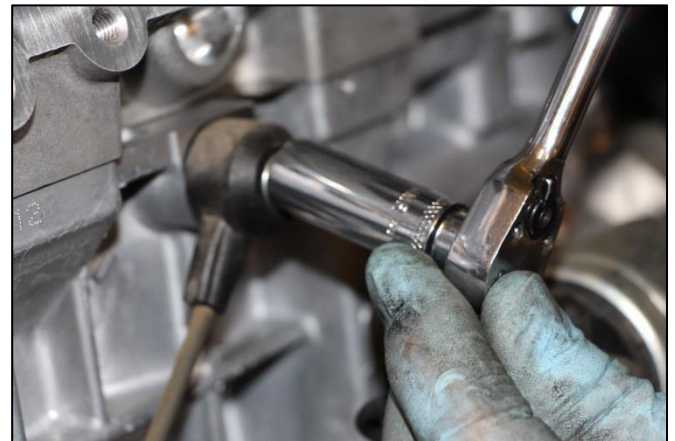
5. Remove and reinstall the engine knock sensor from the old engine to the new engine.

**Knock Sensor Fastener**  
**Tightening torque: 21Nm (15.5lb-ft)**

Ensure the knock sensor is torqued to specification using a torque wrench. Improper installation can result in DTC codes.

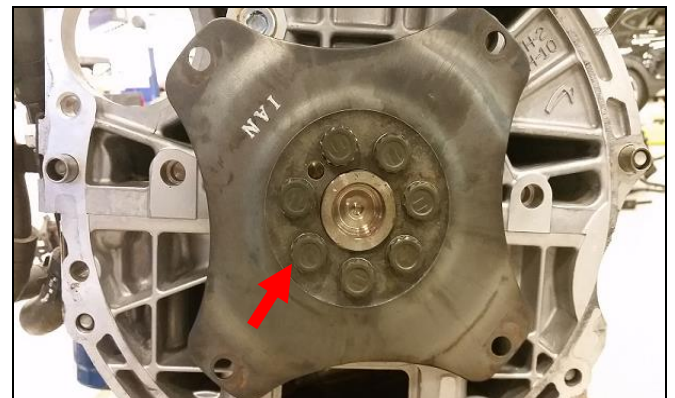
6. **If 21101-2GK70QQA engine is used:**

- Install the oil filler cap from the old engine to the new one.
- Install the drive plate/flywheel on the new engine using new bolts (QTY 7).

**Drive Plate Tightening torque :**  
 111.7 ~ 127.5 Nm (86.8 ~ 94.1 lb-ft)

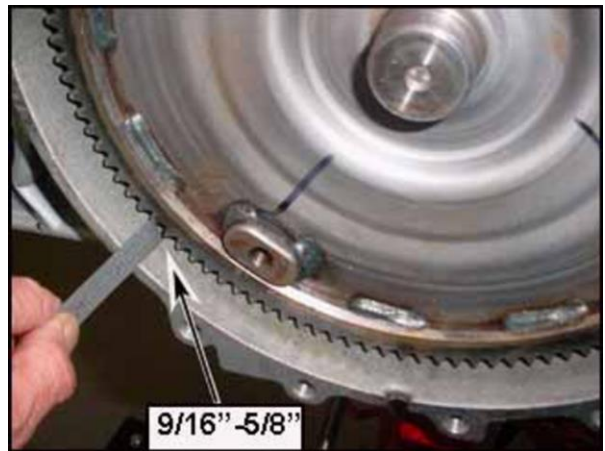
If the torque converter has moved from the fully inserted position, carefully push inward and rotate the torque converter until the converter is recessed approximately  $9/16 - 5/8$ " (14 -16 mm) into the transaxle case when reinstalling the automatic transaxle.

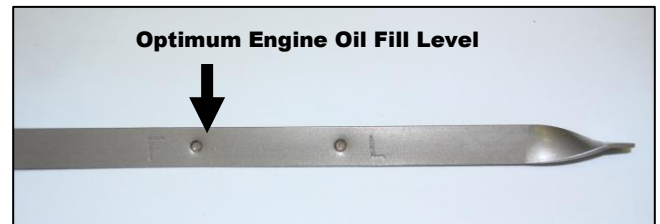
13. Start the engine to warm it up and begin the cooling system air bleeding process.
  - Check for any leaks during this time.
  - After the engine has warmed up to normal operating temperature, turn the engine off, wait a few minutes, and then **adjust the engine oil level to near the “F” mark as shown.**
