## SERVICE ACTION: PROGRAM OR REPLACE DUAL STORAGE SYSTEM BATTERY

G05 (X5 Sports Activity Vehicle)	G07 (X7 SAV)	G20 (3 Series Sedan)	G29 (Z4 Roadster)

Software error in Dual Storage System Battery

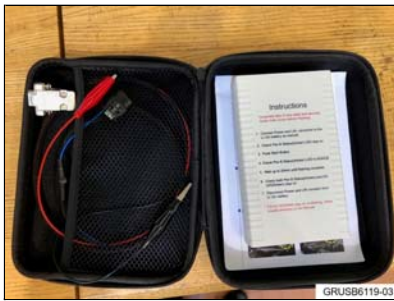
<p style="text-align: right; font-size: small;">GRUSB6119-03</p>	<p>4. Obtain the flashing tool with adapter cable.</p>

2. Make sure the key is off and connect the battery charger to the vehicle.
3. Remove the passenger side rear engine compartment cover.

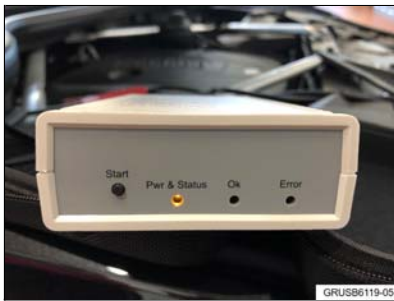
<p style="text-align: right; font-size: small;">GRUSB6119-04</p>	<ol style="list-style-type: none"> <li>5. Remove the 4-pin connector from the battery and connect the 4-pin adapter from the tool.</li> <li>6. Connect the power and ground from the tool directly to the battery terminals.</li> </ol>

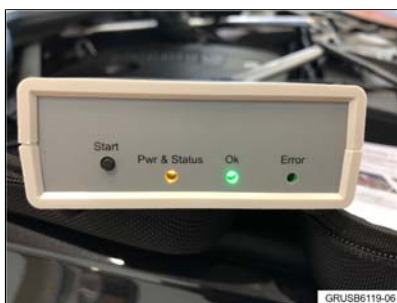
<p style="text-align: right; font-size: small;">GRUSB6119-05</p>	<ol style="list-style-type: none"> <li>7. Place the flashing tool away from any engine heat.</li> <li>8. Once connected, the flashing tool amber LED (Pwr &amp; Status) will be lit up.</li> </ol>
	<p>9. Press the start button and the amber LED will flash indicating the DSS battery is being programmed.</p>

10. After about 10-20 minutes the OK LED turns green indicating a successful programming.
11. If the Error LED lights up red, refer to the troubleshooting guide that came with the tool.
12. Remove the flashing tool and connect the 4-pin vehicle harness back to the battery.
13. Reinstall the battery cover.

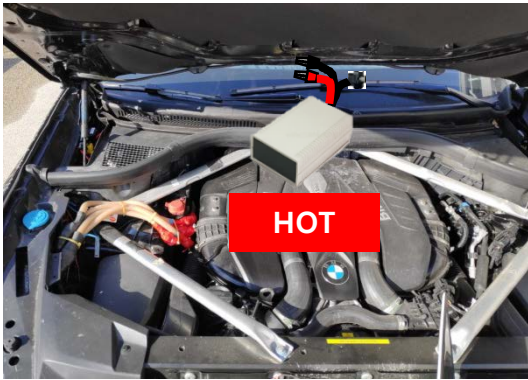
( X )

1) Engine compartment may be hot after driving. Wait until enough time to cool down and **DO NOT** put this flashing kit over **HOT** components during the software update.

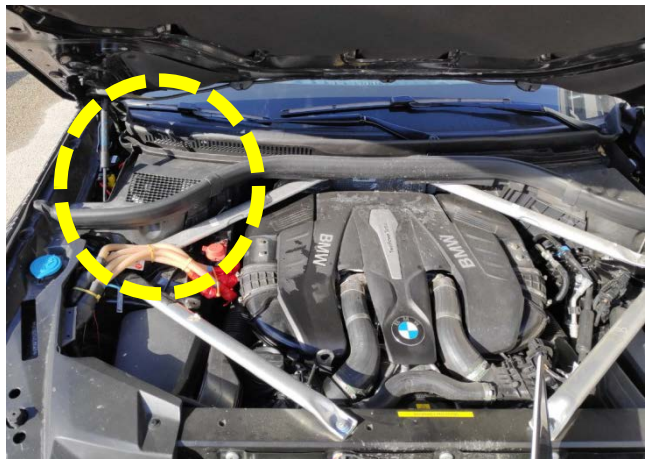
### Step 1

Engine "OFF"  
Open vehicle hood  
&  
Remove battery panel

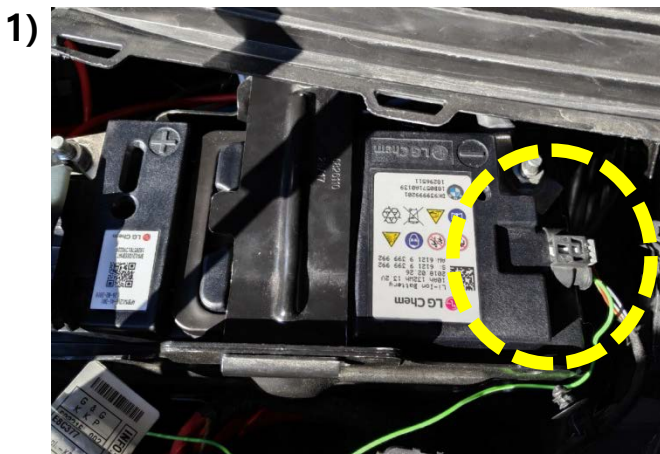
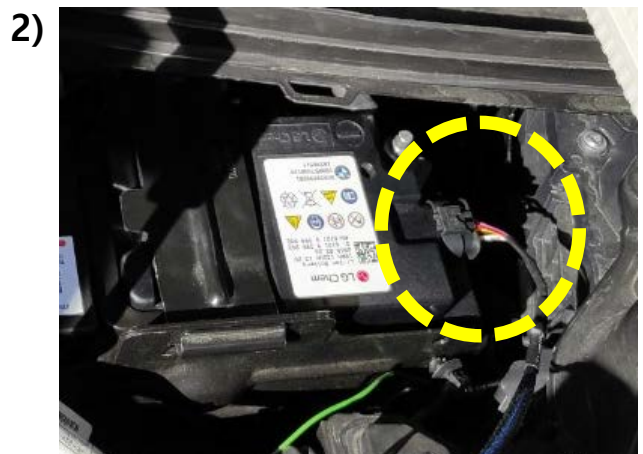
### Step 2

Replace vehicle  
connector with KIT  
connector

1) Remove vehicle connector from Li-12V Battery

2) Connect KIT connector to Li-12V Battery

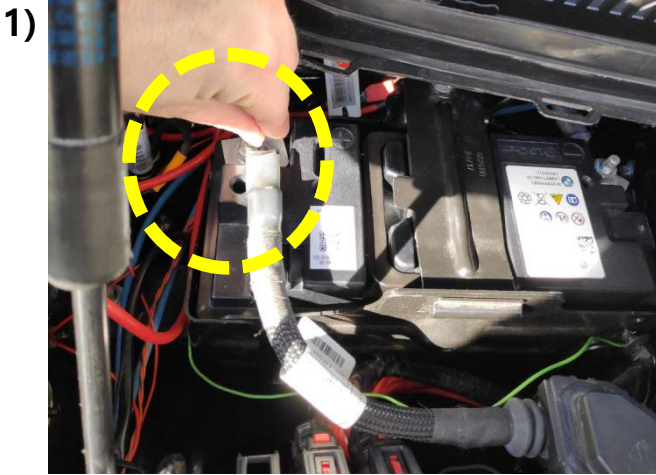
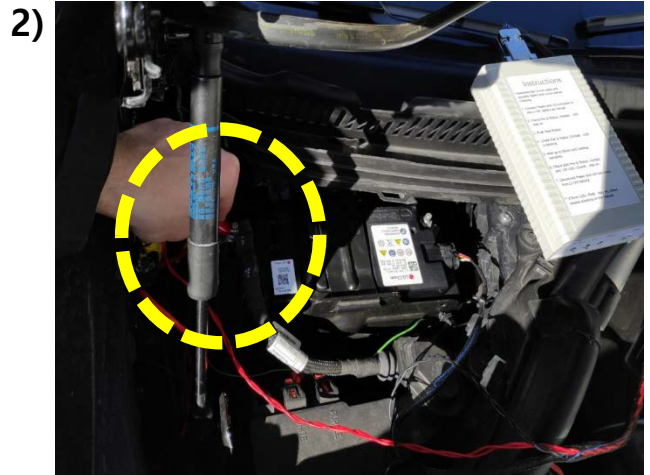
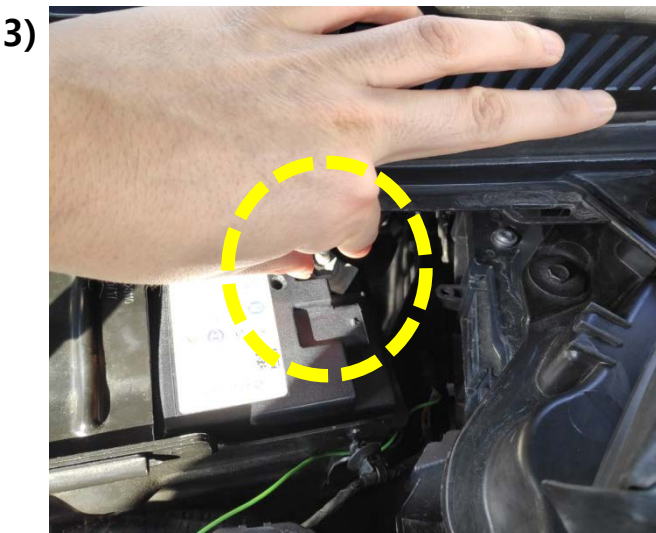
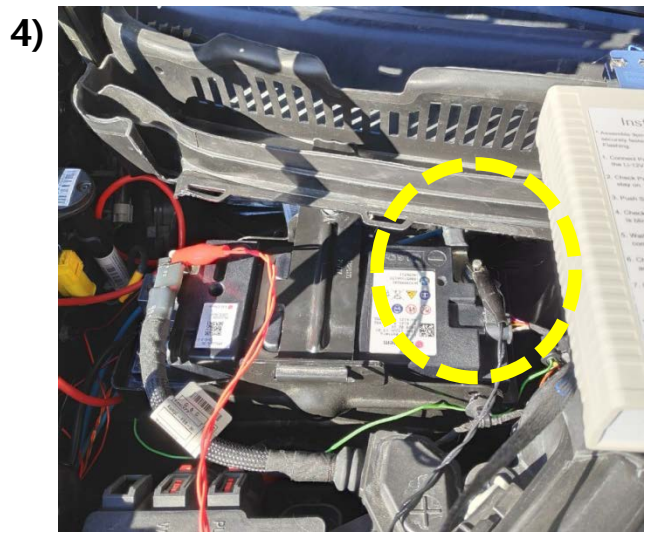
Step 3

Supply power to KIT

- 1) Remove **positive** pole protection
- 2) Attach a **RED** alligator clip to positive pole
- 3) Remove **negative** pole protection
- 4) Attach a **BLACK** alligator clip to negative pole

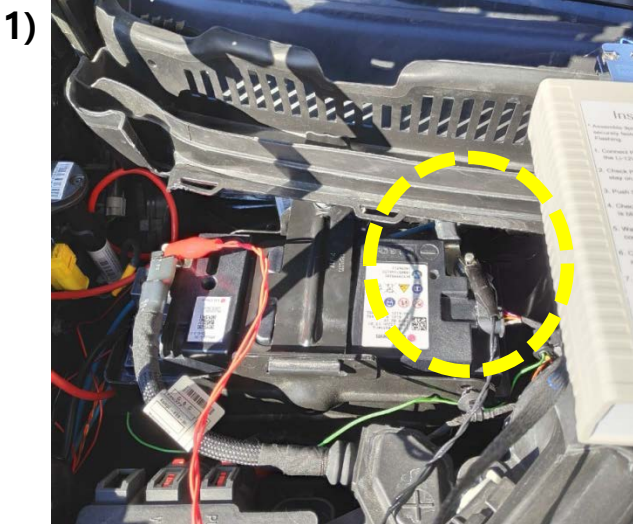
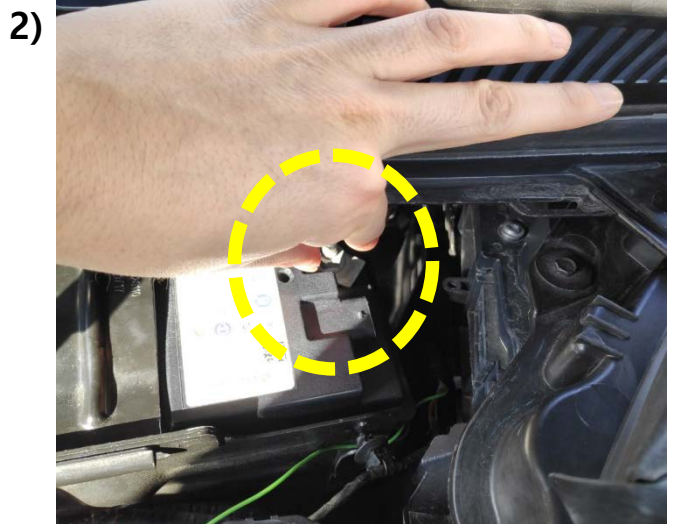
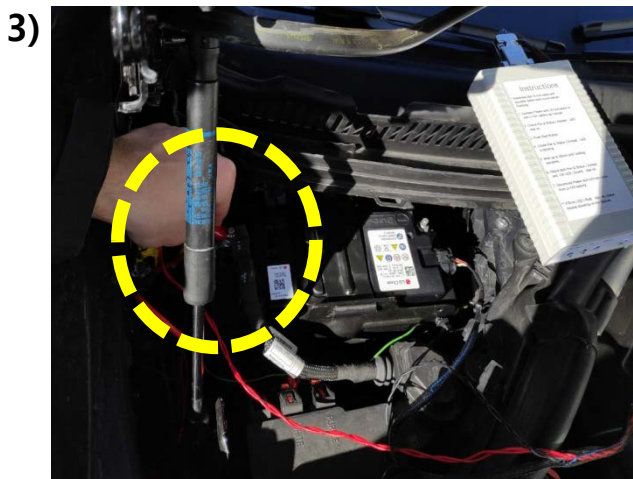
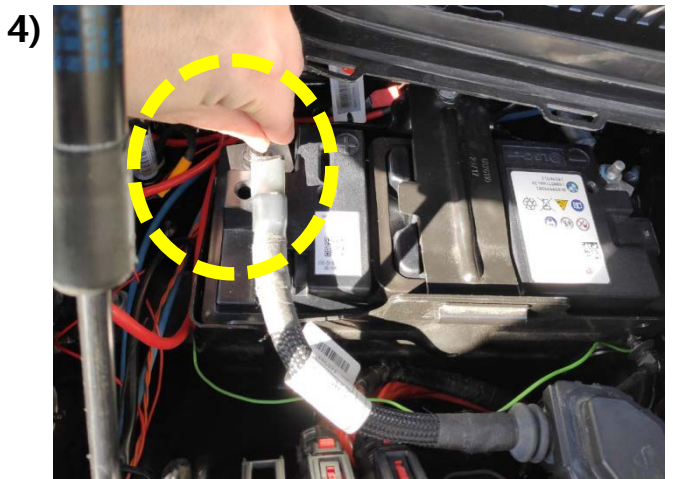
**Step 7** Remove power to KIT

- 1) Remove a **BLACK** alligator clip from negative pole
- 2) Attach **negative** pole **protection**
- 3) Remove a **RED** alligator clip from positive pole
- 4) Attach **positive** pole **protection**

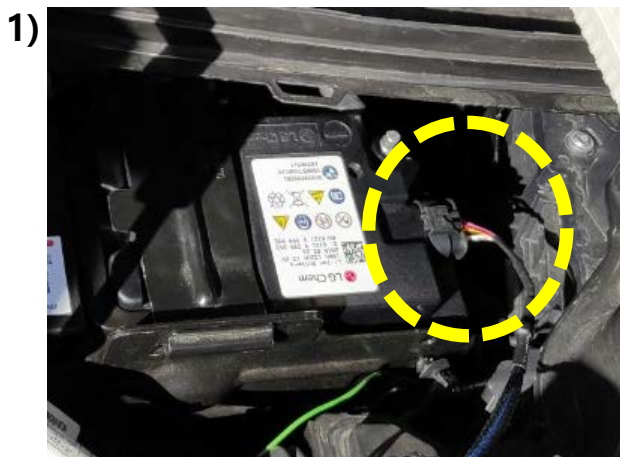
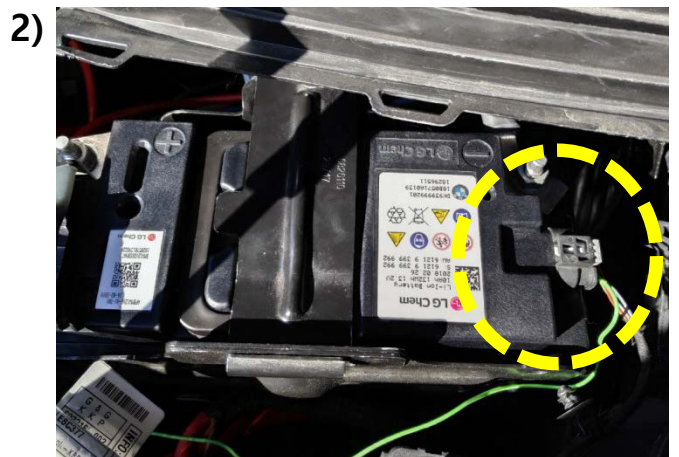
**Step 8** Replace KIT connector with vehicle connector

- 1) Disconnect KIT connector from Li-12V Battery
- 2) Connect vehicle connector to Li-12V Battery
