Service Action

Code: 91V6

Subject	Apple CarPlay Activation
Release Date	May 10, 2019
Affected Vehicles	U.S.A. & CANADA: Certain 2018 MY Audi R8 Coupe & R8 Spyder <i>Check Campaigns/Actions screen in Elsa on the day of repair to verify that a VIN qualifies for repair under this action. Elsa is the <u>only</u> valid campaign inquiry & verification source.</i> <ul style="list-style-type: none">✓ Campaign status must show "open."✓ If Elsa shows other open action(s), inform your customer so that the work can also be completed at the same time the vehicle is in the workshop for this campaign.
Problem Description	In certain vehicles, the Apple CarPlay feature may not have been activated.
Corrective Action	Activate the Apple CarPlay feature via software update.
Parts Information	Software update only; no parts needed.
Code Visibility	On or about May 10, 2019, affected vehicles will be listed on the Inventory Vehicle Open Campaign Action report under My Dealership Reports (found on www.accessaudi.com & OMD Web). A list will not be posted for dealers who do not have any affected vehicles. On or about May 10, 2019, this campaign code will show open on affected vehicles in Elsa. On or about M

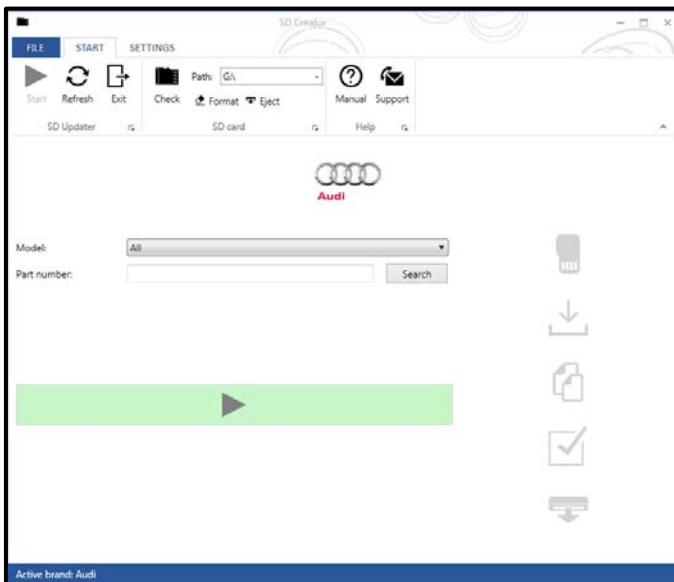
Required SD Card

- SD Card part # **4M0906961CF** will need to be created using the SD Creator program.

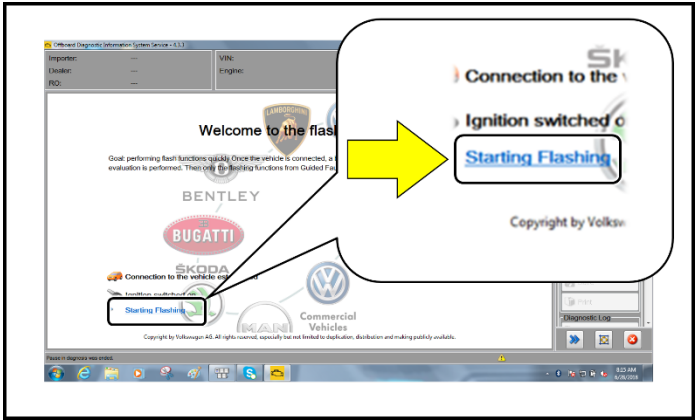
- Select "Starting Flashing" and follow the on-screen prompts.

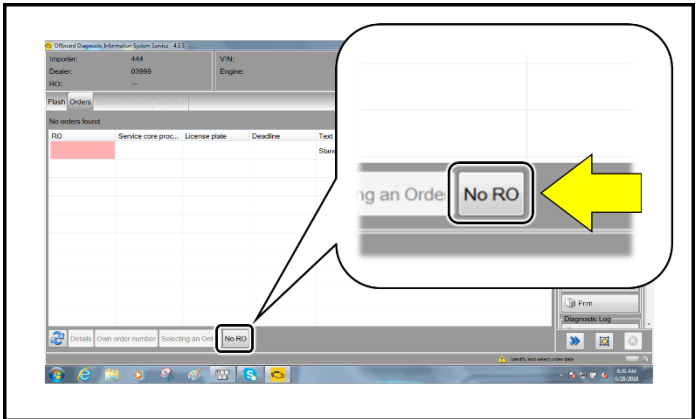
- Select "No RO".

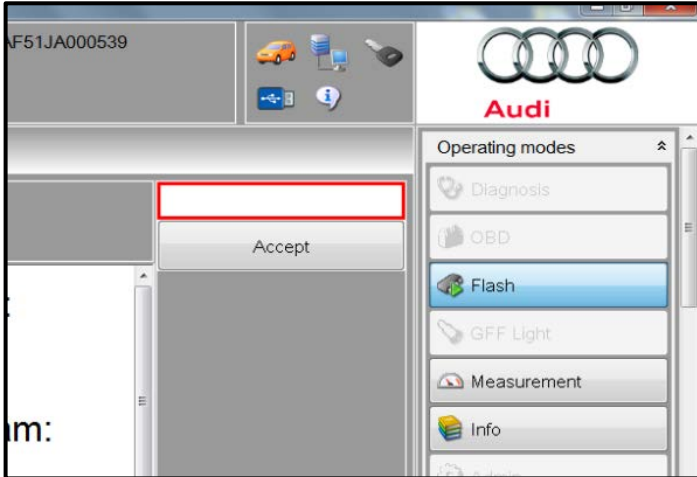
SVM code
91V6A188

- Select "Accept".
- Follow the on-screen prompts and insert the SD card in the SD card reader when prompted.
