GROUP ELE	MODEL 2018-19MY Niro (DE PHEV)
	NUMBER 169	DATE May 2019
TECHNICAL SERVICE BULLETIN		
SUBJECT: SERVICE ACTION: IGPM CHARGING DOOR OPERATION LOGIC IMPROVEMENT (SA382)

This bulletin provides the procedure to improve the charge port actuator logic of the IGPM (Integrated Gateway Power Module) on some 18-19MY Niro (DE PHEV) vehicles, produced from September 26, 2017 to May 9, 2018, which may not operate normally. To correct this concern, apply the improved logic to the IGPM using the KDS ECU Upgrade function as described in this bulletin. For confirmation that the latest reflash has been applied to a vehicle you are working on, verify the ROM ID using the table on page 2 of this bulletin. Before conducting the procedure, verify that the vehicle is included in the list of affected VINs.

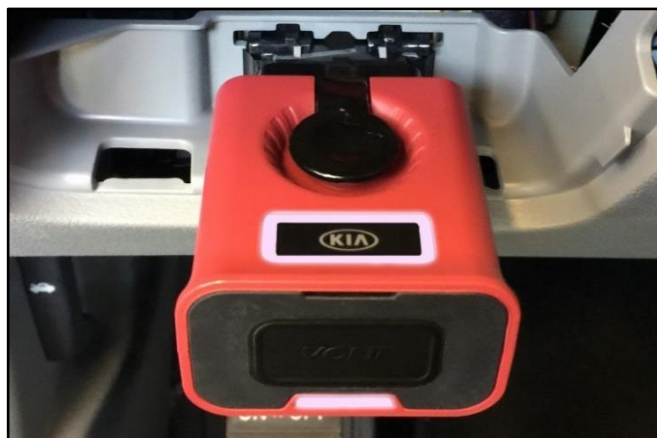
1. Connect the VCI-II to the OBD-II connector, located under the driver's side of the instrument panel.

The ECU upgrade function on KDS operates wirelessly. It is not necessary to perform the upgrade via USB cable.

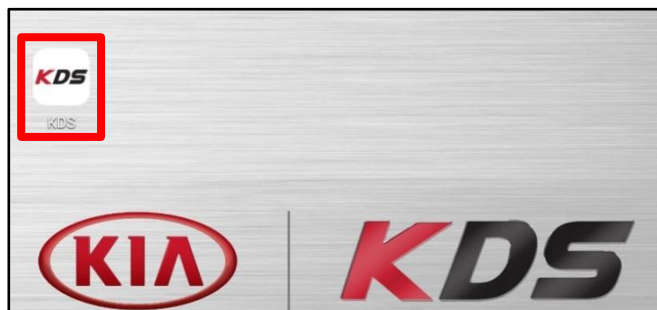
2. With the ignition ON, turn ON the KDS tablet. Select **KDS** from the home screen.

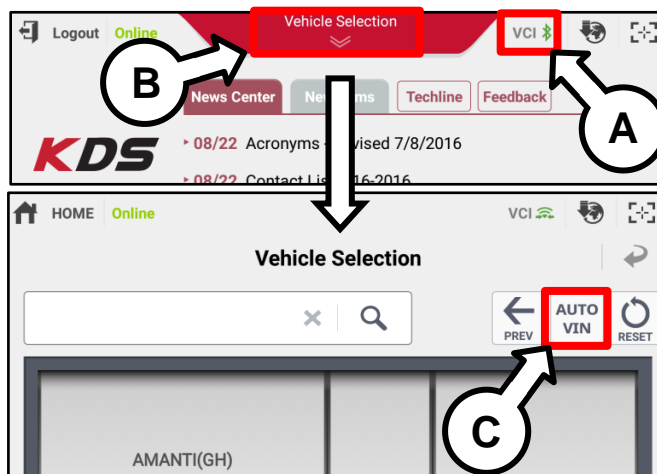
3. Confirm communication with VCI (A) and then configure the vehicle (B) using the **AUTO VIN** (C) feature.

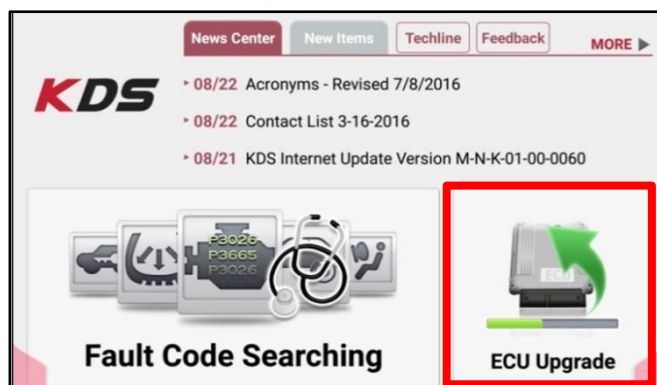
4. Select **ECU Upgrade**.

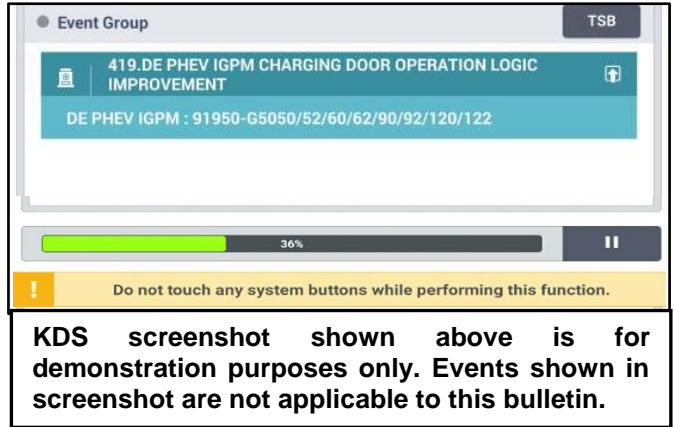
- The KDS will check the server for recently uploaded Events and then automatically download **Upgrade Event #419**.

*** NOTICE**
 The vehicle must be identified in Vehicle Selection to download an Event for that vehicle.

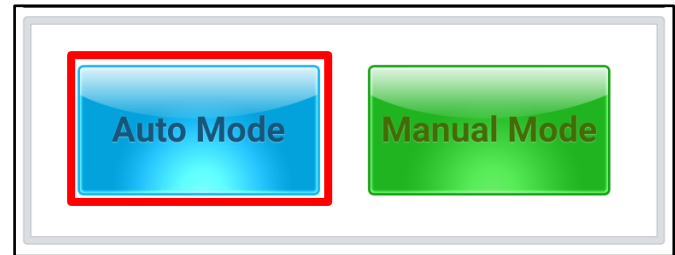
- Select **Auto Mode**.

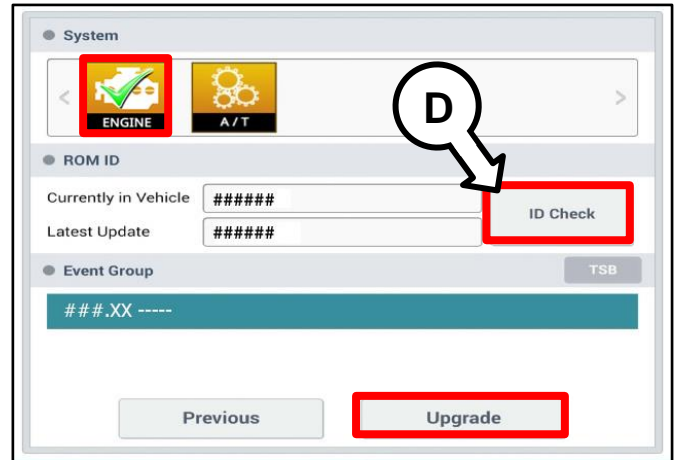
- Select the **IGPM** system under the System selection menu.

Touch **ID Check** (D) and confirm that the latest update is available.

Select **Upgrade Event #419** and select **Upgrade** to continue.

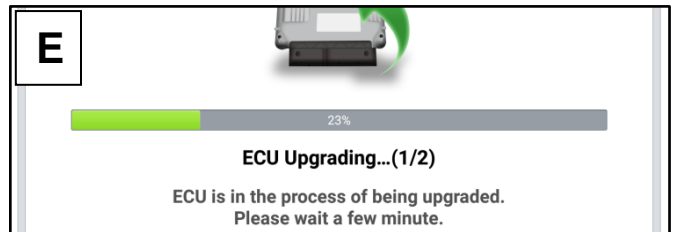
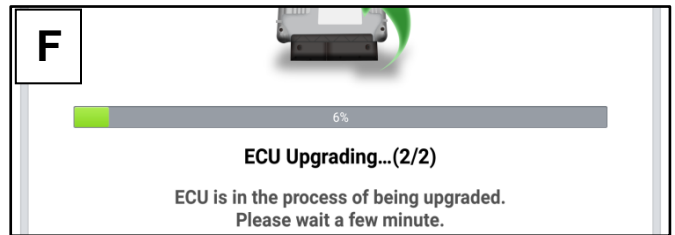
- The ECU upgrade will begin and the progress of the upgrade will appear on the bar graph. Upgrade part (1/2) (E) will download the upgrade event to the VCI-II. Upgrade part (2/2) (F) will upgrade the ECU.

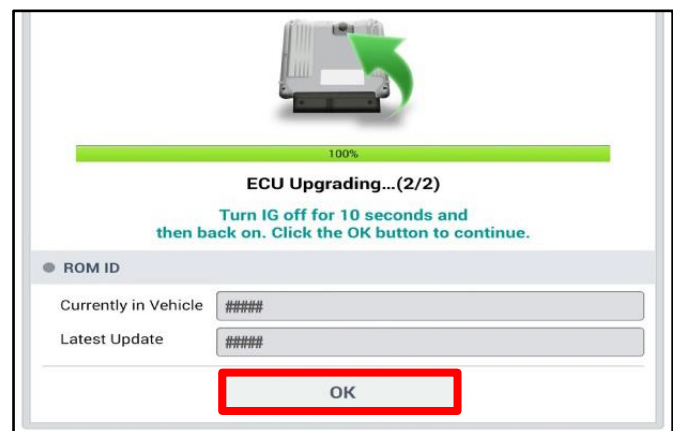
10. When instructed on the KDS, turn the ignition **OFF** for ten (10) seconds then back on. Touch **OK** to continue.

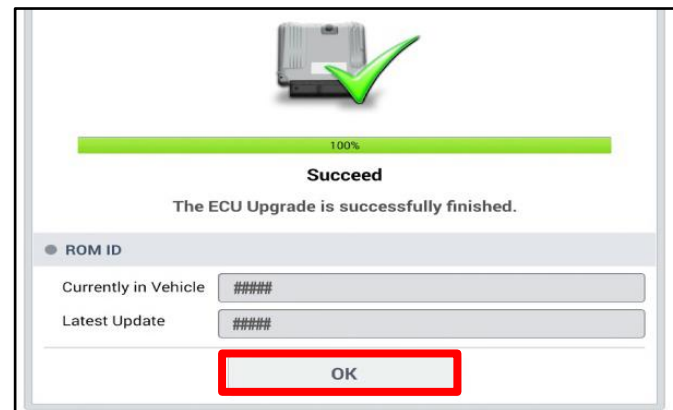
11. Once the upgrade is complete, touch **OK** to finalize the procedure.

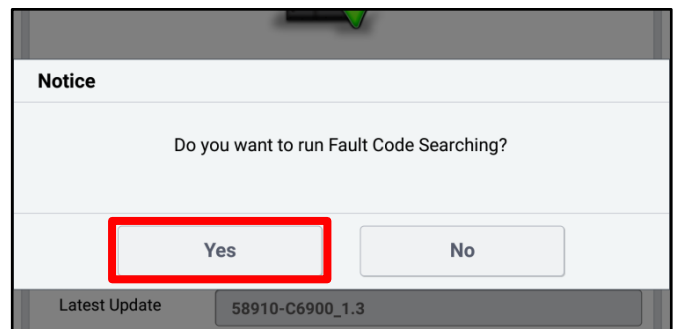
12. When prompted, select **YES** to check for Diagnostic Trouble Codes (DTC) and erase any DTCs stored such as EPS, ESC, and TPMS that may have been set during the upgrade.
