| | GROUP Product Improvement | MODEL 2011-2014MY Optima (QF/TF) 2012-2014MY Sorento (XMa) 2011-2013MY Sportage (SL) |
| | NUMBER 1803 (Rev 2, 05/16/2019) | DATE November 2018 |
| PRODUCT IMPROVEMENT CAMPAIGN | | |
| SUBJECT: KNOCK SENSOR DETECTION SYSTEM - ECU LOGIC IMPROVEMENT (PI1803) | | |

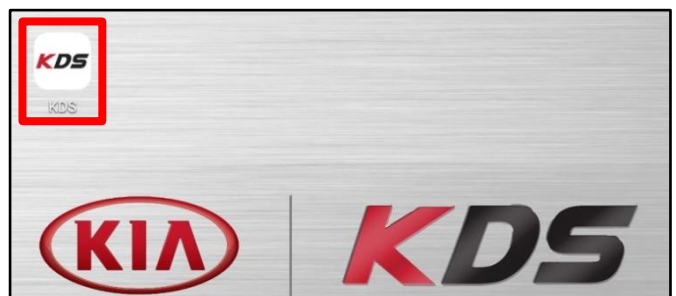
2. With the ignition ON, turn ON the KDS tablet. Select **KDS** from the home screen.
