April 2019  
SF560A-0  
SECOND REVISED NOTICE

## **Subject: Freightliner Cascadia Software Updates**

**Models Affected:** Specific Freightliner Cascadia vehicles manufactured June 13, 2016, through April 6, 2018, and equipped with one or more of the following modules: ASAM, FCU, ACU, PCU, and MPC.

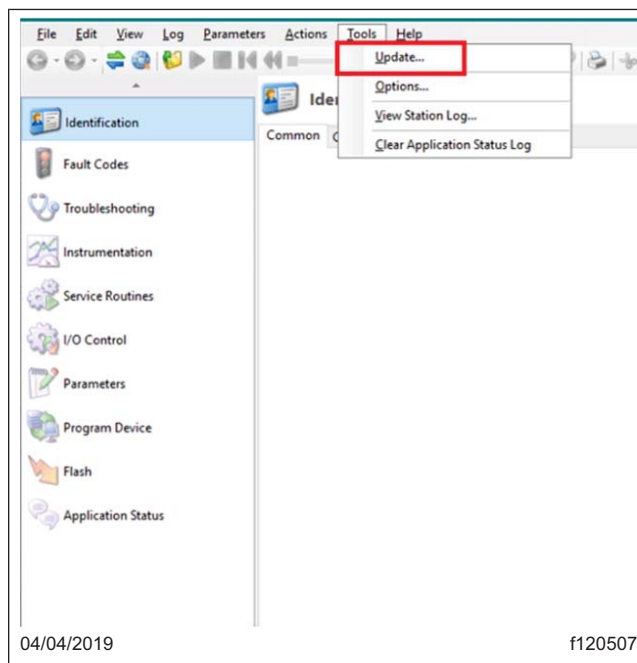
Fig. 1, Updating DiagnosticLink to the Latest Version

- Check the base label (Form WAR259) for a completion sticker for FL560 (Form WAR260) indicating this work has been done. The base label is usually located on the passenger-side door, about 12 inches (30 cm) below the door latch. If a sticker is present, no work is needed. If there is no sticker, proceed with the next step.
- Park the vehicle on a level surface, set the parking brakes, and shut down the engine. Chock the tires.
- Connect the vehicle to DiagnosticLink. Make sure that DiagnosticLink is updated to the latest version, 8.09sp2. To update DiagnosticLink, select "Update" from the dropdown menu under "Tools." See [Fig. 1](#).

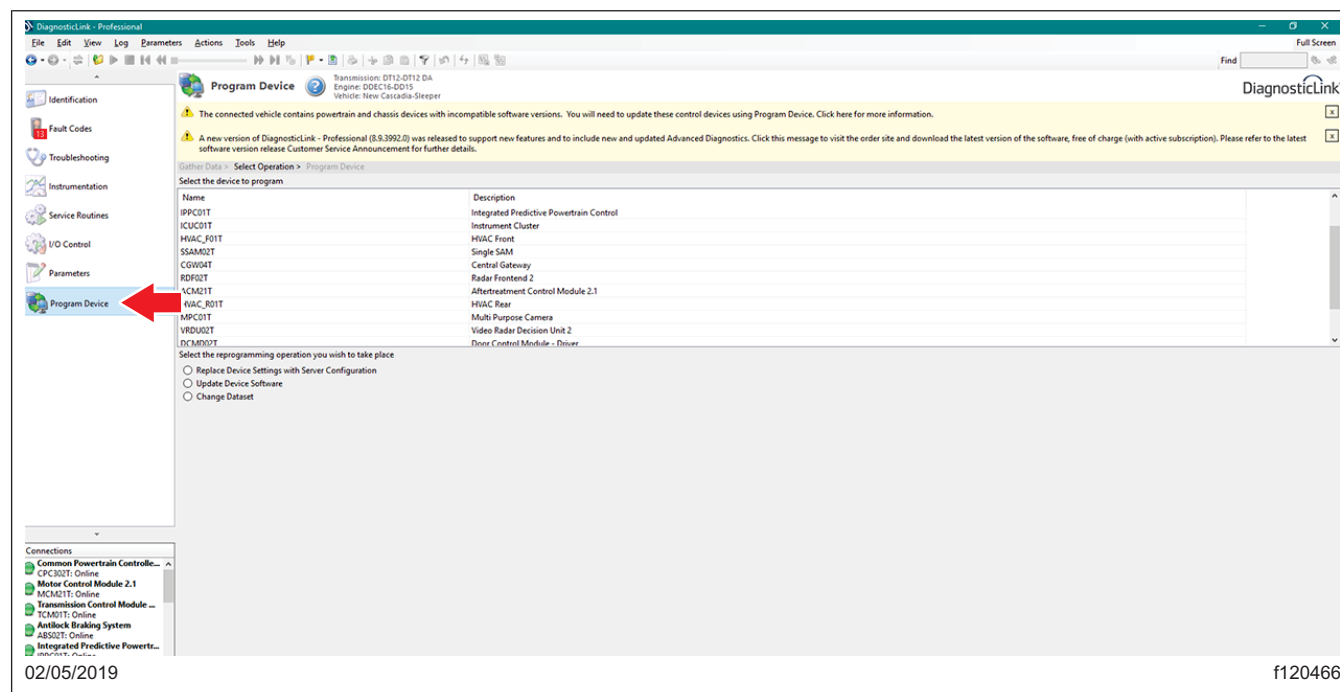
**Fig. 2, DiagnosticLink Program Device Panel**

4. Go to "Program Device" and click "connect to server." See [Fig. 2](#)

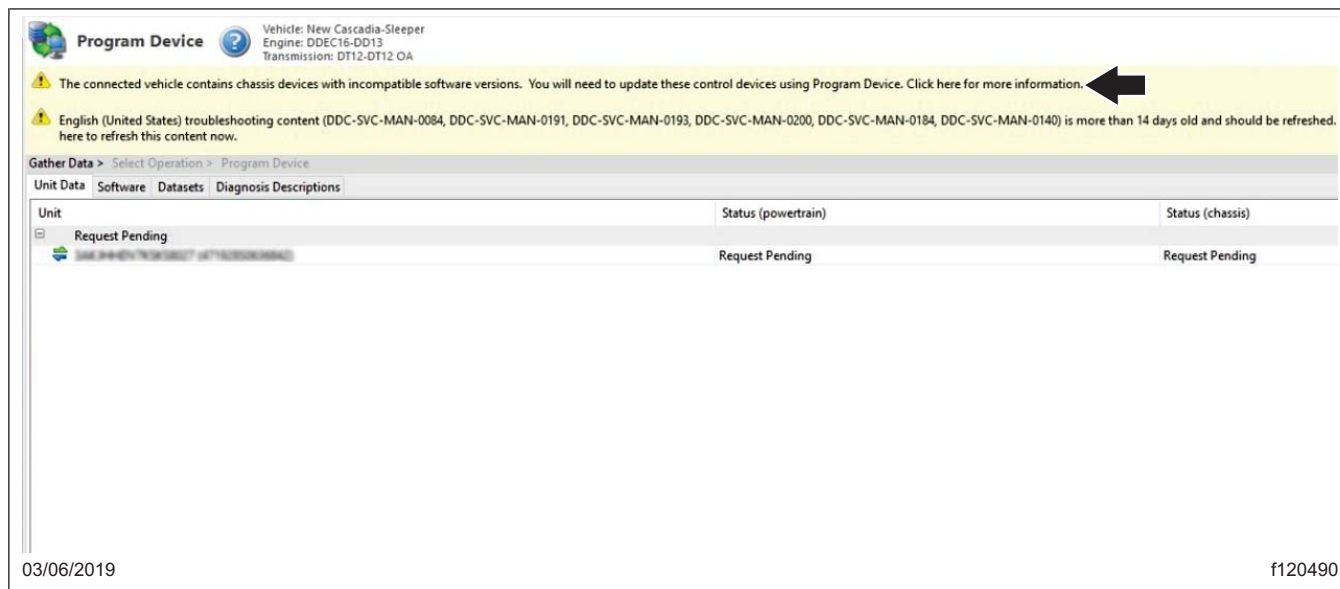
Fig. 3, Clicking on the Banner Message

11. Click on the banner message. See [Fig. 3](#).

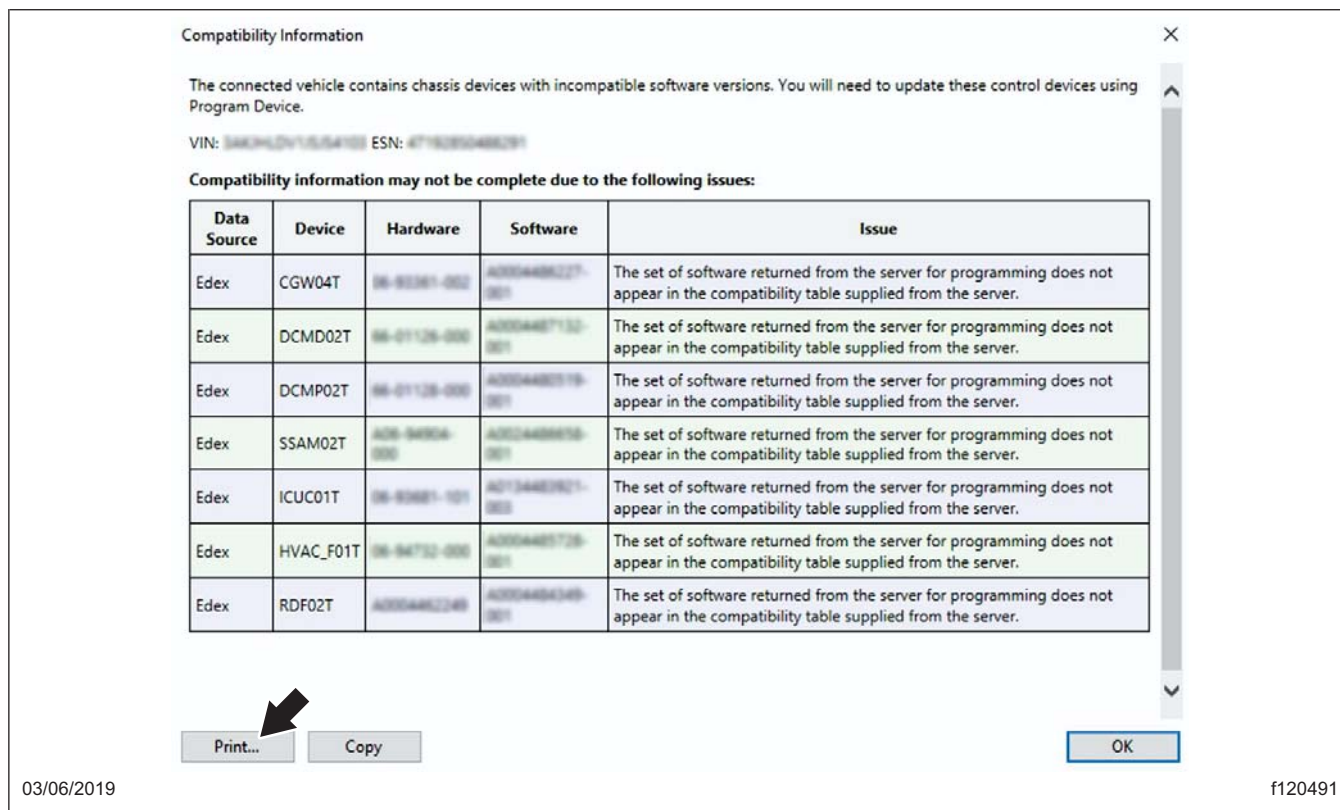
Fig. 4, Printing the List of Incompatible ECUs

12. Print or take a screen shot of the incompatible ECUs. See [Fig. 4](#).
