Technical Service Bulletin

SUBJECT:			No: TSB-19-54-013
SOFTWARE UPDATE FOR SMARTPHONE LINK DISPLAY AUDIO - REVISED			DATE: May 2019
			MODEL: See below
CIRCULATE TO:	<input type="checkbox"/> GENERAL MANAGER	<input checked="" type="checkbox"/> PARTS MANAGER	<input checked="" type="checkbox"/> TECHNICIAN
<input checked="" type="checkbox"/> SERVICE ADVISOR	<input checked="" type="checkbox"/> SERVICE MANAGER	<input checked="" type="checkbox"/> WARRANTY PROCESSOR	<input type="checkbox"/> SALES MANAGER

A software update is now available for the Smartphone Link Display Audio built by JVC Kenwood. This update resolves several issues that may occur in various models, as listed below.

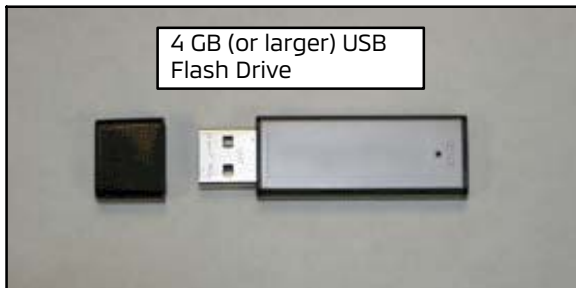
A USB version 2.0 standard flash drive (thumb drive) with a **minimum capacity of 4.0 GB**, formatted to FAT32 is required for this procedure. Formatting to FAT32 will erase all data from the flash drive. The flash drive must have no other files or folders saved to it.

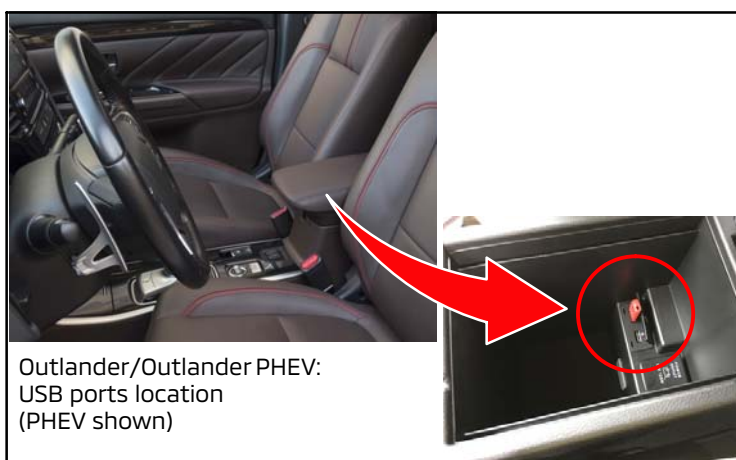
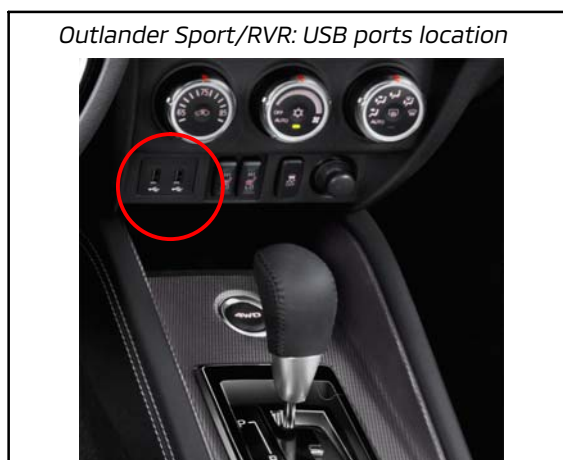
1. **For Outlander and Outlander Sport/RVR vehicles:** Turn vehicle ON, and keep the engine idling for the entire update procedure.
For Outlander PHEV: Put vehicle in READY mode for the entire update procedure.
2. Plug in the USB flash drive containing the ***CORRECT software update file* for that vehicle*** into the vehicle's USB port (either port may be used for the update).
****Refer to step 4 of "B. Transfer Files to USB Flash Drive" in this TSB for correct file identification.***
 - For Outlander and Outlander PHEV, two USB ports are located inside the center console.
 - For Outlander Sport/RVR, two USB ports are located in the front lower dash.

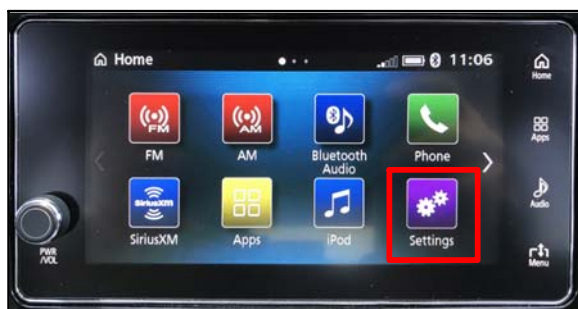
3. Before starting the update process, confirm the current software version.
 - a. Touch the "Settings" icon on the Home screen.

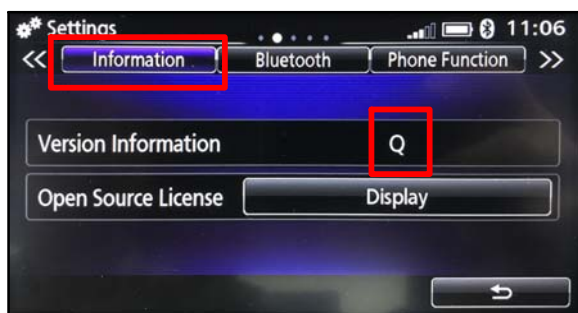
- b. On the Settings screen, touch the "Information" tab and check the Version Information.

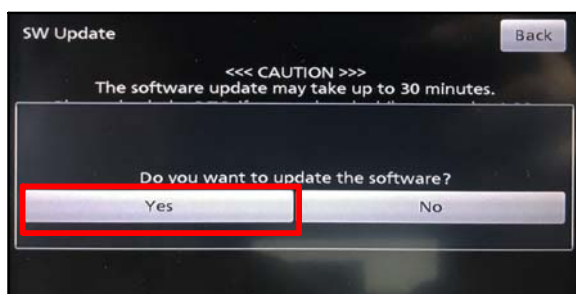
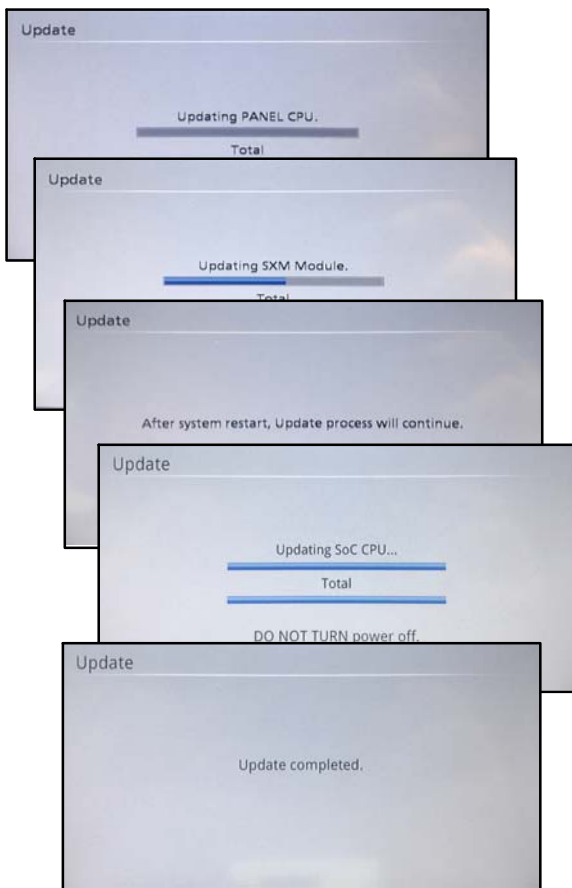
The system will automatically reboot twice during the update, ending with an "Update completed" screen.

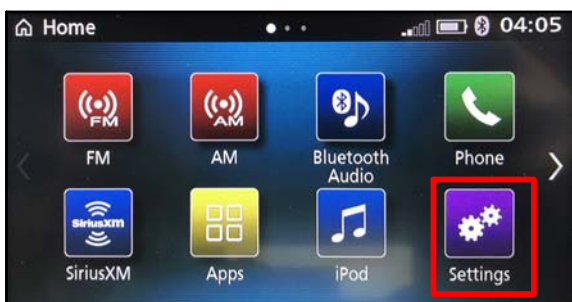
a. On the Home screen, touch the "Settings" icon.

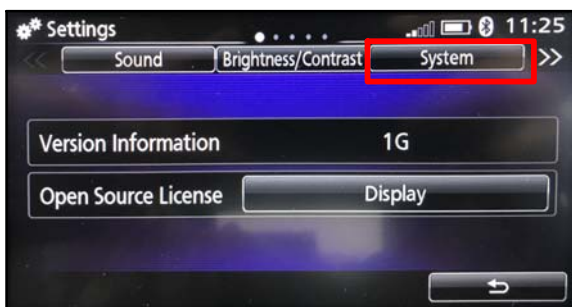
b. Touch the "System" tab.

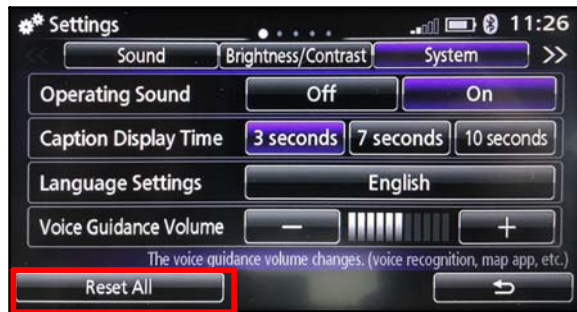
- c. Touch the "Reset All" button.

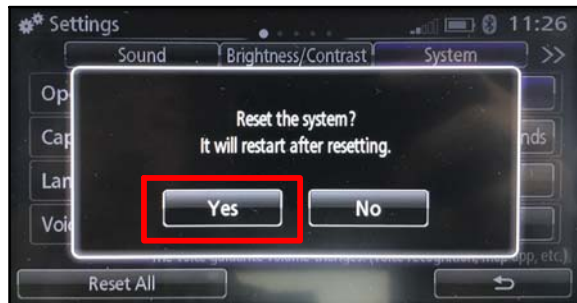
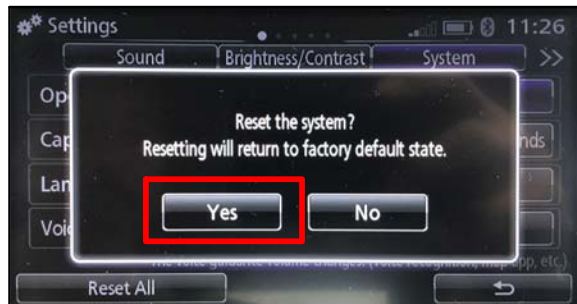
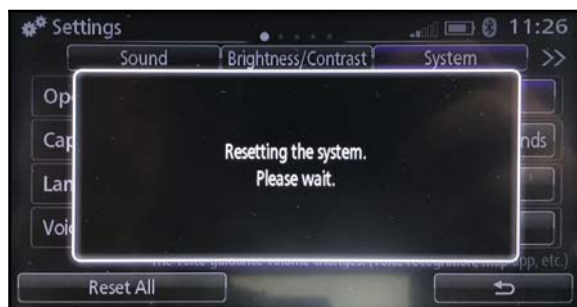
- d. Touch "Yes" on the next 2 screens to continue resetting the system.

The system will reboot one more time after resetting.

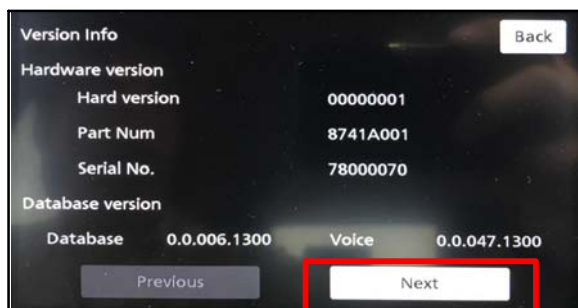
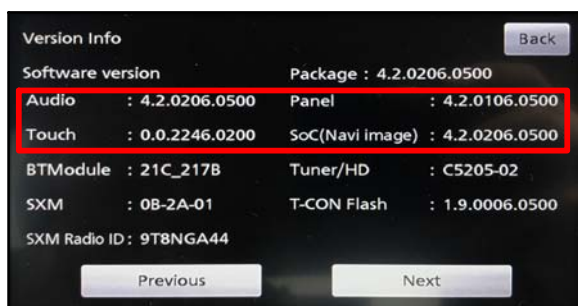
- f. Confirm the software version has been updated and matches the New version shown for the applicable model in the "**Display Audio Software Version Chart**," on page 2 of this TSB.

NOTE: Version info for 2018 Outlander PHEV shown at left.

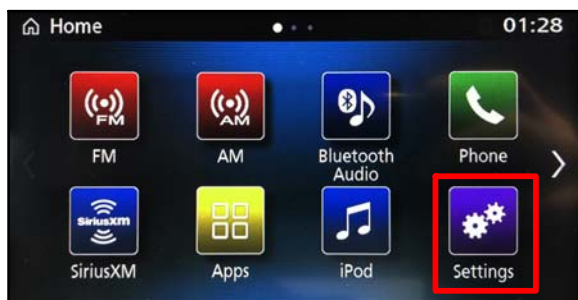
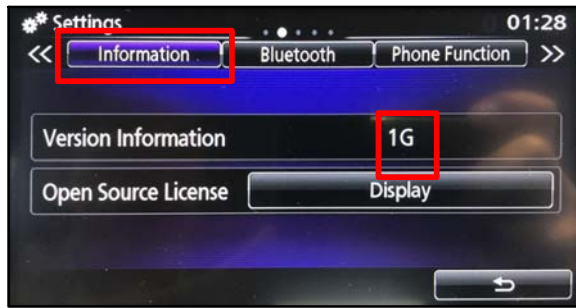
- b. On the Settings screen, touch the "Information" tab and check the Version Information.

NOTE: Updated Version information for Outlander and Outlander PHEV shown at left.

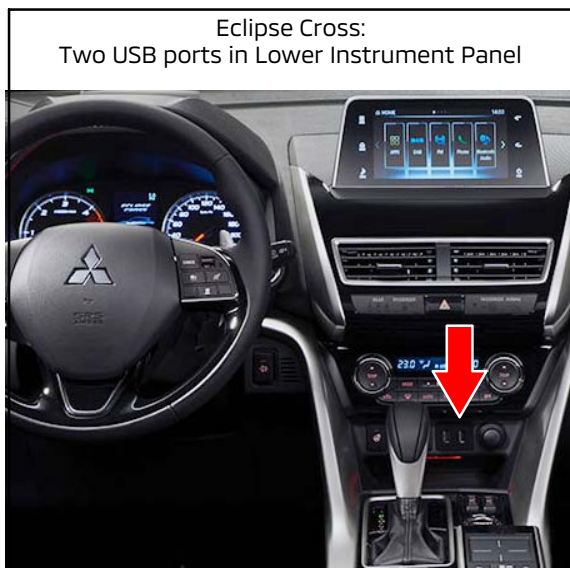
2. Plug in the USB flash drive containing the **CORRECT software update file* for Eclipse Cross** into the vehicle's USB port (either port may be used for the update).

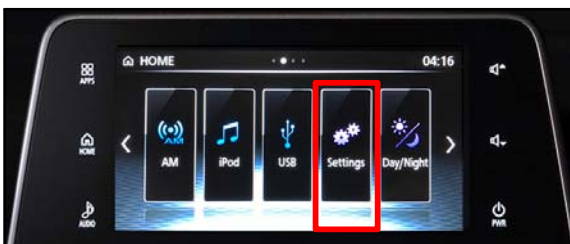
- a. On the Home screen, touch the right arrow to get to the Settings icon.

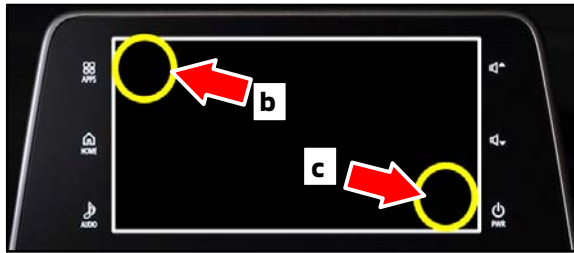
- a. Push and hold the Power button for at least 1 second, until the audio unit beeps and the screen goes blank.
- b. Press and hold the area indicated in the upper left of the screen for 5 seconds, until you hear a beep, then release.
- c. Press and release the area indicated in the lower right side of the screen. Then the "Service Menu" will appear.
- d. On the Service Menu screen, touch the "Next" button to go to the next page.

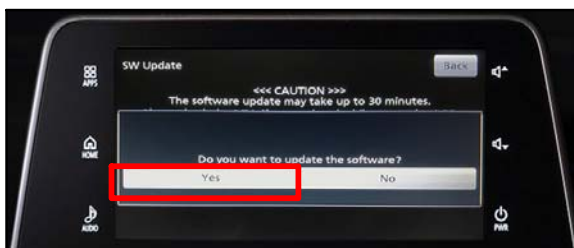
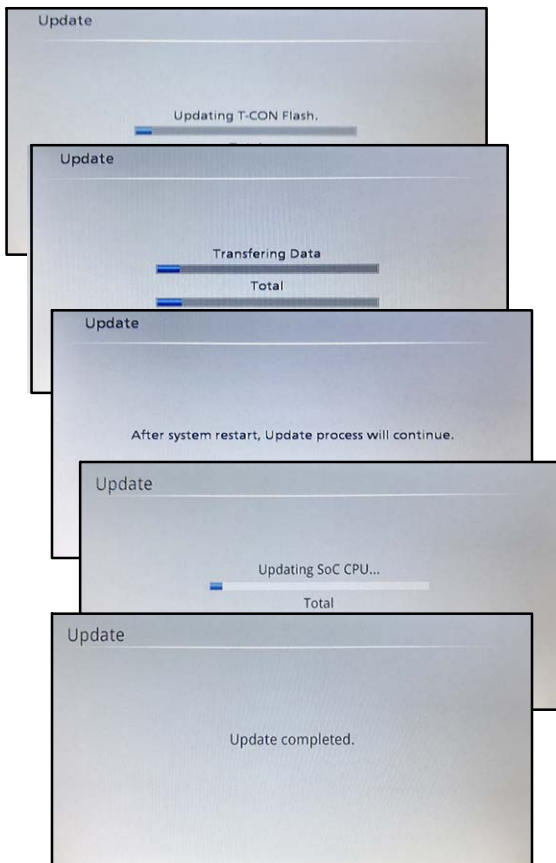
The system will automatically reboot twice during the update, ending with an "Update completed" screen.

When the update is completed, the Home screen should appear.

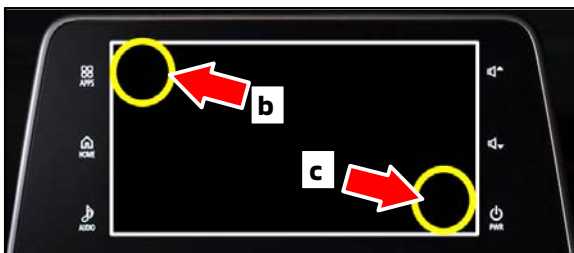
a. Push and hold the Power button for at least 1 second, until the audio unit beeps and the screen goes blank.

b. Press and hold the area indicated in the upper left of the screen for 5 seconds, until you hear a beep, then release.

c. Press and release the area indicated in the lower right side of the screen. Then the "Service Menu" will appear.

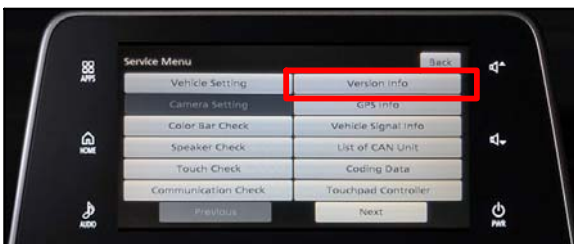
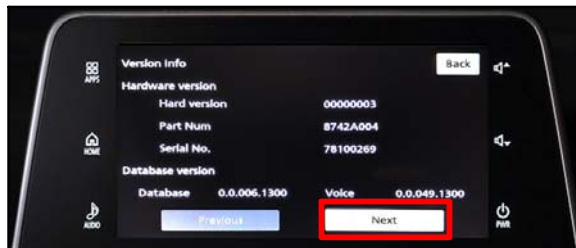
d. On the Service Menu screen, touch the "Version Info" button.

e. Touch the "Next" button.

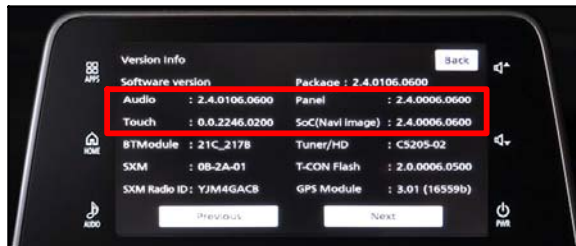
f. Confirm the software version has been updated and matches the New version shown in the **"Display Audio Software Version Chart,"** on page 2 of this TSB.

Updated Version info for 2018 Eclipse Cross:
2.4.0106.0600

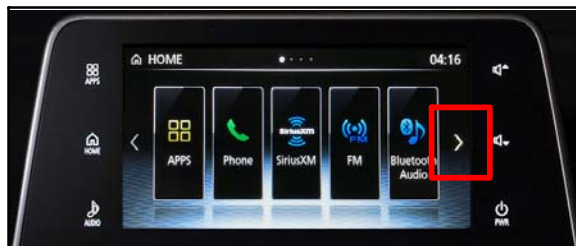
a. On the Home screen, touch the right arrow to get to the Settings icon.

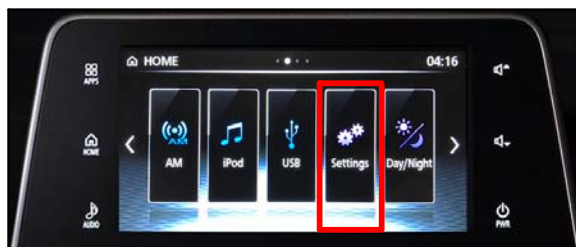
b. Touch the "Settings" icon.

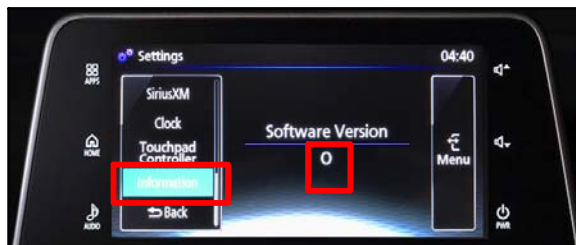
c. On the Settings screen, touch the "Information" tab and check the Version Information.

NOTE: If necessary, scroll to the right or left to see the Information tab.

d. Verify that the version shown matches the "New" version shown in the **"Display Audio Software Version Chart,"** on page 2 of this TSB.
