TECHNICAL INSTRUCTIONS FOR SPECIAL SERVICE CAMPAIGN K0B MILLIMETER WAVE RADAR SENSOR

**CERTAIN:
2018 – 2019 TACOMA
2018 – 2019 TUNDRA**

Update 4/2/2019: Instructions provided for Tacoma Bar Type grill EPT Sealer application. Correction made to the Tundra TRD Pro grill photo.

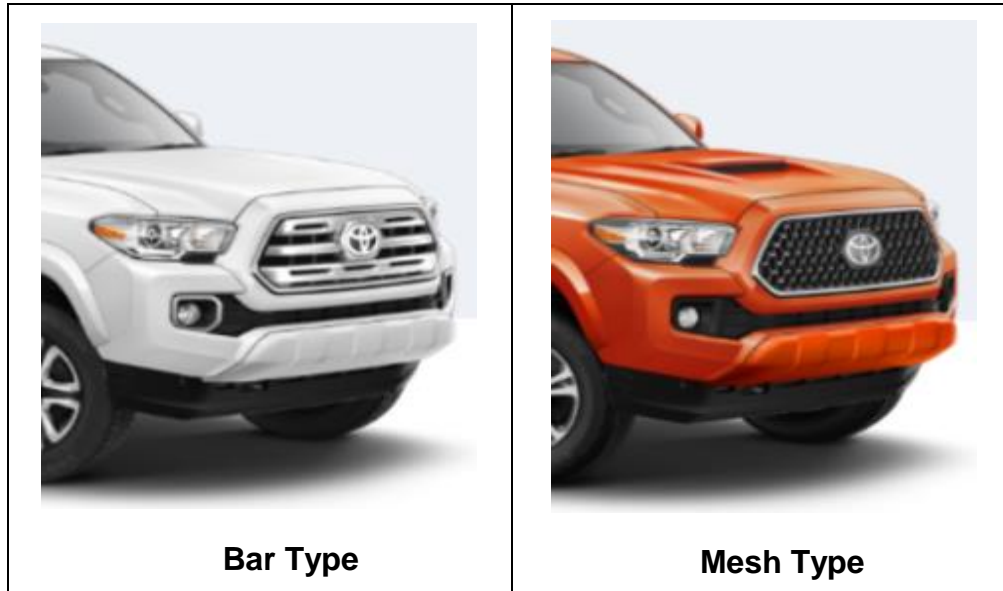
TACOMA - Repair A vehicles will have radiator grills of these designs:

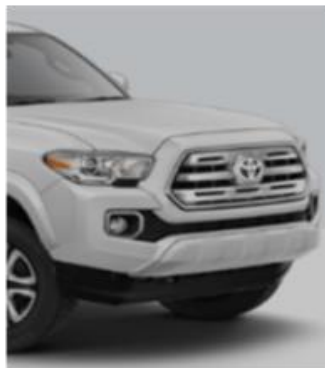
10. APPLY EPT-SEALER – Tacoma Bar Type

Note: This application will use P/N **88278-0C010**. (75mm x 150mm x 5mm)

This process is only for Tacoma's with the Bar type grill:

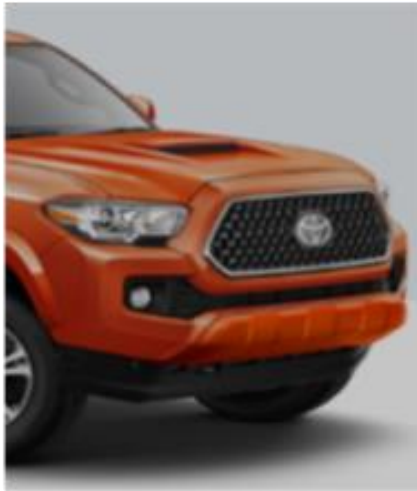
11. APPLY EPT-SEALER – Tacoma Mesh Type

Note: This application will use P/N **88278-0C010**. (75mm x 150mm x 5mm)

This process is only for Tacoma's with the Mesh type grill:

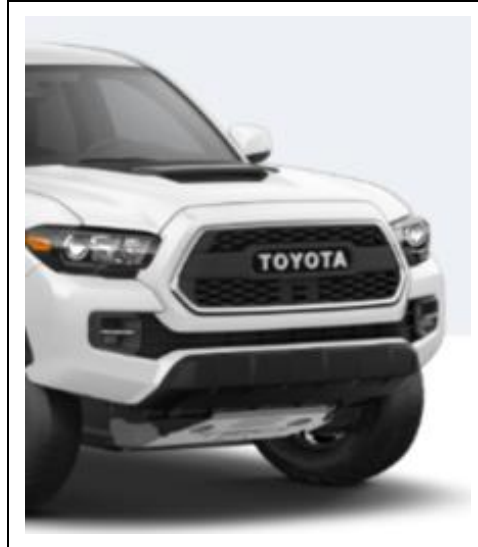
TACOMA Repair B vehicles will have a radiator grill of this design:

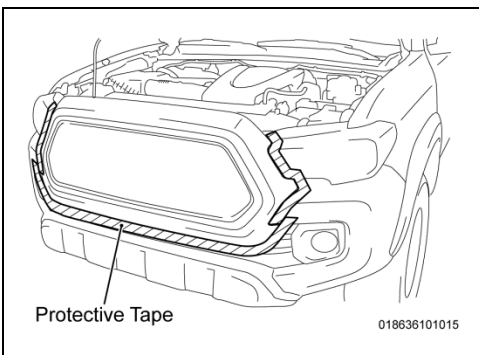
- c. Apply protective tape to the bumper around the radiator grille.

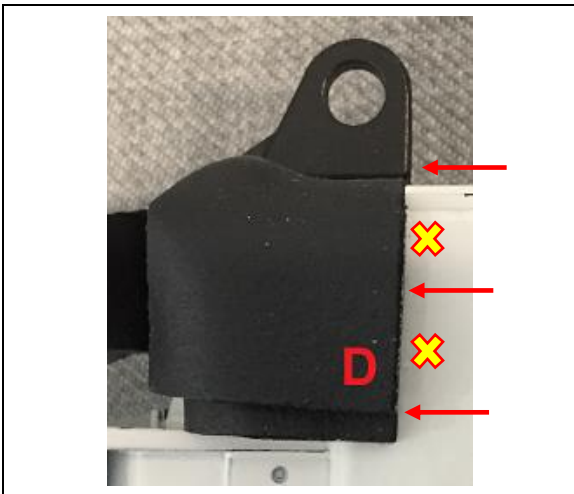
- f. Bend the lower flap (Corner “C”) onto the face of the MWRS and align the edge with the edge of the upper flap and metal bracket.
- g. Press the EPT-Sealer into the face of the MWRS to seat it firmly. **DO NOT** press in the area indicated as it’s critical there is an air gap for the vent.

<p>ONLY PRESS THE EPT-SEALER ONTO THE UPPER FACE OF THE MWRS. DO NOT press the EPT sealer into the vent hole. It’s critical that the vent hole remains open.</p>
---	---

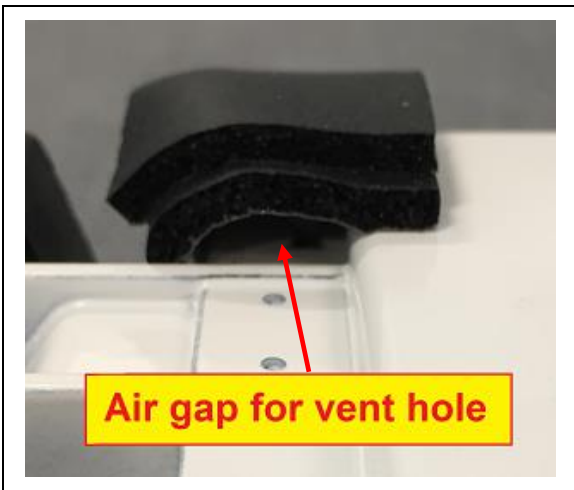
- h. Roll Corner “D” downward from the top, aligning the edge with the edge of the lower section and metal bracket.
- i. Press the EPT sealer into place, being careful to leave an airgap above the rear vent hole.

- a. Verify that all the contact points of the EPT sealer are thoroughly applied.
- b. Verify that the bottom is still open to properly allow airflow to the rear vent hole.

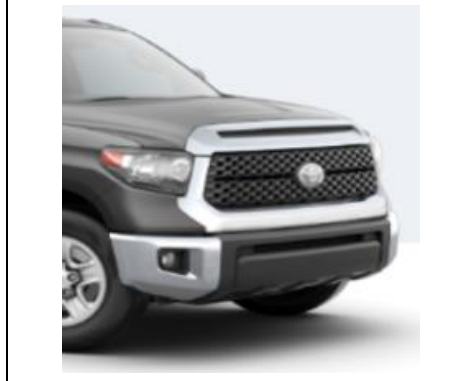
TUNDRA Repair A vehicles will have a radiator grill of this design:

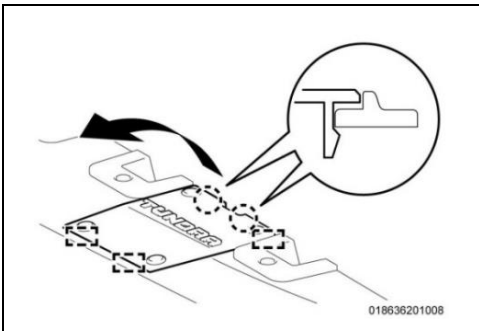
- a. Detach the 2 claws and 3 guides to remove the cover.
- b. Disconnect the electrical connector under the cover.

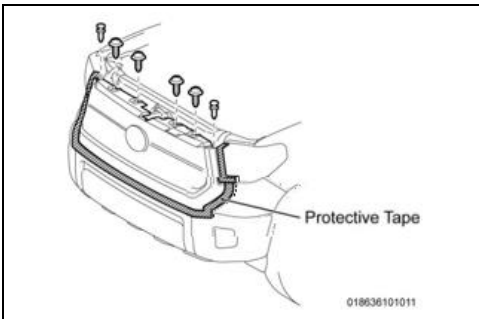
- c. Place protective tape on the front bumper and headlights, at the edge of the grill assembly, to protect the surfaces during removal and installation.
- d. Remove the 4 screws and 2 clips

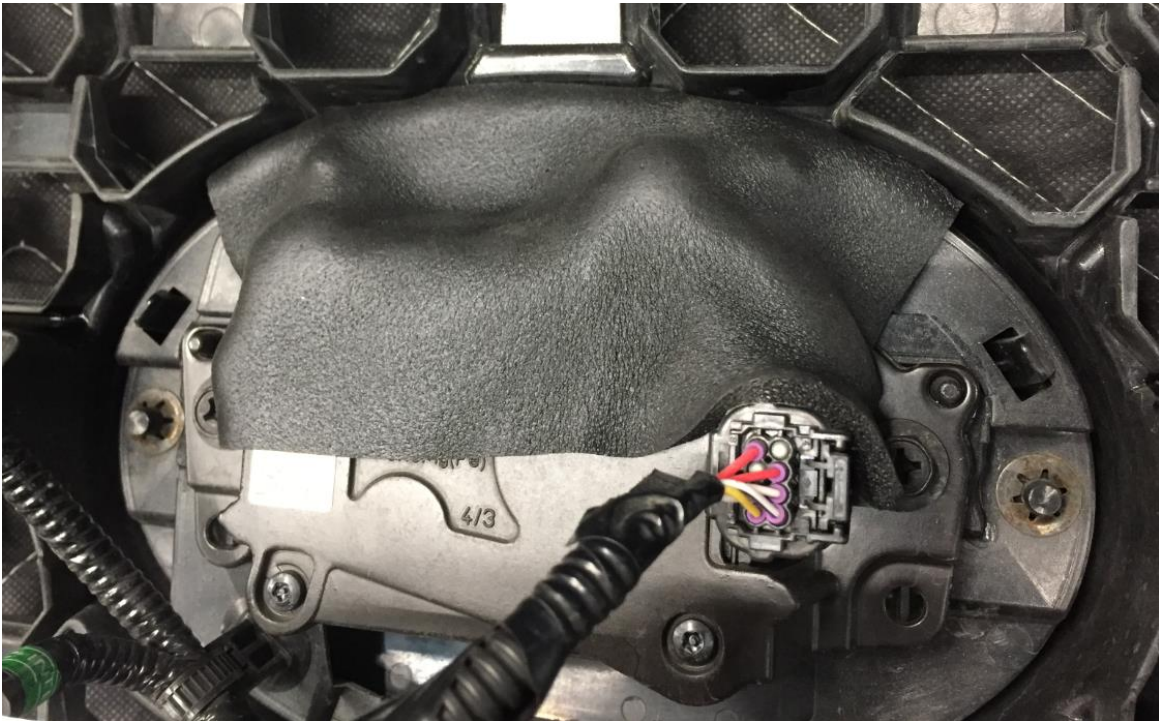
- Apply the EPT Sealer to the back face of the MWRS in the position shown below.
- Roll the EPT sealer onto the inside lip of the radiator grill to create a waterproof shield over the top of the sensor.
- Using finger pressure, thoroughly press the entire surface of the EPT sealer to securely adhere it to all contact surfaces.

Recommended temperature for adhesion is 50° F and above.
Keep stock at room temperature.

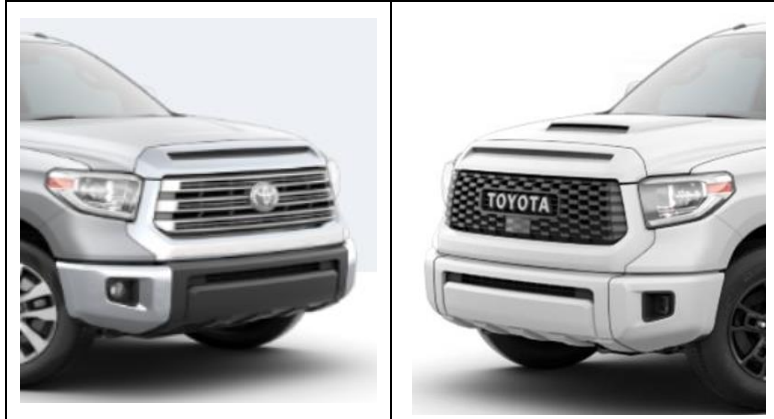
TUNDRA Repair B vehicles will have radiator grills of these designs:

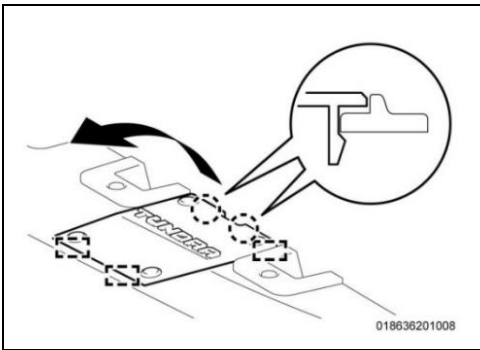
- a. Detach the 2 claws and 3 guides to remove the side grill.
- b. Disconnect the electrical connector under the cover.

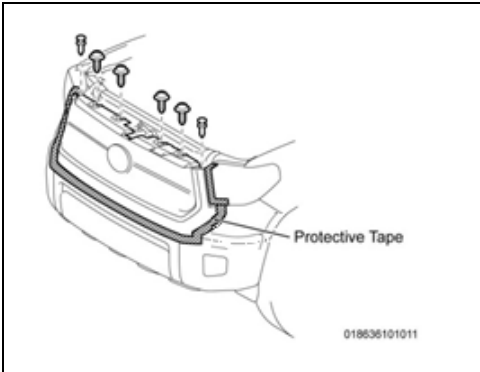
- c. Place protective tape on the front bumper and headlights, at the edge of the grill assembly, to protect the surfaces during removal and installation.
- d. Remove the 4 screws and 2 clips

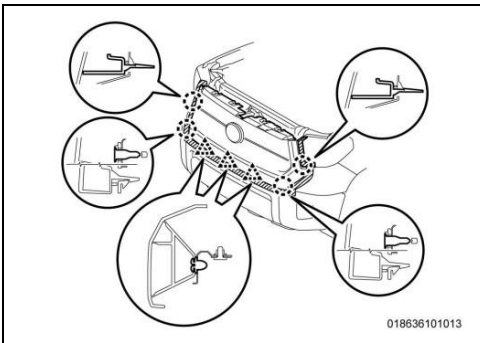
- e. Detach the 4 claws and 3 clips by pulling the grill assembly forward.
- f. Place a blanket onto the table or workbench.
- g. Place the radiator grill onto the blanket, front side down.

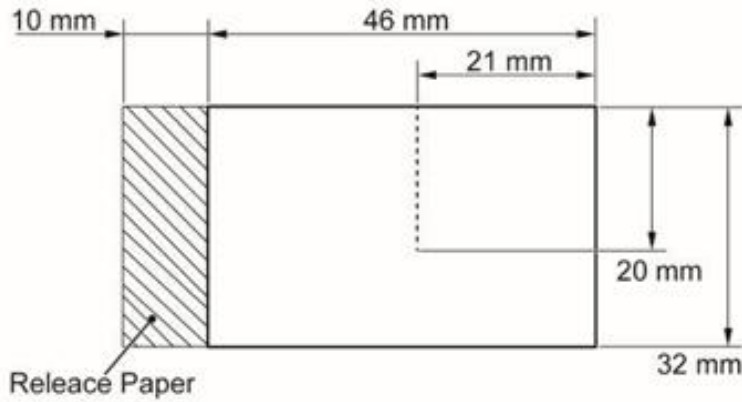
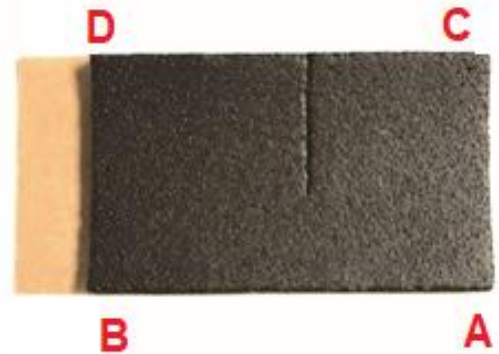
Note: This application will use P/N **88278-0C020**. (46mm x 32mm x 5mm)

The EPT-Sealer will be applied in a specific way, using the following points for orientation. Please note the arrangement of corners A, B, C, D.

Note: A diagram of the EPT sealer can be found on page 15.

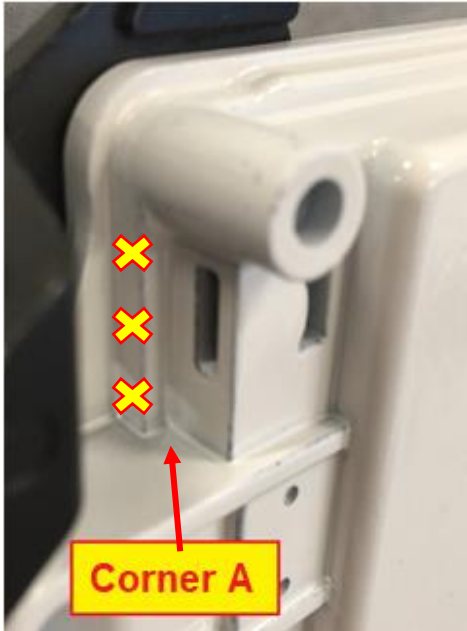
Left Side

- a. Wear Nitrile Gloves to prevent adhesive contamination.
- b. Apply the EPT-Sealer to the left side of the MWRS to the following standard:
 - **Left Side View:** Corner "A" of the EPT-Sealer should be placed at the inner corner of the MWRS as indicated.
 - **Top View:** Place the EPT-Sealer on the surface of the side vent hole (it is ok to cover the side vent hole). **DO NOT place the EPT Sealer on top of the ridge**, as indicated with the yellow X's.

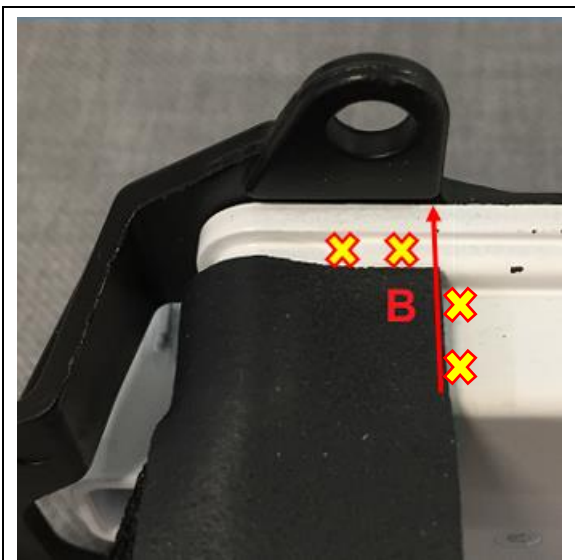
Top View

- c. Press the EPT sealer firmly into place in this area to seat it thoroughly. Use flathead screw driver or trim tool if necessary to reach the corner.

- d. Roll the EPT-Sealer Corner "B" onto the top edge of the MWRS sensor as shown, **aligning its edge with the end of the metal bracket. Be sure to keep the EPT-Sealer off the upper ridge.**
- e. Press the EPT sealer firmly into place in this area to seat it thoroughly.

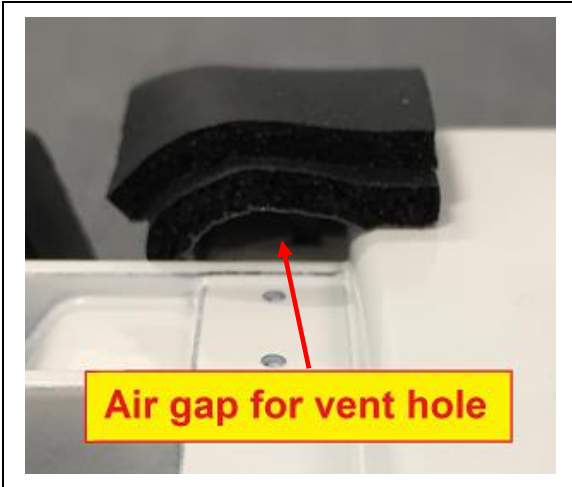
- a. Verify that all the contact points of the EPT sealer are thoroughly applied.
- b. **Verify that the bottom is still open to properly allow airflow to the rear vent hole.**
