Multimedia System Enhancements - Phase 3 (Pioneer)

Service Category Audio/Visual/Telematics

Section Navigation/Multi Info Display

YEAR(S)	MODEL(S)	ADDITIONAL INFORMATION
2018	Camry, Camry HV, Sienna

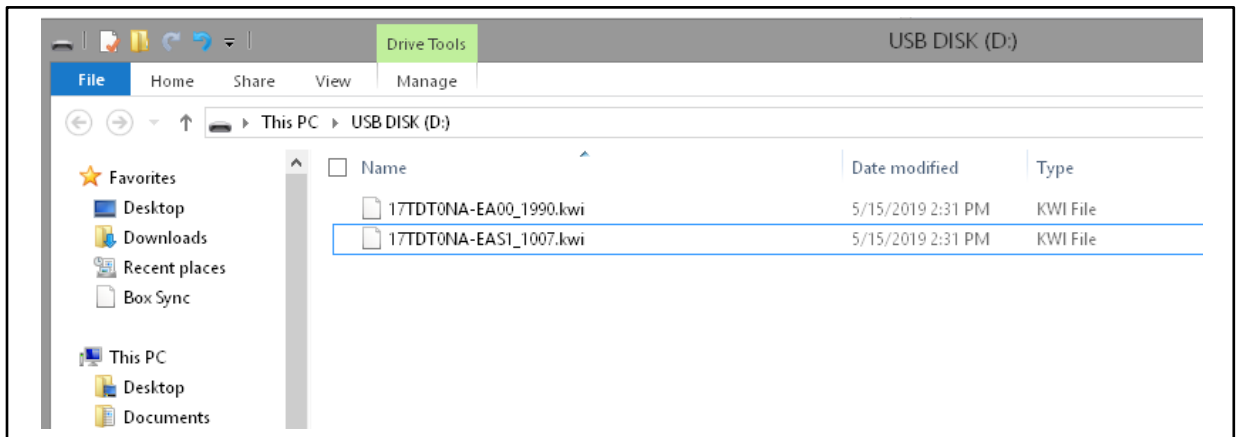
Figure 1.

The USB flash drive must NOT contain an additional folder name above the content folders and files (root directory). The audio head unit will NOT be able to search past an unrecognized folder name to view the internal folders and files. See the Entune 3.0 Audio example below.

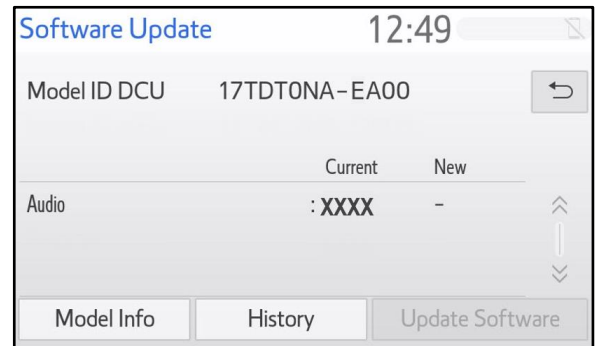
Figure 5.

- Verify that the NEW software is up to date on the Software Update screen.

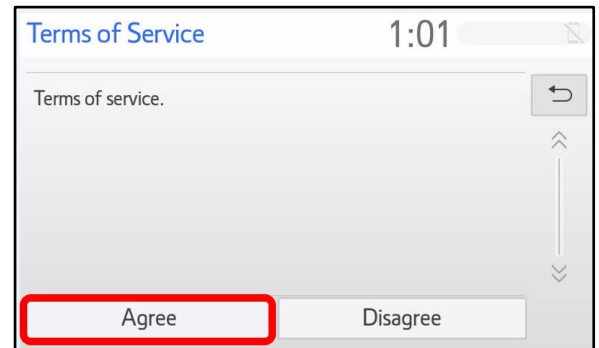
Figure 8.

11. Select Agree on the Terms of Service screen.
