Quick tip

Title: 2019 GLI and MY 2020 vehicles with 2.0T engines

Remote start with extended range.

(Only applies to 2019 Jetta GLI, 2020 Tiguan LWB, 2020 Atlas, 2020 Arteon)

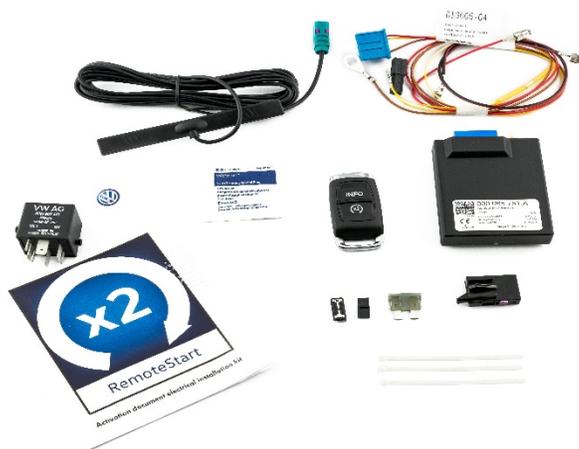
Remote start kit part number: 3CN065760

Extended range kit part number: 000065760

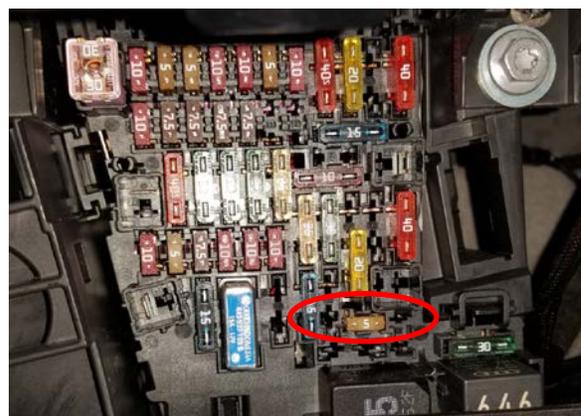
Step 6:

- Locate fuse 49
- Remove and discard.

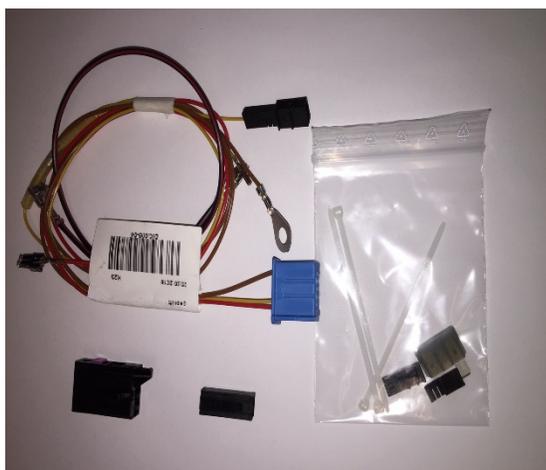
Step 7:

- Insert red wire into the fuse holder.
- Insert black/red wire into fuse holder.
- Insert the 2-amp fuse into the fuse holder.
- Insert the red/black wire into the connector.

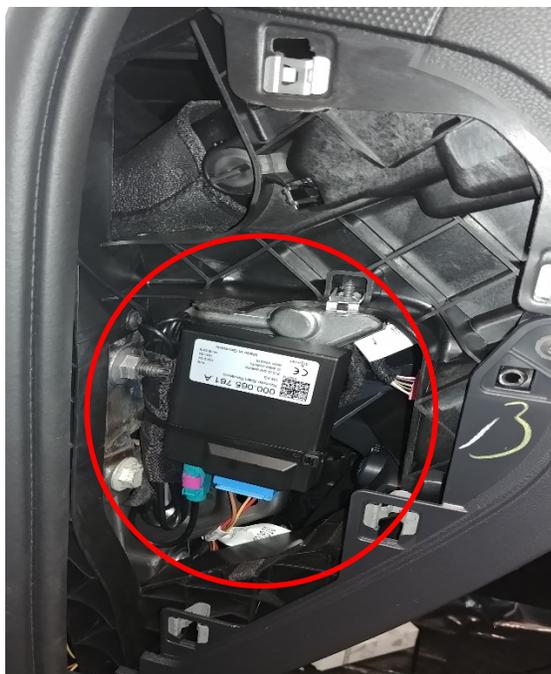
Step 8:

- Use a cable tie and secure the module at the base of A-pillar.

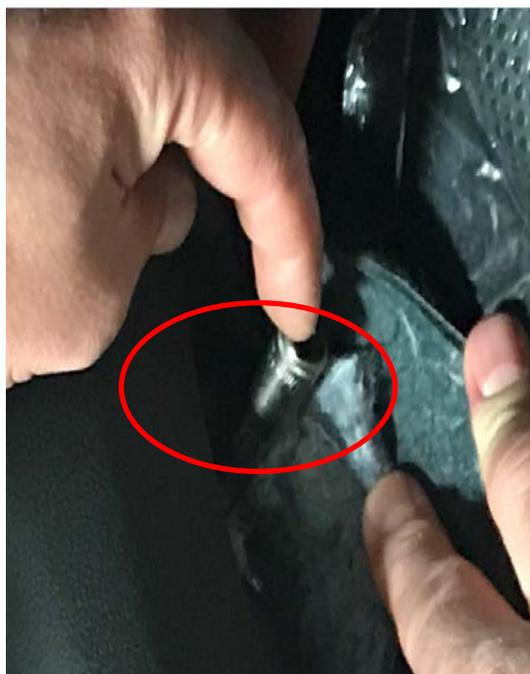
Step 9:

- Route ground wire behind lower A-pillar trim and connect to the chassis ground location under the carpet near the base of A-pillar.
- Torque nut to 9Nm.

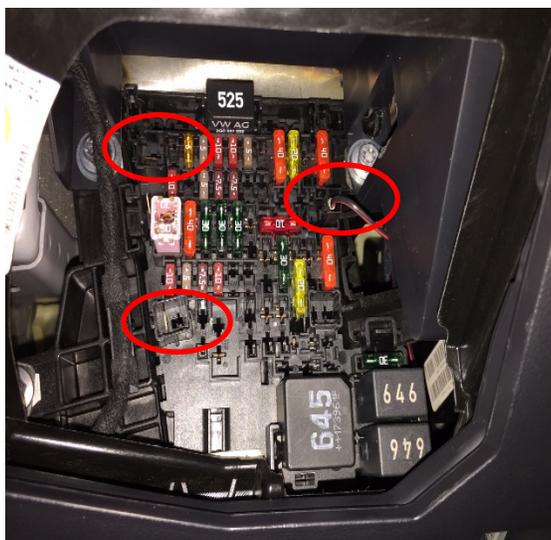
Step 10:

- Insert the power wire in any open location shown above.
