| Title | Dignostic Trouble Code (DTC, Fault Code) MID 140 PSID 210 FMI 12, Faulty Unit of |
| | Component Present On DTC Readout; Vehicle Operation Not Affected: No Physical |
| | Symptoms Or Warning Lights In Instrument Cluster - Model Year 2018 |

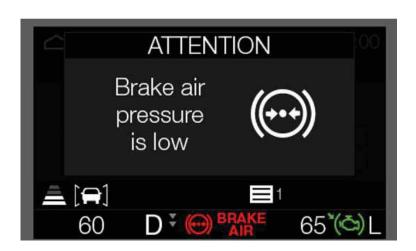
update, the Brake Air Low icon will now appear in the information display when the correct conditions are met. The new icon can be seen below.

• This function is not related to the symptoms described for this Solution. Driver or customer reports of this new screen may be received after performing the update, and this note is meant to advise that this is a normal function of the new software.
