NUMBER  
180 (Rev 1, 06/20/2019)

MODEL  
2020MY  
Telluride (ON)  
Soul (SK3)

## TECHNICAL SERVICE BULLETIN

SUBJECT: SERVICE ACTION: AVN 5 WIDE SOFTWARE UPDATE  
BLUETOOTH MEMORY ISSUE (SA386)

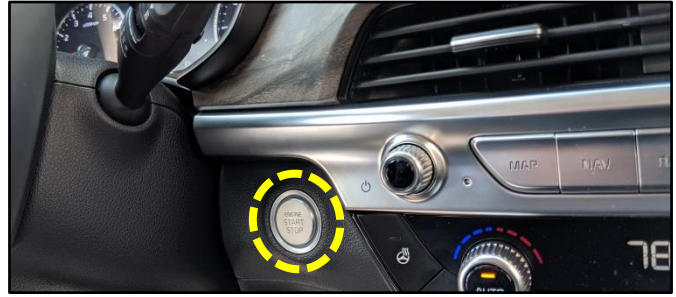
1. Turn engine **ON** and record customer radio presets.

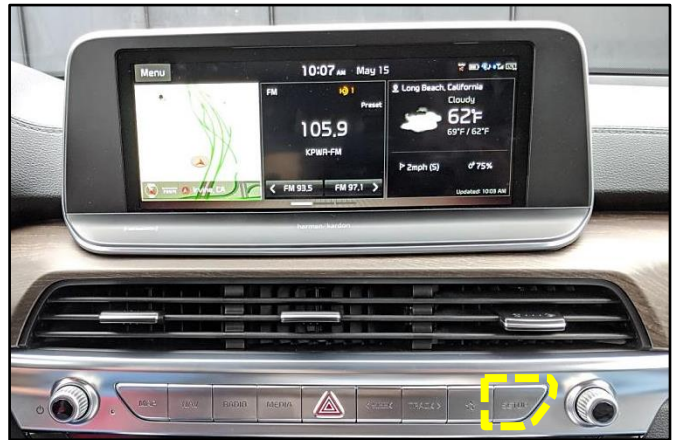
2. Press the **SETUP** hard key on the head unit. Telluride (ON) shown; Soul (SK3) will be similar.

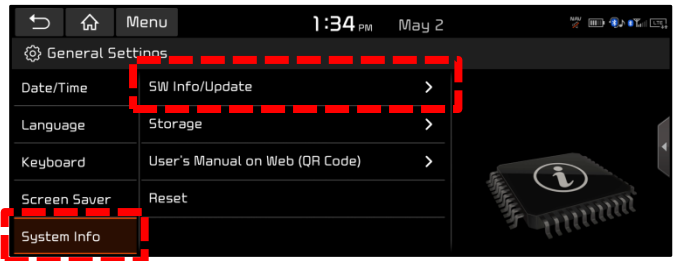
4. Select "System Info" and then select "SW Info/Update".

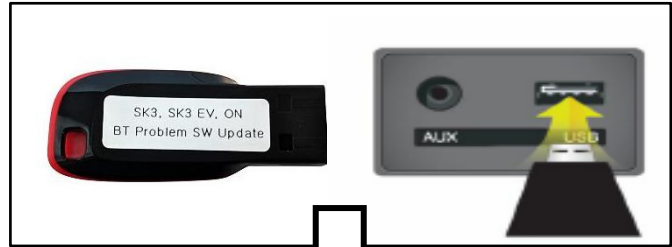
6. Insert USB Flash Drive into the vehicle's USB Port. (Location will vary by model)

Note: When inserting the USB flash drive, the "Update to next version now?" screen may pop up. If so, proceed to step 7.

If the "Update to next version now?" screen does not pop up, select "Update".

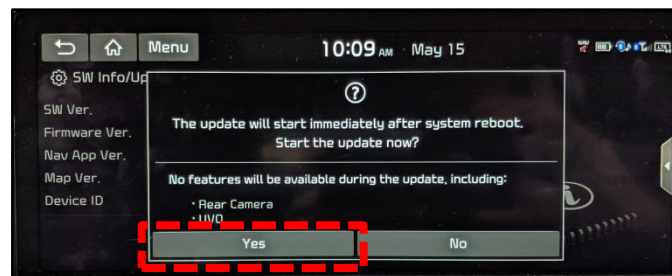
9. Select "Yes" to begin software update.

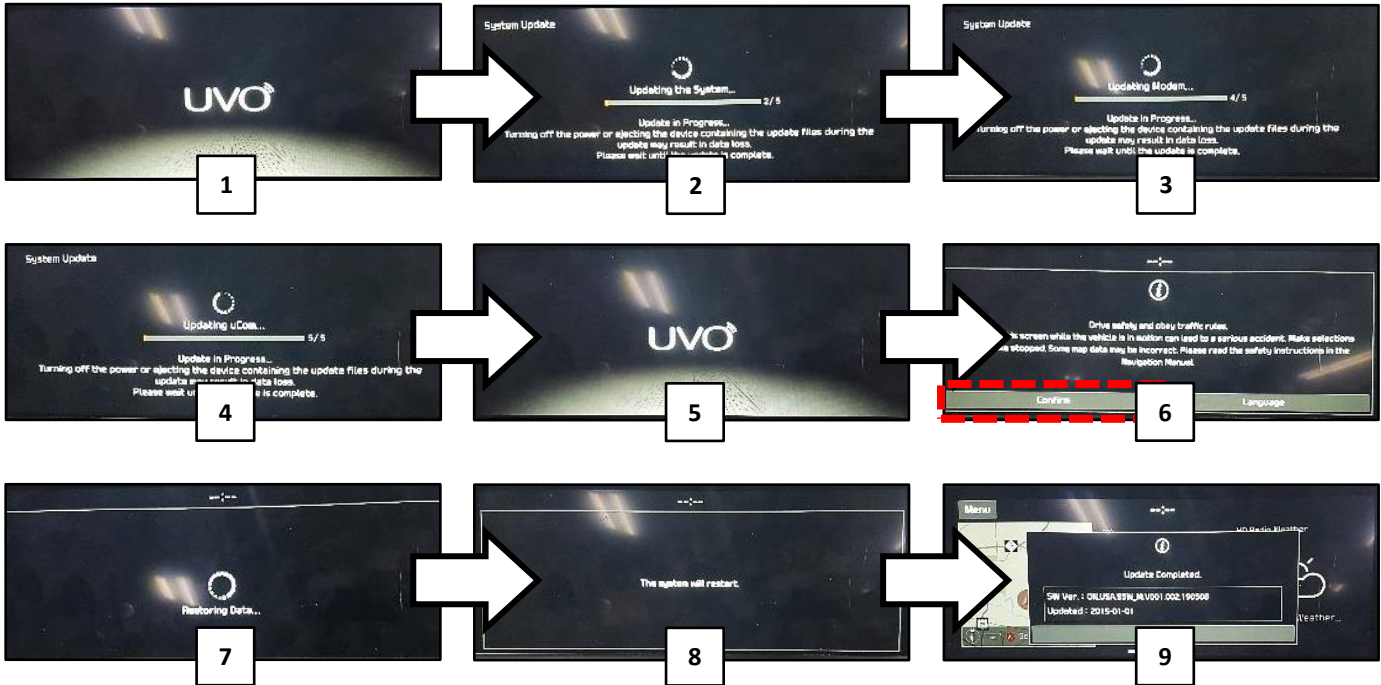
Allow for the following nine (9) screen sequences to complete.

Do NOT press any hard keys or touch screen unless instructed to do so. (Example: On screen six (6) select “Confirm” to continue.)

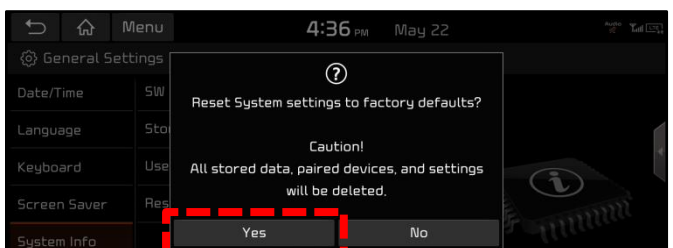
12. Select “Yes” to reset system settings to factory defaults.

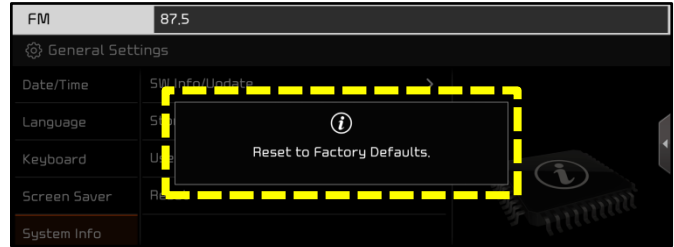
13. The “Reset to Factory Defaults” message will appear for a few seconds and clear.
