**SERVICE
CENTER
INFORMATION**

SCI19-20

DATE :	June 2019	SECTION : 23 ACCESSORIES
SUBJECT :	MUX UPDATE-VEHICLE PROGRAM GENERATION

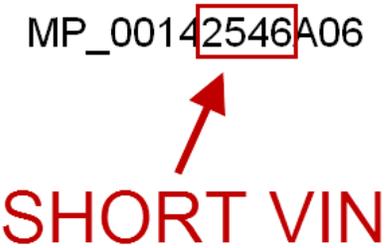
4. Set the parameters as needed.
5. Generate the program.
6. Close VPG.
7. Locate the program:
 - **C:\MUX_Local_V2\GenProg** if you have generated the program offline.
 - **C:\MUX_Prod_V2\GenProg** if you have generated the program online.
8. The vehicle program file name includes the short VIN.
9. Rename the file and add the extension ".txt" after the extension ".exe".
10. Send the file to the owner by email.
11. Bulletin is complete.

MP_00142546A06

SHORT VIN
