WKC6 - Re-programming Air-conditioning Control Unit and Various Other Control Units (Workshop Campaign)

Model Line: **Cayenne (9YA)**

Model Year: **2019**

Subject: **Re-programming air-conditioning control unit and various other control units**

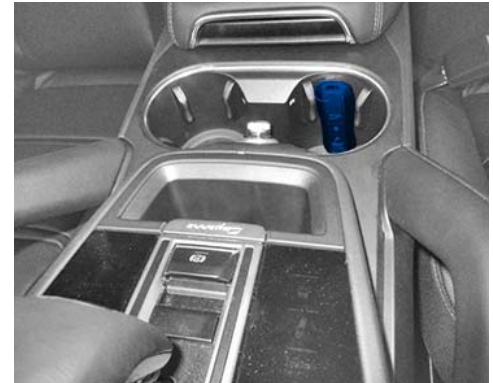
Emergency start tray

- 2 **Position the driver's key** in the rear area of the left cupholder in the center console between the holding struts (emergency start tray) in order to guarantee a permanent radio link between the vehicle and driver's key ⇒ *Emergency start tray*.
