WKD6 - Re-coding Control Unit for Assistance Systems and Re-programming Various Other Control Units if Necessary (Workshop Campaign)

Model line: **Cayenne (9YA)**

Model Year: **2019**

Subject: **Software update of the following control units:**

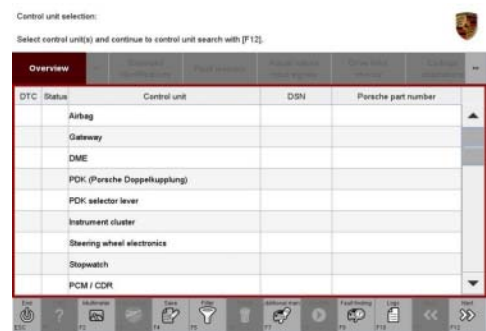
Control unit selection

- 1.1 In the control unit selection screen ('**Overview**' menu) ⇒ *Control unit selection*, press •F7" to call up the '**Additional menu**'.
- 1.2 Select the function "**Read all fault memories and erase if required**" and press •F12" ("Next") to confirm your selection ⇒ *Erasing fault memories*.
