April 2019  
SF560A-0  
SECOND REVISED NOTICE

## **Subject: Freightliner Cascadia Software Updates**

**Models Affected:** Specific Freightliner Cascadia vehicles manufactured June 13, 2016, through April 6, 2018, and equipped with one or more of the following modules: ASAM, FCU, ACU, PCU, and MPC.

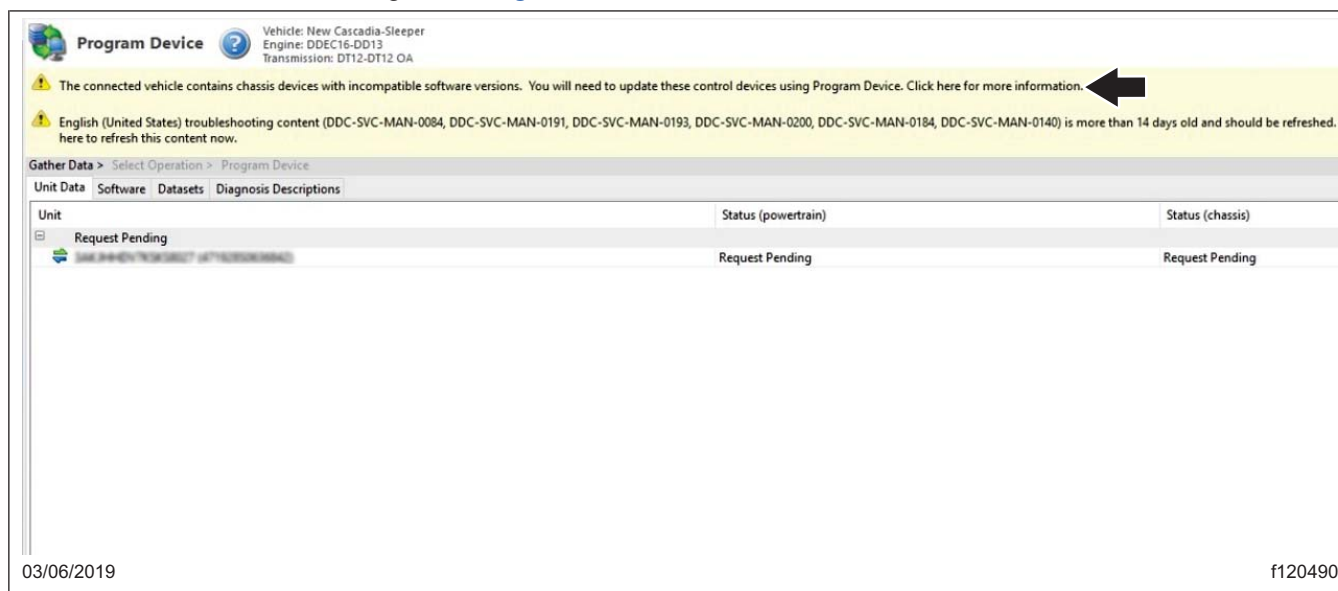
Fig. 3, Clicking on the Banner Message

11. Click on the banner message. See [Fig. 3](#).

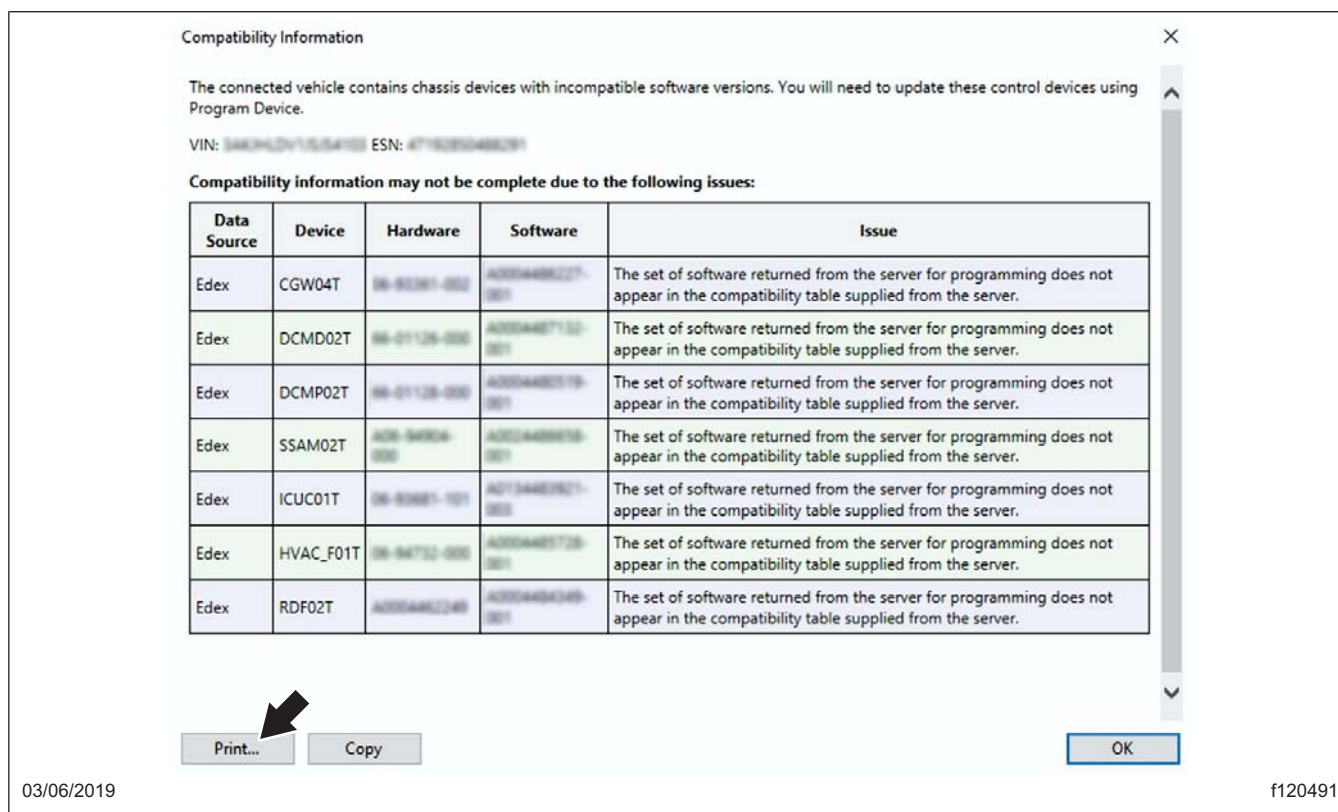
Fig. 4, Printing the List of Incompatible ECUs

12. Print or take a screen shot of the incompatible ECUs. See [Fig. 4](#).
