Multimedia System Enhancements Phase 3 (Pioneer)

Service Category Audio/Visual/Telematics

Section Audio/Video

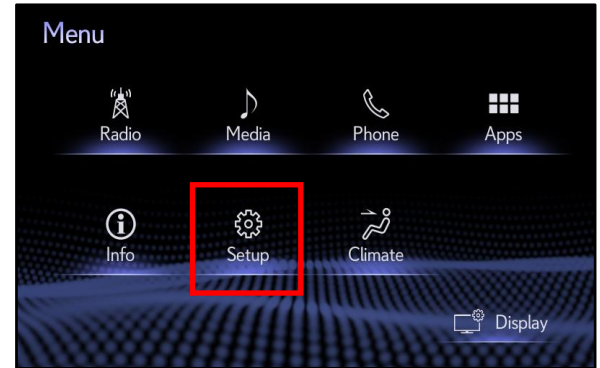
Figure 2.

3. Press the Menu button, then select Setup.

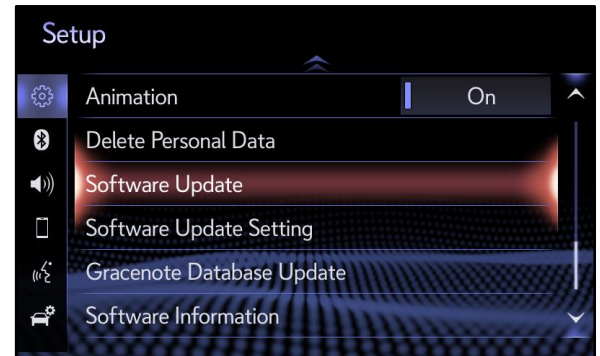
Figure 3.

4. Scroll up or down and select Software Update.

If the ignition has been turned OFF, repeat steps 3 – 4 to re-enter the Software Update screen.

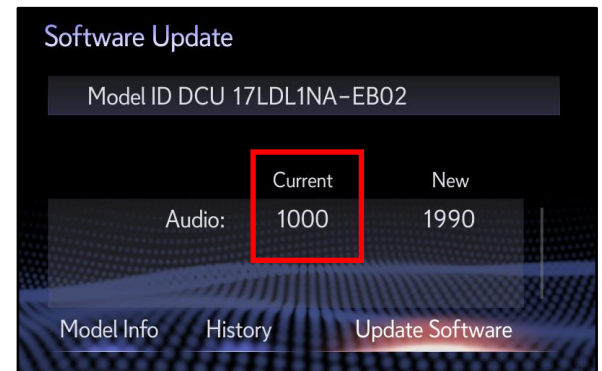
Figure 4.

- Verify the current audio software version using the table below.

Does the current audio software version match one of the current software versions in Table 1?

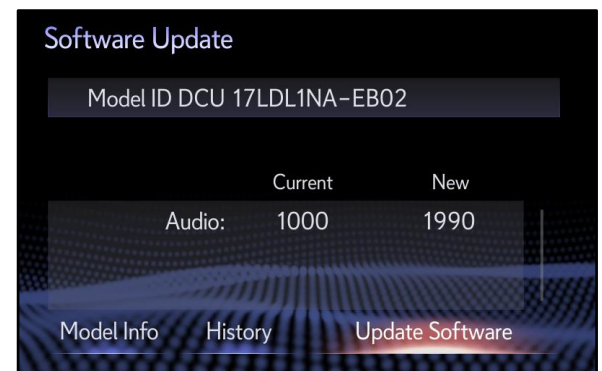
Figure 5.

- Select the Update Software button in the lower right-hand corner.

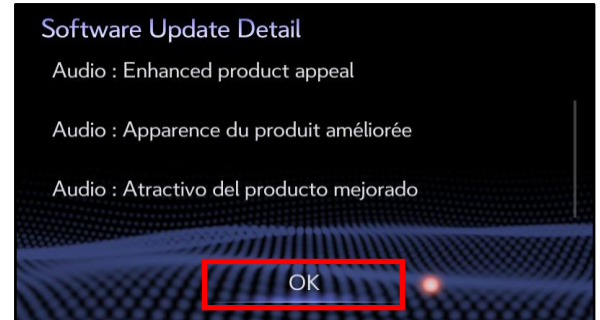
Figure 6.

9. Select OK on the Software Update Detail screen.

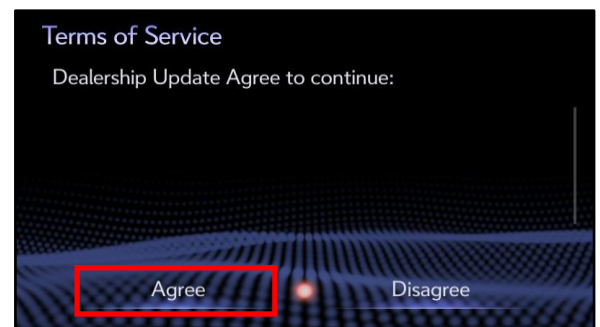
Figure 7.

10. Select Agree on the Terms of Service screen.

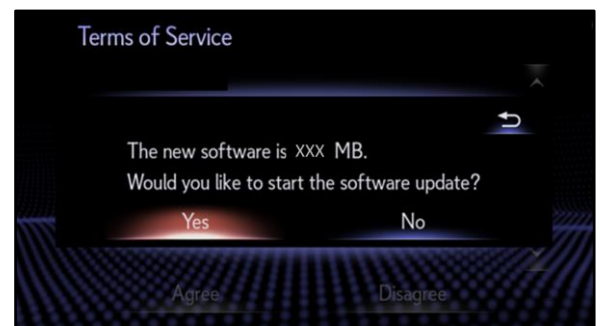
Figure 8.

11. Select Yes on the "Would you like to start the software update?" pop-up.

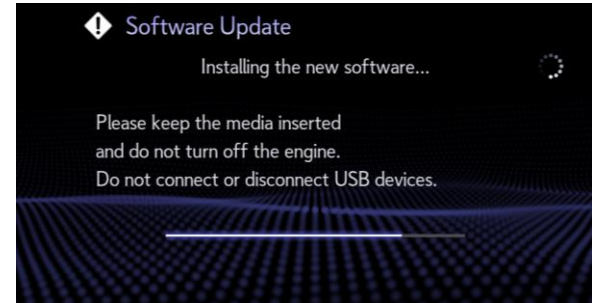
Figure 9.

12. Once the head unit begins installation, the update will take approximately 15 minutes.

- Do NOT turn off the ignition or ACC before the software is ready for updating.
- Do NOT remove the USB flash drive until instructed.

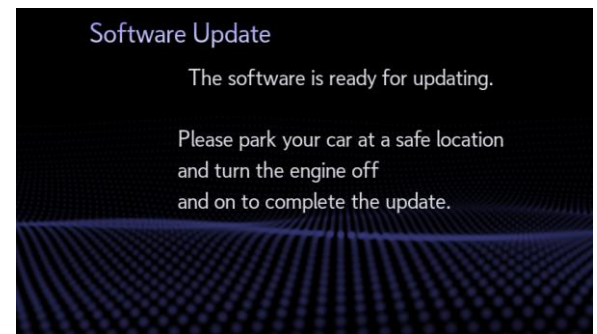
Figure 10.

13. When the “The software is ready for updating” screen appears, turn the ignition OFF.

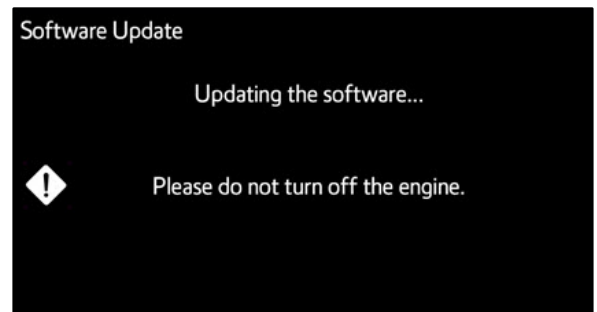
Figure 11.

15. AFTER cycling the ignition switch to the “IG-ON” mode, the Software Update screen will appear.

- Do NOT turn the ignition off or remove the USB flash drive. The head unit may reboot during this time.
- Removing the USB flash drive or cycling the ignition off may cause damage to the head unit.

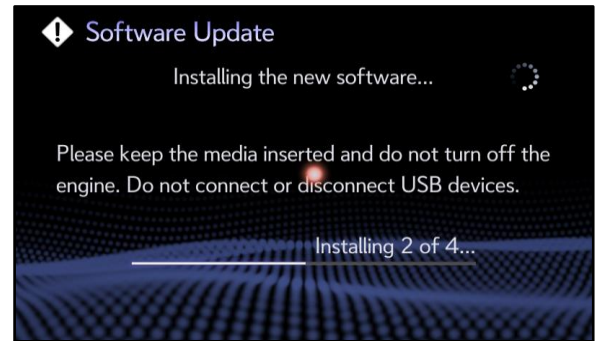
Figure 12.

17. The head unit will begin the second software installation phase.

- Do NOT turn off the ignition or ACC before the software is ready for updating.
- Do NOT remove the USB flash drive until instructed.
- If a "New software is not compatible with system." pop-up occurs at this step, complete the following:
 - (1) Turn the vehicle OFF.
 - (2) Remove the USB flash drive.
 - (3) Verify ALL files mentioned in the Software Download and Extraction Procedure section are present.
 - (4) Begin the Software Update Procedure again.

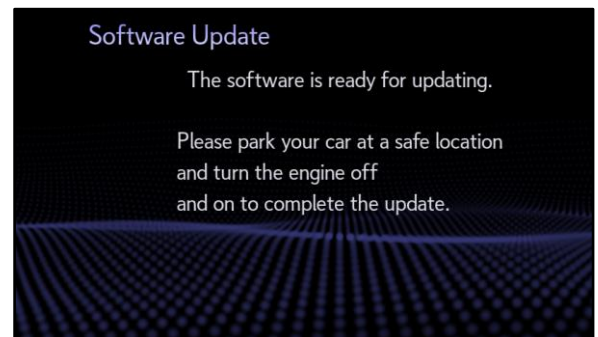
Figure 13.

18. When "The software is ready for updating" screen appears, the head unit will automatically be rebooted.

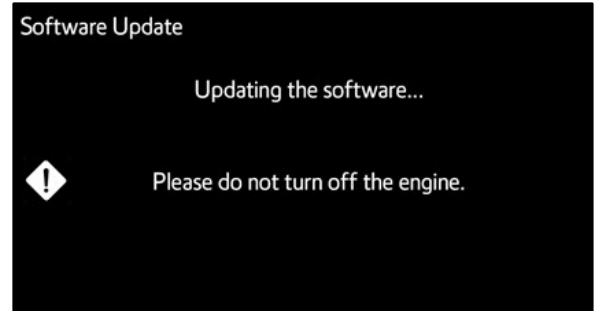
Figure 14.

19. After the reboot, the Software Update screen will appear.

- Do NOT turn the ignition off or remove the USB flash drive. The head unit may reboot during this time.
- Removing the USB flash drive or cycling the ignition off may cause damage to the head unit.
