UPDATE Technical Bulletin

26M1 UPDATE – ECM Software Update (FED_EMS)

UPDATE Code 26M1 ECM Software Update

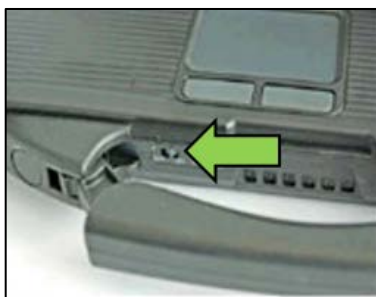
VAS 6150 & VAS 6150A
(Front panel behind handle)

- ✓ **The Bluetooth function of the scan tool is physically switched off <see pictures below>.**

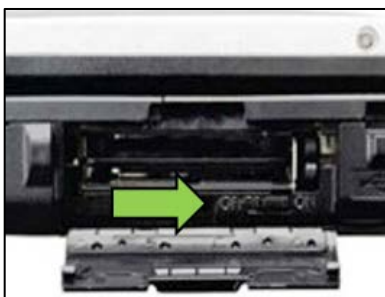
VAS 6150B
(Right side behind WIRELESS door)

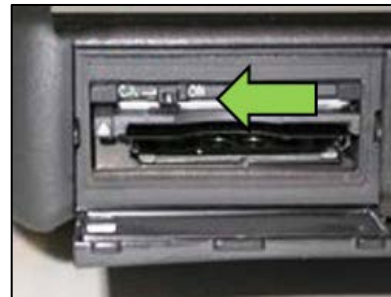
VAS 6150C/D
(Left side behind SC/EX door)

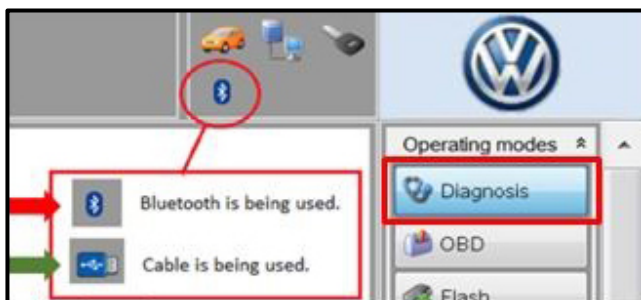
- Confirm that scan tool is communicating with the diagnostic head by USB <Green Arrow>.
 - If the Bluetooth symbol is shown <Red Arrow> then disconnect the diagnostic head from the vehicle and reconnect the USB cable to the diagnostic head and then reattach to the vehicle.
