# Service Action

## Code: 91U8

<b>Subject</b>	<b>Infotainment System Software – Security Patch</b>
<b>Release Date</b>	July 18, 2019
<b>Affected Vehicles</b>	<b>U.S.A.: Certain 2016 MY Volkswagen e-Golf</b> <b>CANADA: Certain 2016-2017 Volkswagen Golf R</b> <i>Check Campaigns/Actions screen in Elsa on the day of repair to verify that a VIN qualifies for repair under this action. Elsa is the <u>only</u> valid campaign inquiry &amp; verification source.</i> <ul style="list-style-type: none"><li>✓ Campaign status must show “open.”</li><li>✓ If Elsa shows other open action(s), inform your customer so that the work can also be completed at the same time the vehicle is in the workshop for this campaign.</li></ul>
<b>Problem Description</b>	Volkswagen has determined that a software update is needed to improve the security of the vehicle’s infotainment system.
<b>Corrective Action</b>	Update infotainment system software.
<b>Parts Information</b>	Software update only; no parts needed.

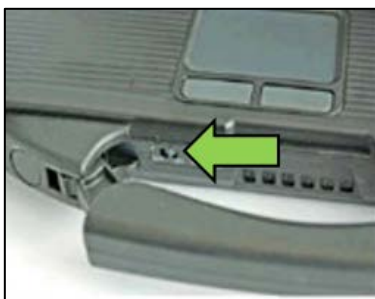
**VAS 6150 & VAS 6150A**  
(Front panel behind handle)

- ✓ **The Bluetooth function of the scan tool is physically switched off <see pictures below>.**

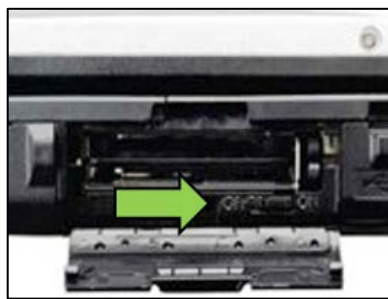
**VAS 6150B**  
(Right side behind WIRELESS door)

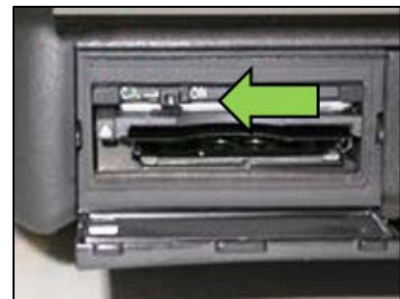
**VAS 6150C/D**  
(Left side behind SC/EX door)

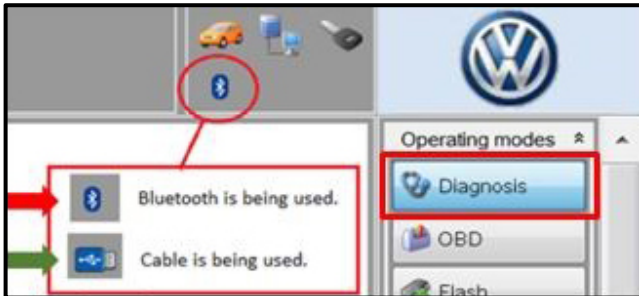
- Confirm that scan tool is communicating with the diagnostic head by USB <Green Arrow>.
  - If the Bluetooth symbol is shown <Red Arrow> then disconnect the diagnostic head from the vehicle and reconnect the USB cable to the diagnostic head and then reattach to the vehicle.
- Upon ODIS startup, verify the “Diagnosis” operating mode is selected <as shown>.

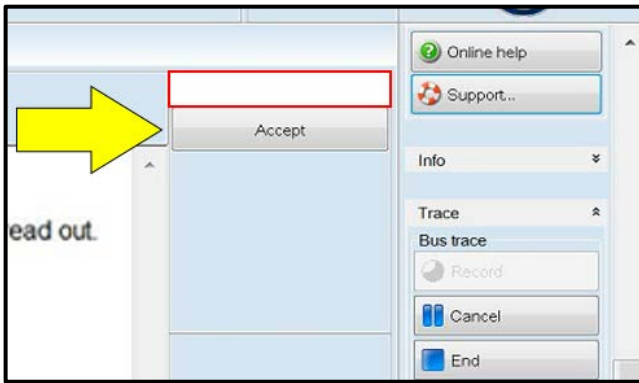
- Select “Accept” <arrow> and follow the on screen prompts.
- Insert the SD card the in the vehicle’s SD card reader when prompted.
- Follow the on screen prompts.
