GROUP TRA	MODEL 2019MY Sorento (UMa) 3.3L Sedona (YP) 3.3L
	NUMBER 082 (Rev 1, 07/03/2019)	DATE May 2019
<p align="center"><b>TECHNICAL SERVICE BULLETIN</b></p>		
<p>SUBJECT: SERVICE ACTION: 3.3L GDI 8AT TCU LOGIC IMPROVEMENT FOR DTC P0741 (SA387)</p>

This bulletin provides the procedure to improve the logic of the Transmission Control Unit (TCU) software on some 2019MY Sorento (UMa) vehicles produced from January 24, 2018 through March 26, 2019, and Sedona (YP) produced from February 14, 2018 through October 15, 2018, which may experience a malfunction indicator lamp (MIL) ON with DTC P0741. To correct this concern, apply the improved logic to the TCU using the KDS ECU Upgrade function as described in this bulletin. For confirmation that the latest reflash has been applied to a vehicle you are working on, verify the ROM ID using the table on page 2 of this bulletin. Before conducting the procedure, verify that the vehicle is included in the list of affected VINs.

### DTC: P0741 – Torque Converter Clutch Circuit Performance or Stuck Off

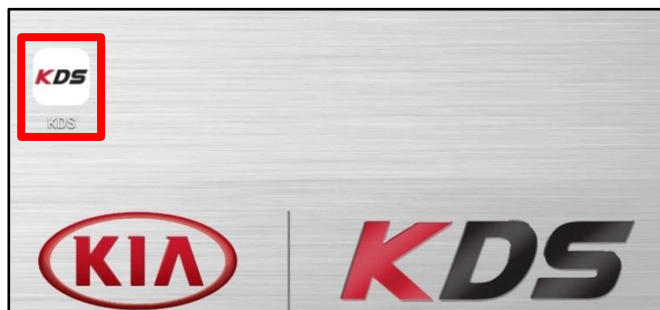
2. With the ignition ON, turn ON the KDS tablet. Select **KDS** from the home screen.

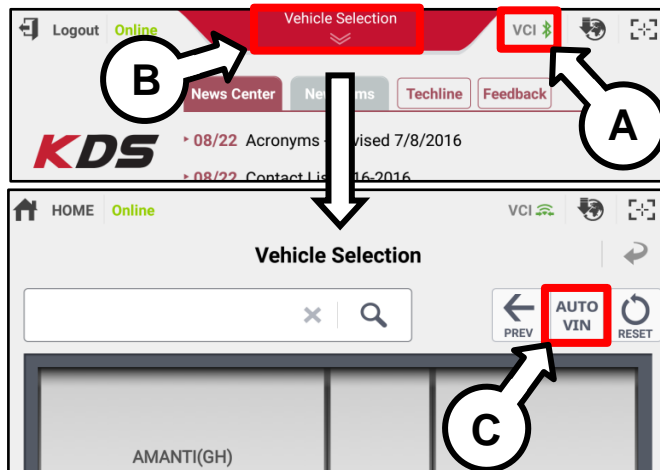
3. Confirm communication with VCI (A) and then configure the vehicle (B) using the **AUTO VIN** (C) feature.

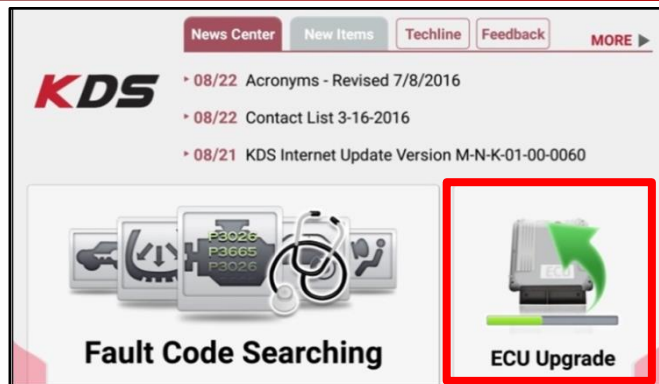
4. Select **ECU Upgrade**.

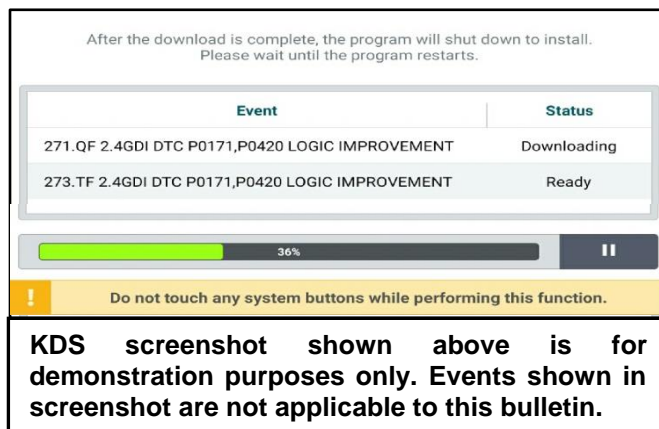
5. The KDS will check the server for recently uploaded Events and then automatically download **Upgrade Event #420 (UMa) or #421 (YP PE)**.

The vehicle must be identified in Vehicle Selection to download an Event for that vehicle.

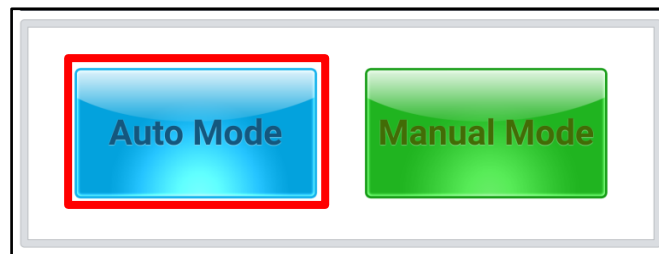
6. Select **Auto Mode**.

Do NOT attempt to perform a Manual Mode upgrade UNLESS Auto Mode fails. Always follow the instructions given on the KDS in either Auto or Manual mode.

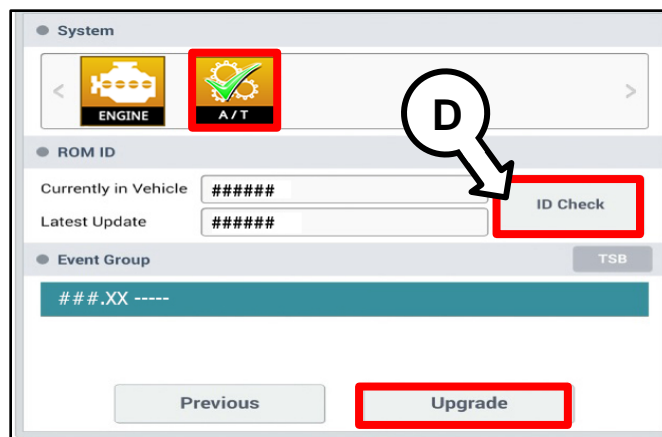
7. Select the **A/T** system under the System selection menu.

Touch **ID Check (D)** and confirm that the latest update is available.

Select **Upgrade Event #420 or #421** and select **Upgrade** to continue.

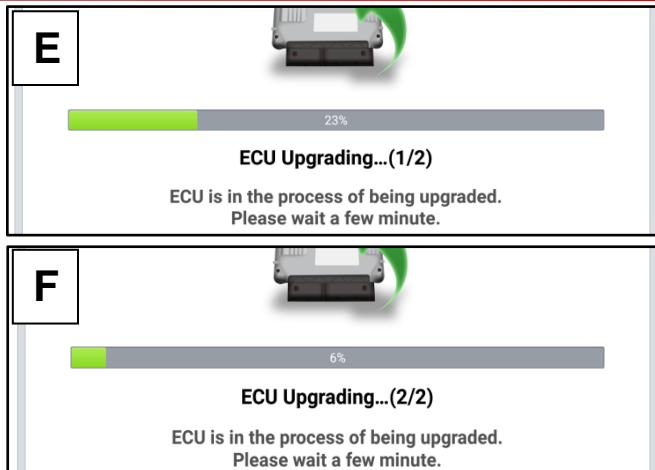
8. The ECU upgrade will begin and the progress of the upgrade will appear on the bar graph. Upgrade part (1/2) (E) will download the upgrade event to the VCI-II. Upgrade part (2/2) (F) will upgrade the ECU.

Do not touch the system buttons (like 'Back', 'Home', 'etc.') while performing ECU Upgrade.

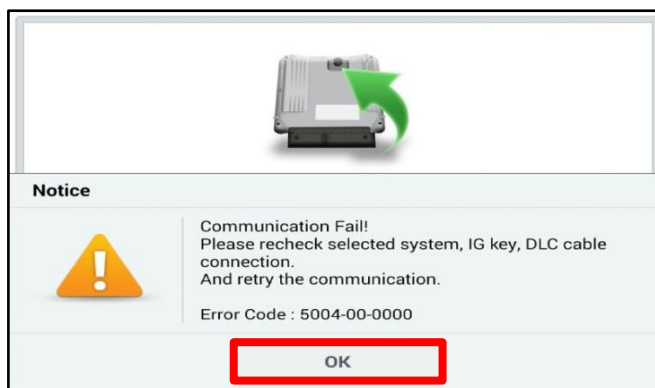
9. If a "Communication Fail" screen appears, verify that the VCI-II and KDS are communicating properly. Touch **OK** and restart the procedure from step 4.

If an error notice continues to appear or if the upgrade cannot be performed, **DO NOT** disconnect the KDS/VCI-II. Contact GIT America Help Desk at (888) 542-4371 or Techline.

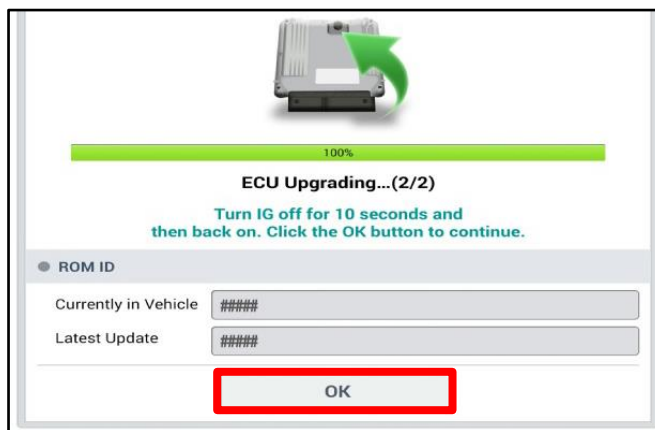
10. When instructed on the KDS, turn the ignition **OFF** for ten (10) seconds then back on. Touch **OK** to continue.

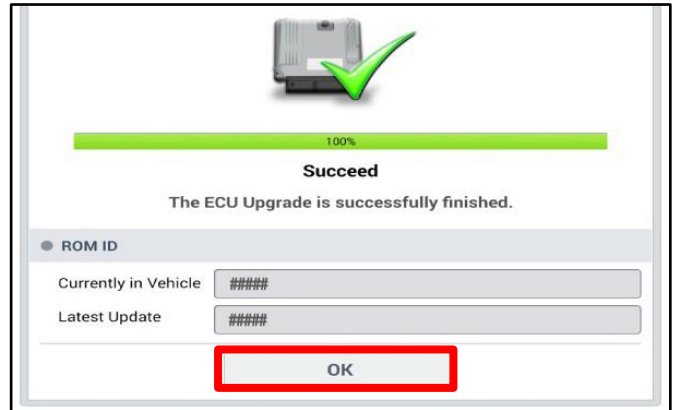
11. Once the upgrade is complete, touch **OK** to finalize the procedure.

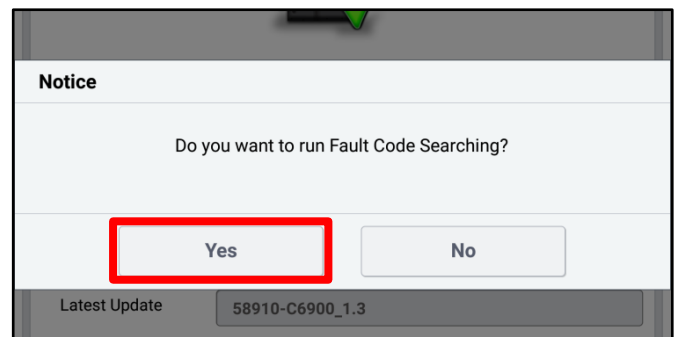
12. When prompted, select **YES** to check for Diagnostic Trouble Codes (DTC) and erase any DTCs stored such as EPS, ESC, and TPMS that may have been set during the upgrade.
