**SERVICE PROGRAM BULLETIN**

**APPLICABILITY:** 2018 MY Legacy  
 2018 MY Outback  
 2017-2018 MY Impreza  
 2018 MY Crosstrek

**NUMBER:** WUA-86R

**SUBJECT:** Harman Kardon Head Unit Reprogramming

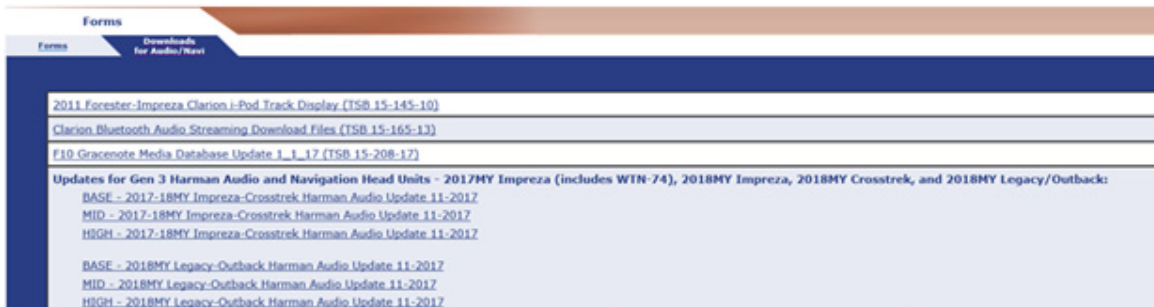
- If the files are being **downloaded from Subarunet**, they will be .zip files and must be unzipped before they can be used. An EXAMPLE image of the Subarunet links page is provided below.

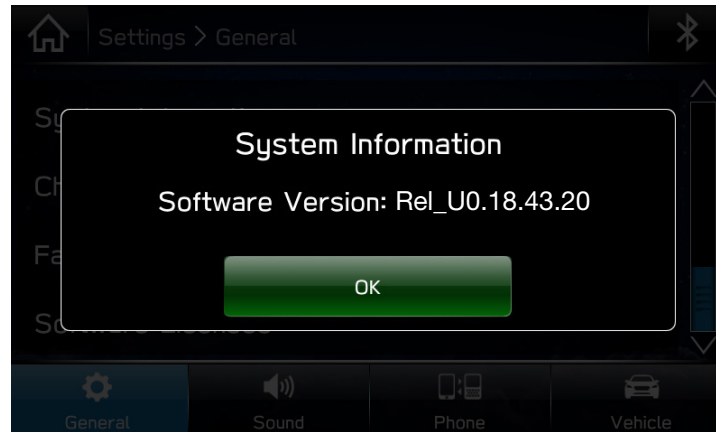
- Confirm Software Version is now “Rel\_U0.18.43.20” (or latest software version as found in bulletin 15-211-17R).
