Technical Service Bulletin

SUBJECT:			No: TSB-19-54-015
VEHICLE POSITION ON NAVIGATION SCREEN DISPLAYS AHEAD OF ACTUAL POSITION			DATE: July 2019
			MODEL: 2018-19 Eclipse Cross
CIRCULATE TO:	<input type="checkbox"/> GENERAL MANAGER	<input checked="" type="checkbox"/> PARTS MANAGER	<input checked="" type="checkbox"/> TECHNICIAN
<input checked="" type="checkbox"/> SERVICE ADVISOR	<input checked="" type="checkbox"/> SERVICE MANAGER	<input checked="" type="checkbox"/> WARRANTY PROCESSOR	<input type="checkbox"/> SALES MANAGER

This TSB instructs dealers to reprogram the Combination Meter with updated software to correct the vehicle position display issue.

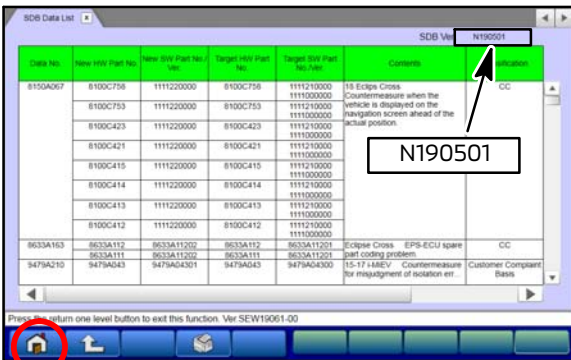
c. Click "SDB Data List."

d. Confirm that the database number displayed in the upper right above the chart is **N190501 or higher**

- If the database number displayed on your MUT3-SE is N190501 or higher, continue to the next section.
- If the reprogramming database number displayed on your MUT3-SE is **lower** than **N190501**, then the MUT3-SE database needs to be updated.

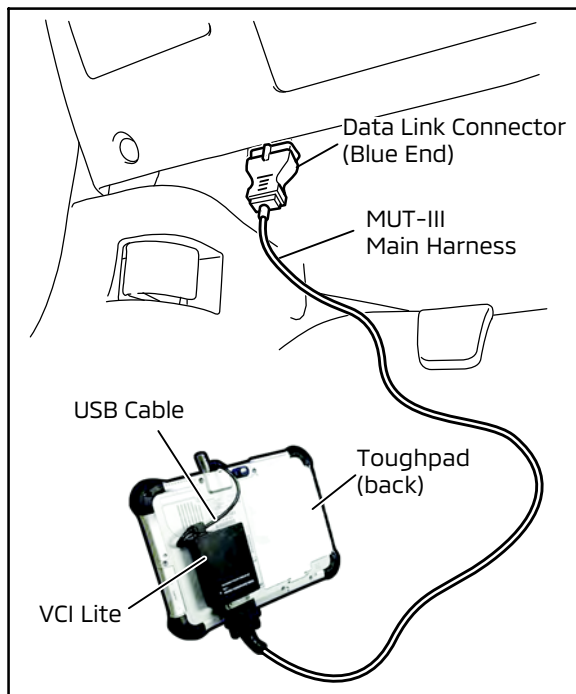
1. Connect the equipment as follows:

NOTE: VCI Lite and MEDIC 4.0 Toughpad shown for illustration purposes only.

- Turn the MEDIC PC/tablet on. If the battery indicator in the lower right hand corner of the screen does not show a full charge, it is recommended that either the battery be charged prior to beginning, or be used with the A/C power adaptor connected.
- Connect the USB cable to the VCI/VCI Lite.
- When the laptop/tablet displays the MUT-III main screen, connect the USB cable to the device.
- Connect the MUT-III main harness with the blue DLC connection to the VCI/VCI Lite.
- Connect the blue connection of the MUT-III main harness to the vehicle's data link connector.
- For VCI only (p/n MB991824): Turn the VCI power switch ON. Verify that the indicator lamp in the upper right corner of the screen is green.

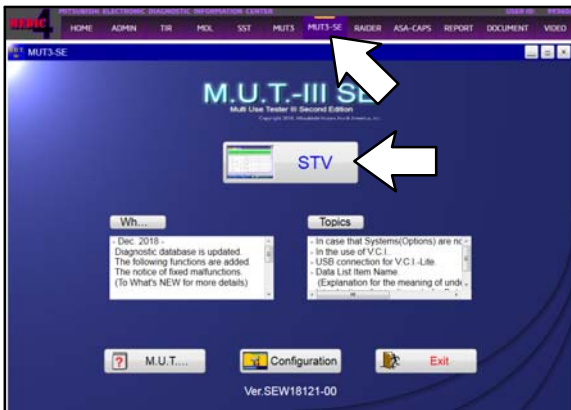
2. Turn the ignition switch to the "ON" position.

- Using MEDIC, from the main page, click the "MUT3-SE" icon at the top center of the screen to open MUT-III SE.

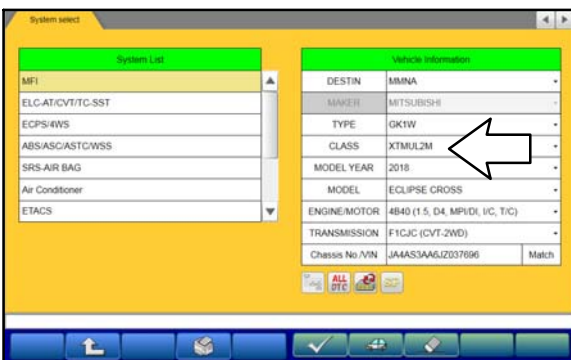
Click the STV button.

- The System Select screen opens and populates with some basic information from the vehicle.

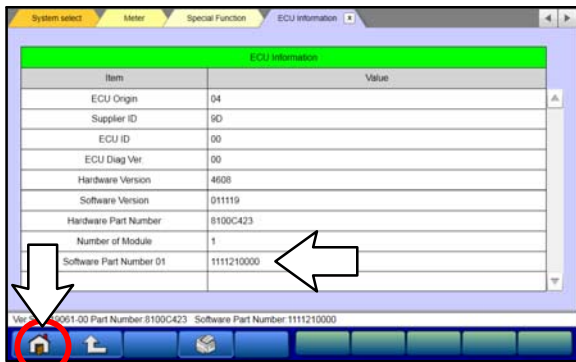
c. Select "ECU Information."

d. If the Software Part Number listed is **not** at the latest level (shown in the "**Combination Meter Reprogramming Chart**" in this TSB), proceed with the next step. Click the Home button to return to the System Select screen.

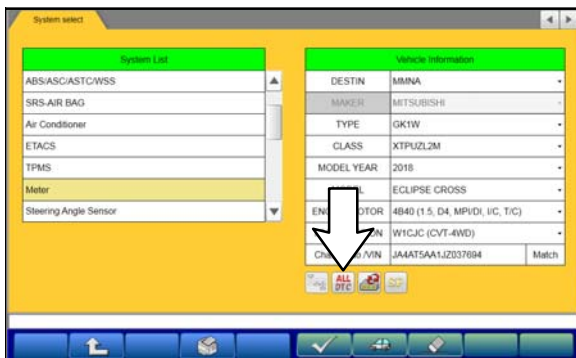
6. Before reprogramming, perform an "Erase and Read All DTCs" to clear any DTCs that may have set.

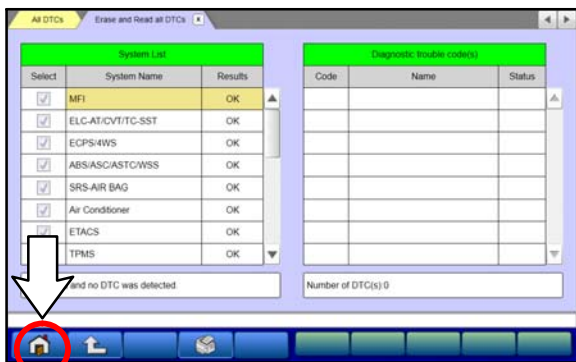
- 7. When DTC erasing is completed, click the check mark in the pop-up message that reads "All erasing and checks are completed."
 - a. If any DTCs return after erasing is completed, click the check mark to clear the window. Diagnose and repair per the Service Manual.

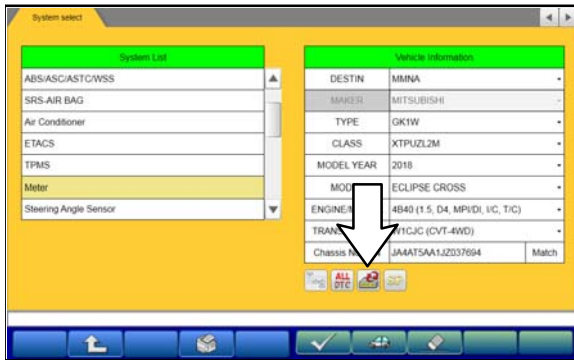
8. Reprogram the Combination Meter following the steps below.

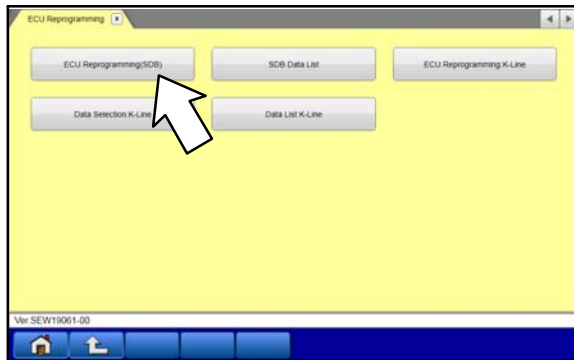
a. On the System Select page, click on the Reprogram button.

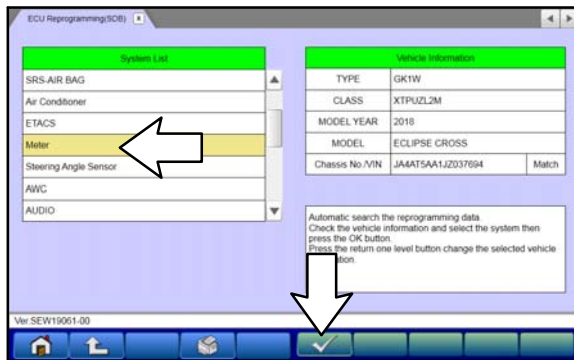
b. Select "ECU Reprogramming (SDB)."

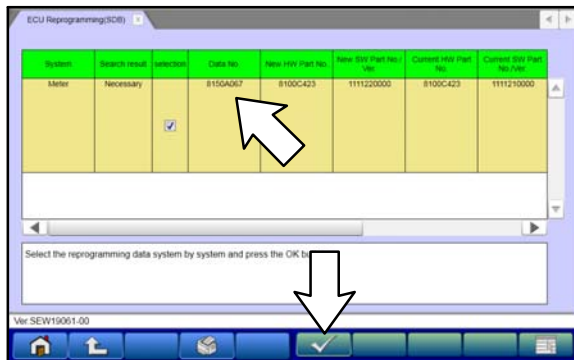
c. Select "Meter" in the System List, then click the check mark.

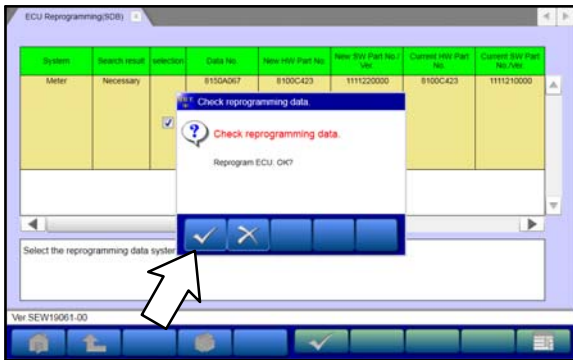
d. Verify that the correct data file listed in the table matches the one in the **"Combination Meter Reprogramming Chart."**

e. Click the check mark at the bottom of the page to initiate reprogramming.

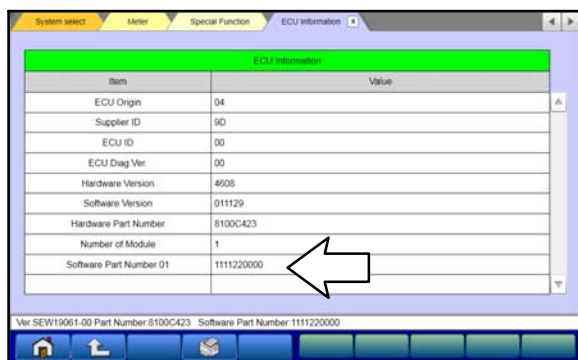
9. Perform an "Erase and Read All DTCs" again to clear any DTCs that may have set.
For instructions, refer to steps 6 and 7 in this TSB.
10. Confirm the software version has been updated.
For instructions, refer to step 5 in this TSB.

Confirm "Software Part Number" now matches the NEW one shown in the **"Combination Meter Reprogramming Chart"** in this TSB.
