SERVICE BULLETIN

EL19-018

2018-2019 LEAF; LITHIUM-ION BATTERY WILL NOT QUICK CHARGE

APPLIED VEHICLE: 2018-2019 LEAF (ZE1)

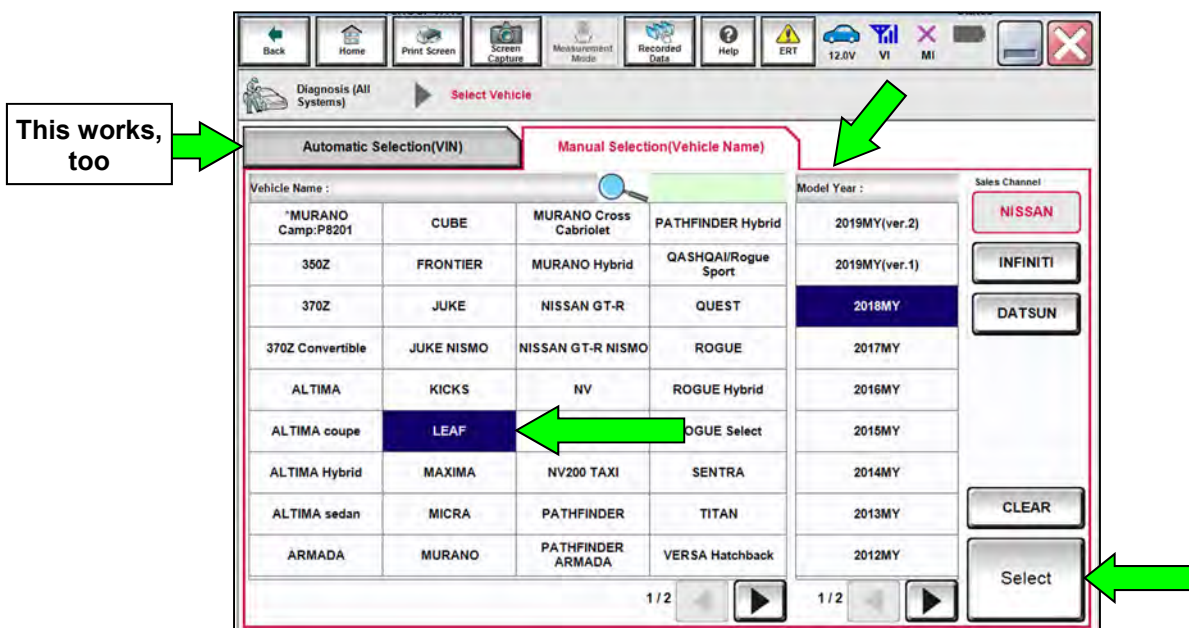
14. Select **LEAF** and the correct **Model Year**, or the **Automatic Selection(VIN)** tab.
 - If **Automatic Selection(VIN)** is selected, wait for the **Reading VIN** screen to complete (picture not shown).
 - If the screen in Figure 4 does not display, skip to step 16.

15. Select **Select**.

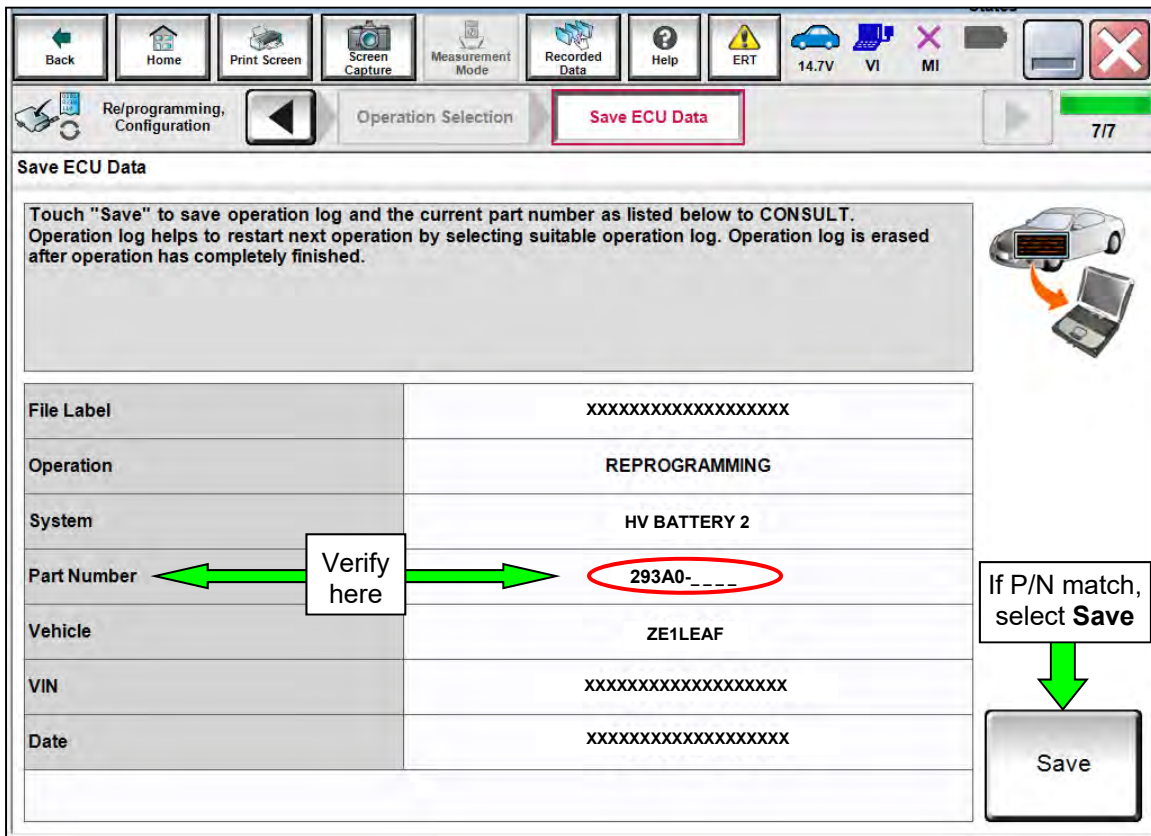
Figure 9

20. Find the **Part Number** (see Figure 9) and write it on the vehicle's repair order.
21. Compare the **Part Number** written down to those listed in **Table A** below.

- If there is a match, select **Save**, and then continue to Step 22.
- If there is not a match, this bulletin not apply. Go to ASIST and the Electronic Service Manual (ESM) for further diagnosis.

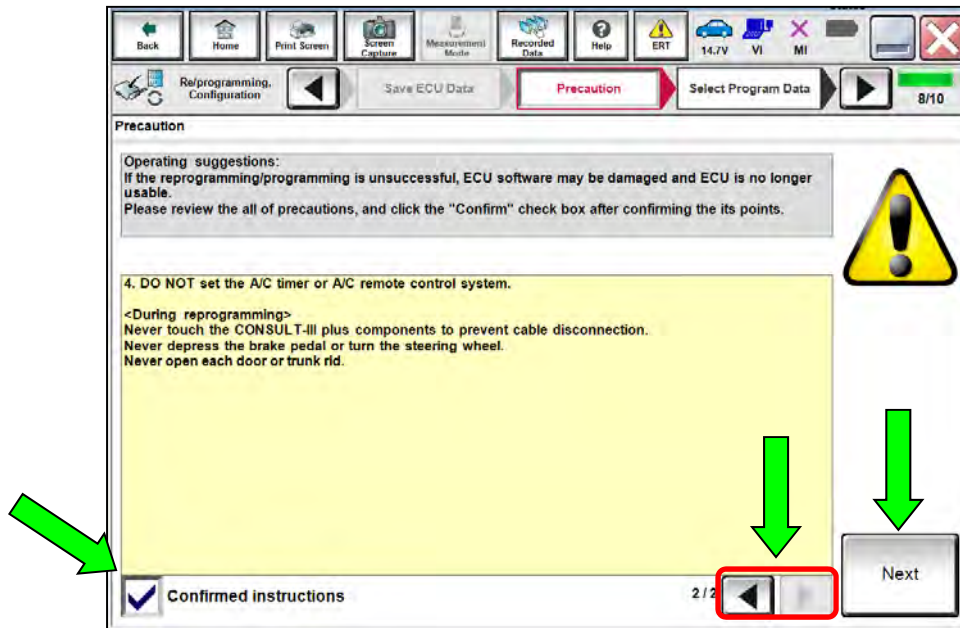
Figure 10

22. Read the **Precaution** on page 1, and then select page 2 (Figure 10) with the arrows. After reading page 2, select **Confirmed instructions**, and then select **Next**.

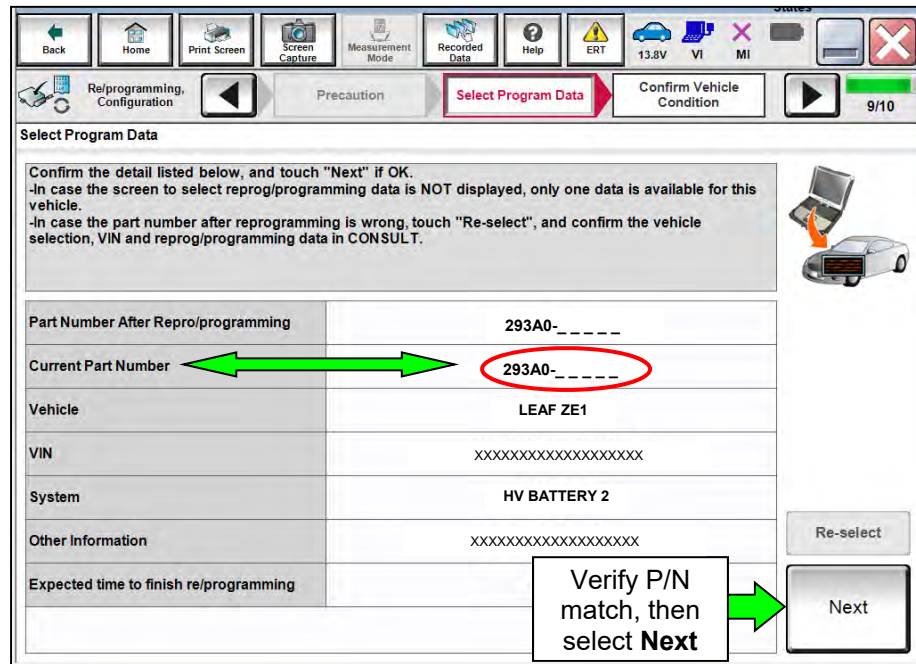
Figure 12

23. Verify the **Current Part Number** matches the Part Number written down in step 20, and then select **Next**.

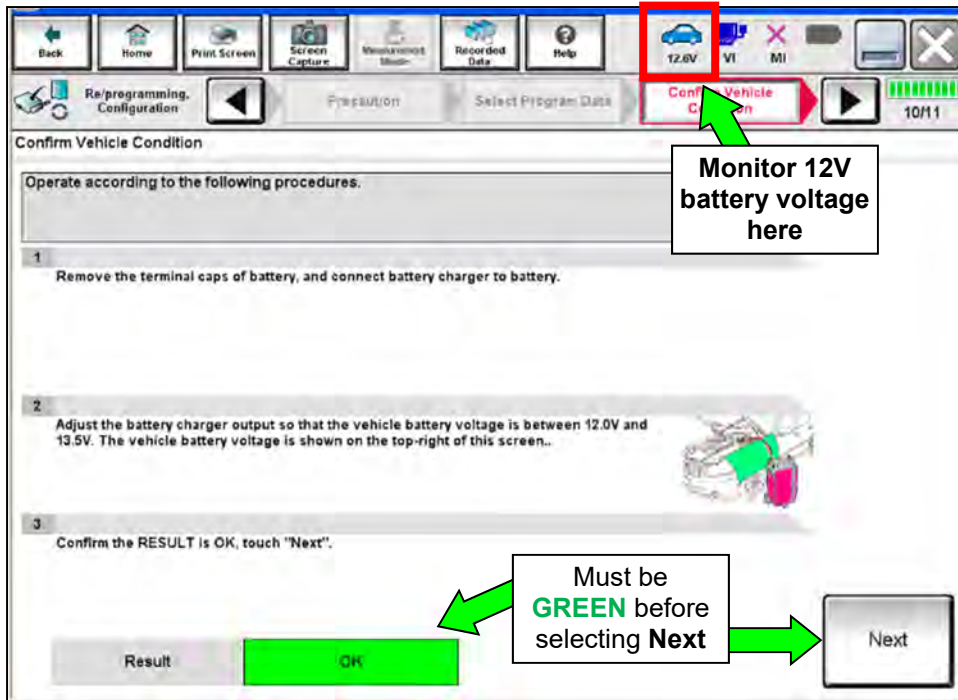
25. Confirm the battery voltage is within the specified range, and then select **Next**.

NOTE: The battery voltage must stay within the specified range to make the **Result** turn **GREEN**.

24. If the screen in Figure 13 appears, first select **Delete**, select **Confirm**, and then select **Other Operation**.
- This will erase the **Saved Data List** and restart the reprogram from step 18.
 - If no **Saved Data List** is stored, Figure 14 will be displayed. Proceed to step 25.

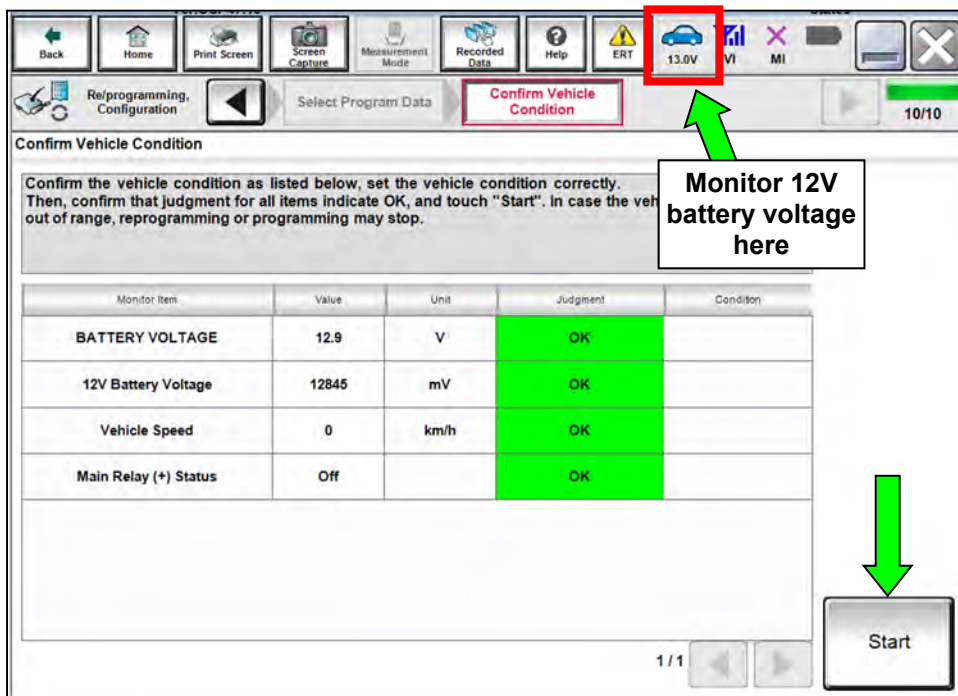
Figure 15

26. With the **BATTERY VOLTAGE** showing **GREEN**, select **Start**.

NOTE: For reprogramming to continue, the vehicle's 12V battery must stay between 12 volts and 15.5 volts.

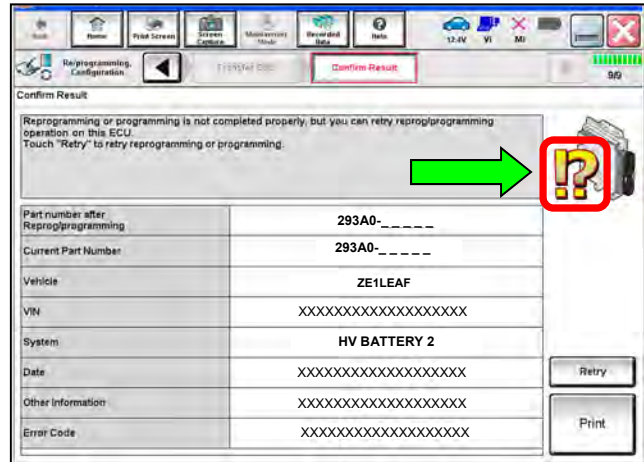
Figure 21

CAUTION: If reprogramming does not complete and the **!?** displays as shown in Figure 21:

- Check battery voltage (12.0-15.5V).
- Ignition is ON, Ready Mode is OFF.
- External Bluetooth® devices are OFF.
- All electrical loads are OFF.
- **Select Retry and follow the on screen instructions.**
- Retry may not go through on first attempt and can be selected more than once.

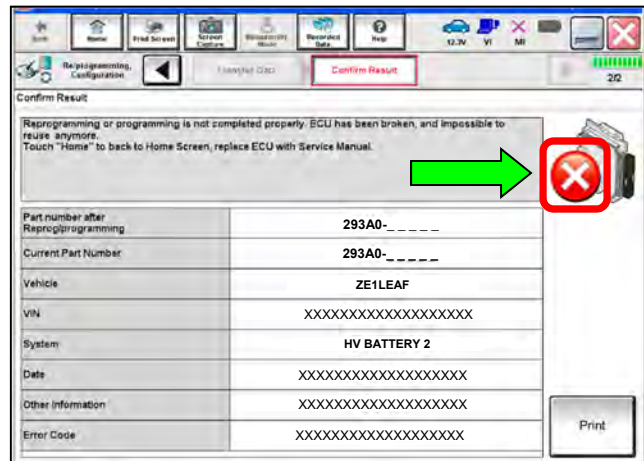
Figure 22

OR: If reprogramming does not complete and the **X** displays as shown in Figure 22:

- Check battery voltage (12.0-15.5V).
- Ignition is ON, Ready Mode is OFF.
- External Bluetooth® devices are OFF.
- All electrical loads are OFF.
- **Select Retry and follow the on screen instructions.**
- Retry may not go through on first attempt and can be selected more than once.

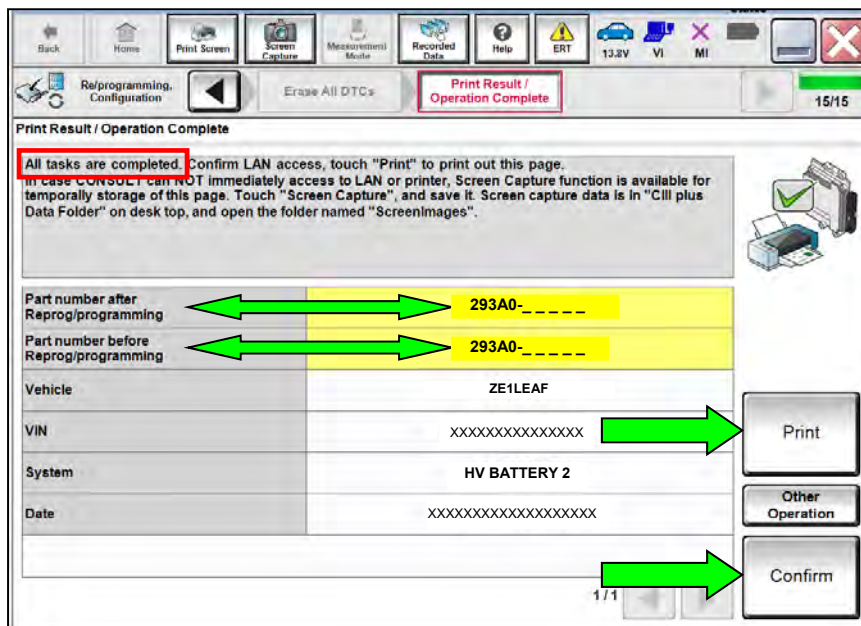
Figure 26

- 34. Verify the part number has changed.
 - a. Print a copy by selecting **Print**.
 - b. Attach the copy to the repair order.
 - c. Once a copy has been printed, select **Confirm**.

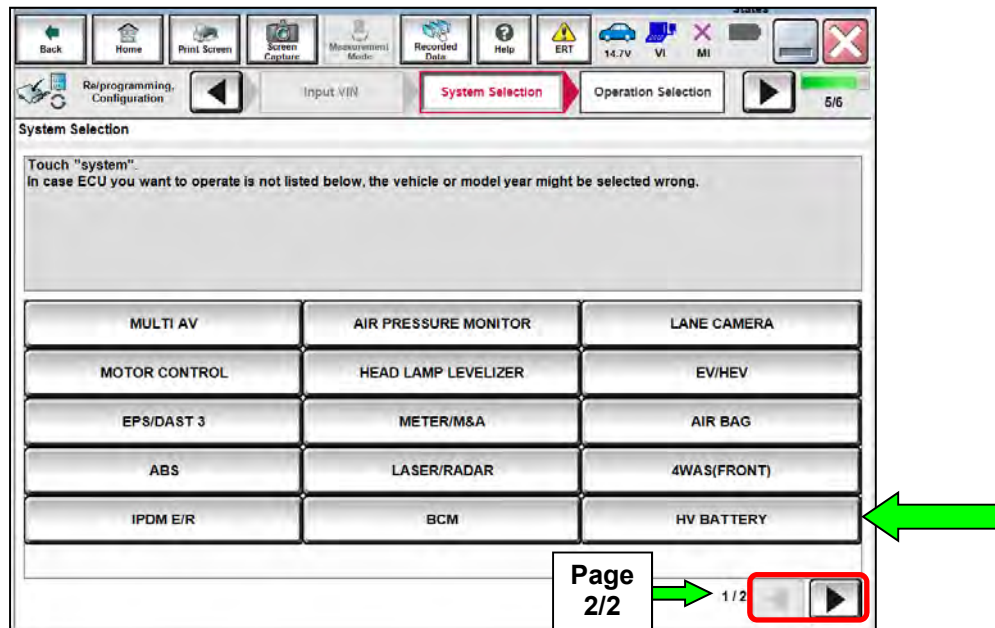
Figure 28

36. With LBC reprogramming completed for **HV BATTERY 2**, reprogram the LBC for **HV BATTERY** starting at step 9.

37. When performing step 13, select **HV BATTERY**, and then continue to step 14.

- To access **HV BATTERY**, select page **2/2** using the arrow keys.
