**WKC7 Re-programming DME Control Unit (Workshop Campaign)**

Vehicle Type: **Panamera (971)/Panamera 4 (971)**  
**Panamera Executive (971)/Panamera 4 Executive (971)**  
**Panamera 4 Sport Turismo (971)**

Subject: **DME control unit**

Information: **Updated software is available for the DME control unit.**  
 This software optimizes control of the oxygen sensor downstream of catalytic converter.

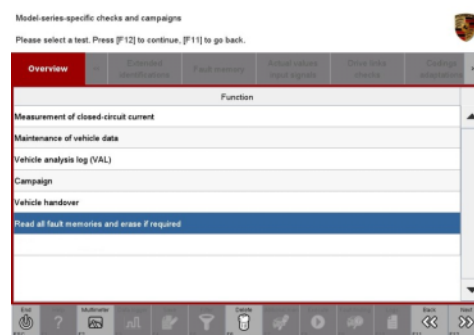
- 1.4 Press •F8“ to delete fault memory entries.
- 1.5 Press •F12“ ('Yes') in response to the question as to whether you really want to delete all fault memory entries.

The faults stored in the fault memories of the various control units are deleted.

*Erasing fault memories*

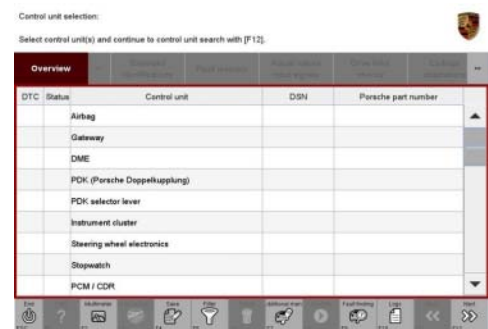
*Control unit selection*

1.6 Once you have erased the fault memories, select the **'Overview'** menu to return to the control unit selection screen ⇒ *Control unit selection*.
