# Service Bulletin

Bulletin No.: 19-NA-121

**Subject:** Shake and/or Shudder During Light Throttle Acceleration Between 25 and 80 MPH (40 and 128 KM/H) at Steady Speed

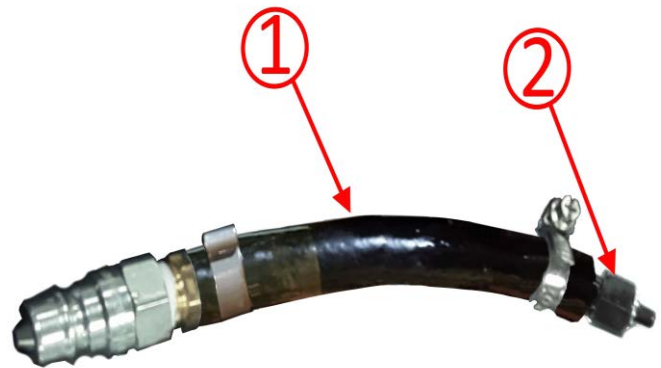
5182541

1. Fill the DT-45096 with 20 quarts of HP fluid.
2. Raise the vehicle on a hoist.

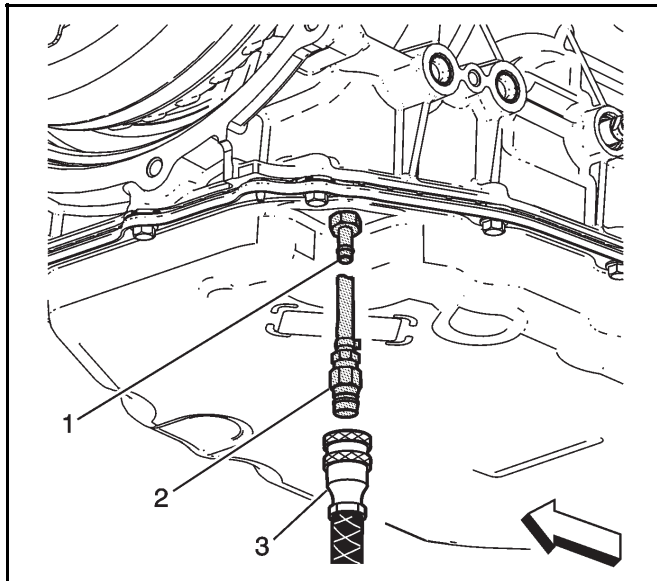
3723839

8. Remove the level set plug (1) from the transmission.

9. Install the DT-51190/DT-45096-31 assembly and hand tighten as shown in the graphic above.

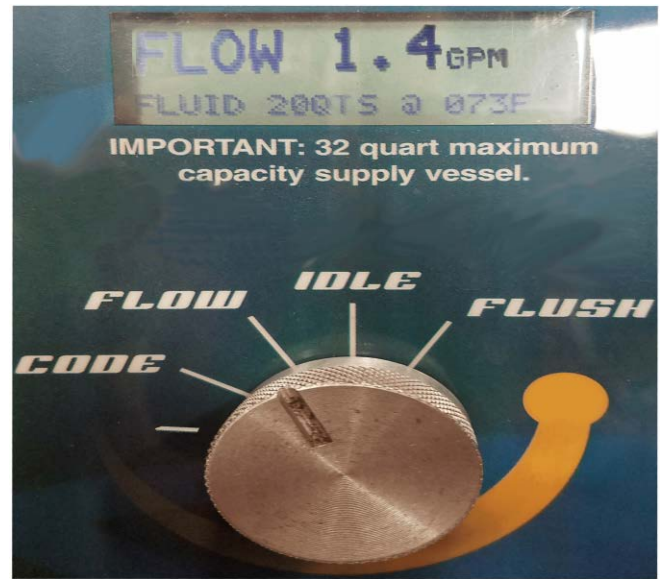
5181027

10. Connect the TransFlow fluid feed (supply) line (3) to the DT-45096-31 adapter (2).

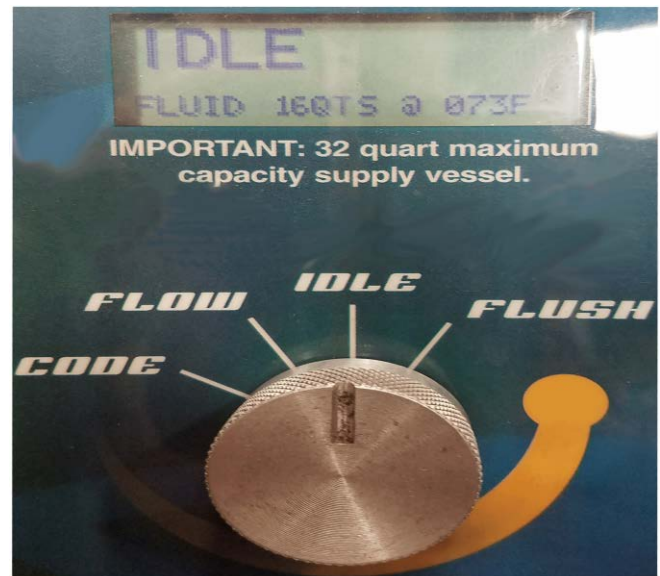
5181020

13. Shut the engine off immediately.  
14. Connect the DT-45096 to the vehicle battery 12 volts and connect shop air to the air connection.

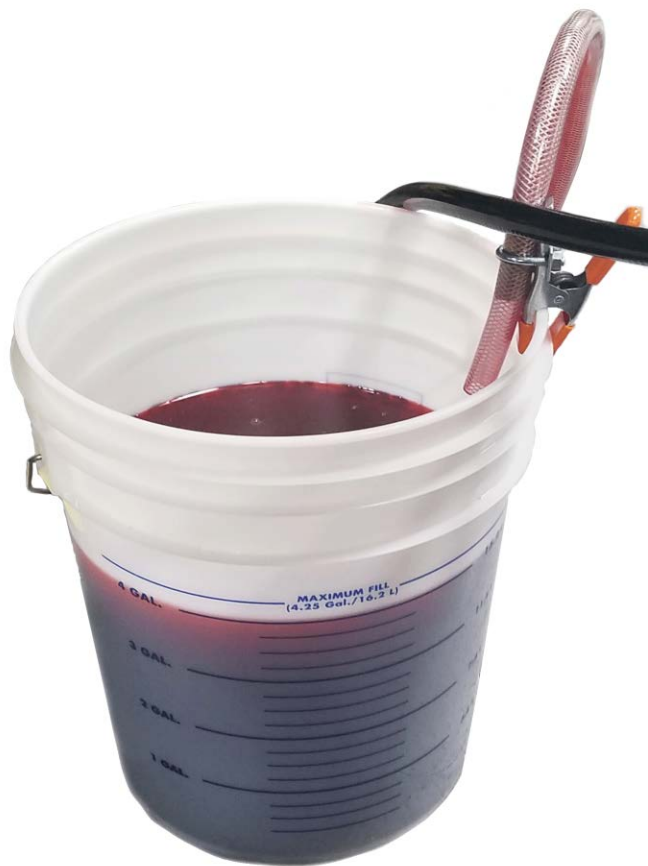
5181401

17.3. Add a maximum of 5 quarts of HP fluid to the transmission while allowing 5 additional quarts of oil to fill the DT-graduated bucket (Reducing fluid level in the TransFlow from 8 – 3).
