The customer reports the Digital Cockpit instrument cluster screen is blank or has no display and multiple warning lamps are illuminated in the instrument cluster.

Start-up initialization error in software of the Instrument Cluster Control Module **-J285-**.

90-19-01 - Digital Cockpit Instrument Cluster Blank Screen

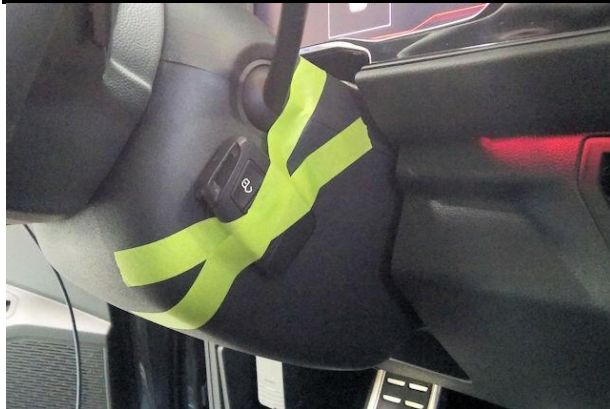
Figure 1.

1. The process of using the SD card to perform the update is controlled by the ODIS tester using Software Version Management (SVM).
2. Connect the ODIS tester to the vehicle and start Guided Fault Finding (GFF).
3. After the full vehicle scan, click on the “Special Functions” tab and select “Adapting Software”.
4. Hold the key against the immobilizer reader coil on the steering column continuously during this entire software update (Figure 1).

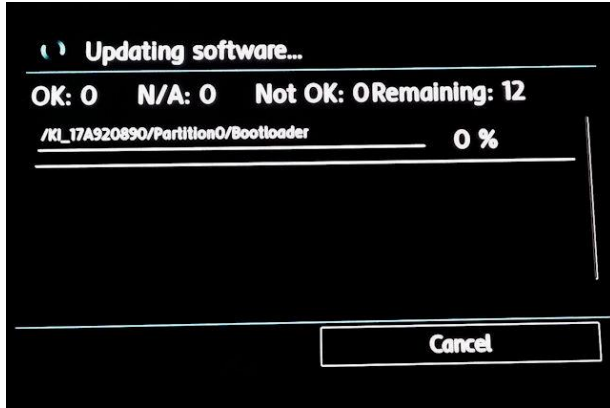
Figure 3.

8. The progress is also displayed on the infotainment system display (Figure 3).
