Freightliner Service Bulletin

On some Cascadia vehicles, when a request for wiper activation is made the wipers may not function. This can result from an overcurrent condition, which causes the wipers to stop functioning and immediately set fault code **SPN 522215 FMI 6**. Any additional change to the wiper request will result in the wipers operating normally.

## **SAM Cab Software Update**

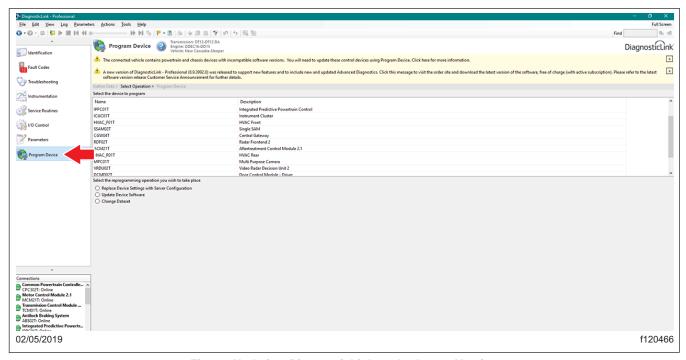
- 1. Park the vehicle, shut down the engine, and apply the parking brakes. Chock the tires.
- 2. Connect the vehicle to DiagnosticLink. Make sure that DiagnosticLink is updated to the latest version, 8.09sp2. To update DiagnosticLink, select "Update" from the dropdown menu under "Tools." See Fig. 1.

Fig. 1, Updating DiagnosticLink to the Latest Version

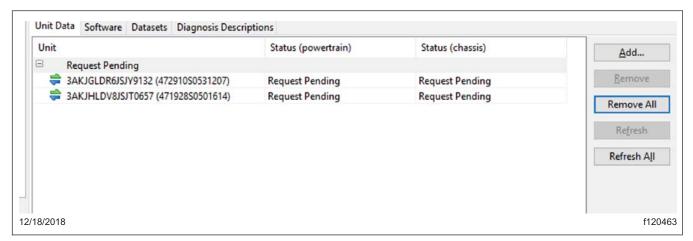
3. Select "Program Device." If there are any items in the section "Request Pending" downloads, they should be removed. To remove them, select the "Request Pending" list item, then press the "Remove" button. See Fig. 2.

Fig. 2, Removing Pending Requests

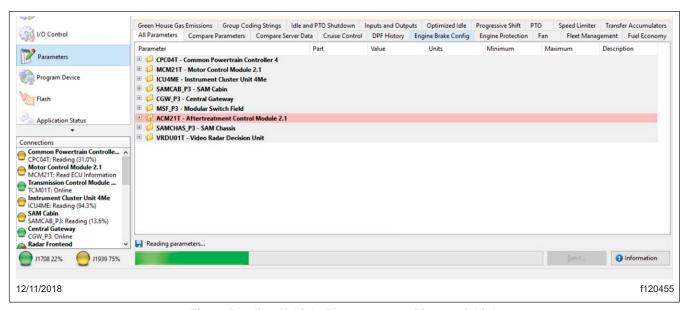
Once all controllers are connected, read the vehicle parameters. See Fig. 3.

Fig. 3, Reading Vehicle Parameters on DiagnosticLink

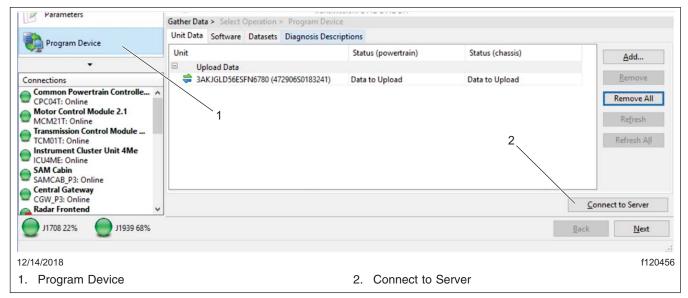
5. Select "Program Device." There should be data to upload. Click "Connect to Server" to upload vehicle parameters to the server. See Fig. 4.

Fig. 4, Uploading Vehicle Parameters

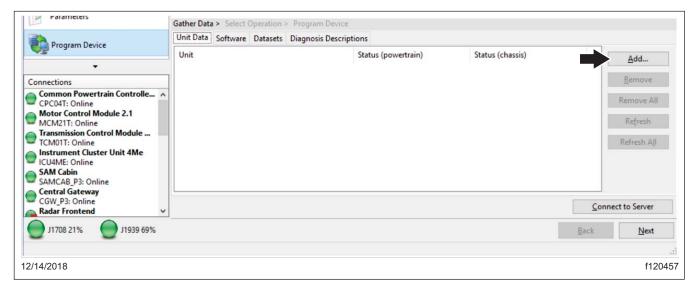
6. Click "Add" to add a download request for the vehicle. See Fig. 5.

Fig. 5, Adding the VIN to Download Updated Server Data

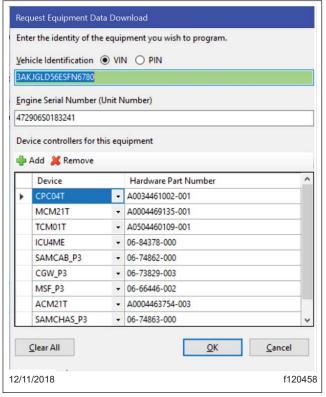
7. Make sure the correct VIN and hardware is populated, then click OK. See Fig. 6.

Fig. 6, Verifying Correct VIN Hardware

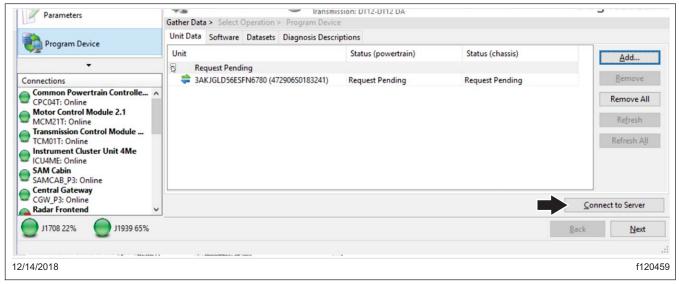
8. There should be a request pending status for the VIN. Click "connect to server" to download the updated unit data. See **Fig. 7**. The server will provide any new software available on the server as well as updated parameter sets for the new software, adjusted for the parameter set that was just uploaded from the vehicle.

Fig. 7, Downloading Updated Unit Data

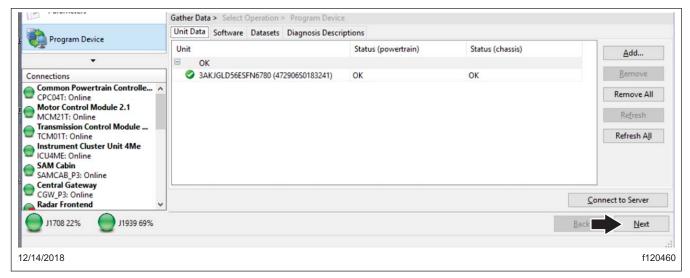
9. Once the data has been downloaded, click "Next". See Fig. 8.

Fig. 8, Clicking Next

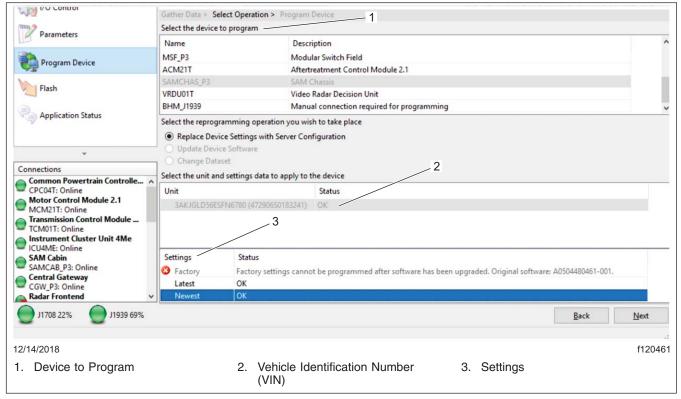
NOTE: "Latest" is the last service record (may be older software) and "Newest" is the most up to date software available for the installed hardware. Both will have parameter sets that have been updated relative to the upload from the vehicle.

10. Select the SAM Cab controller to program, select the VIN, and select "Newest." Click "Next." See Fig. 9.

Fig. 9, Selecting "Latest" or "Newest" Software

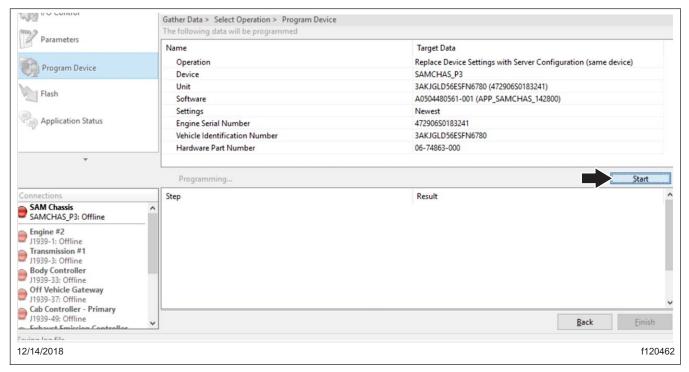
11. Review and verify the VIN and hardware part number. Click "Start" to program the controller. The software will be flashed and the new parameter set will be written to the controller on the vehicle. See Fig. 10.

Fig. 10, Programming the Controller

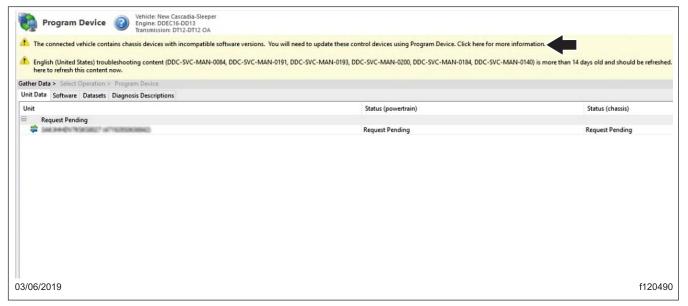
IMPORTANT: After programming is complete, the following message may appear in DiagnosticLink: "The connected vehicle contains powertrain and Chassis devices with incompatible software versions, you will need to update these control devices using Program Device. Click here for more information." If this message is shown, continue with the next step. Otherwise, go to step 15.

12. Click on the banner message. See Fig. 11.

Fig. 11, Clicking on the Banner Message

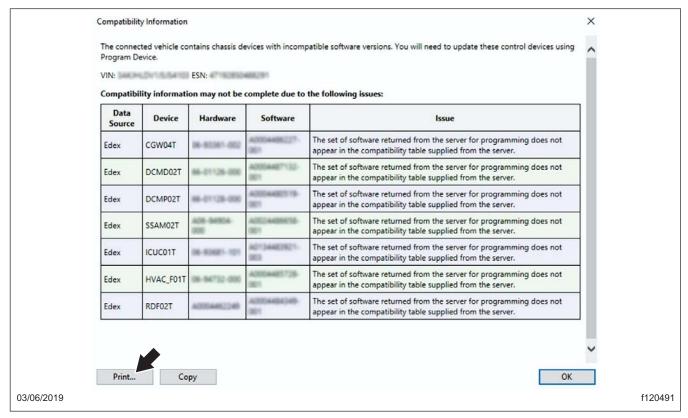
13. Print or take a screen shot of the incompatible ECUs. See Fig. 12.

Fig. 12, Printing the List of Incompatible ECUs

14. Program all devices listed as incompatible from the previous step.

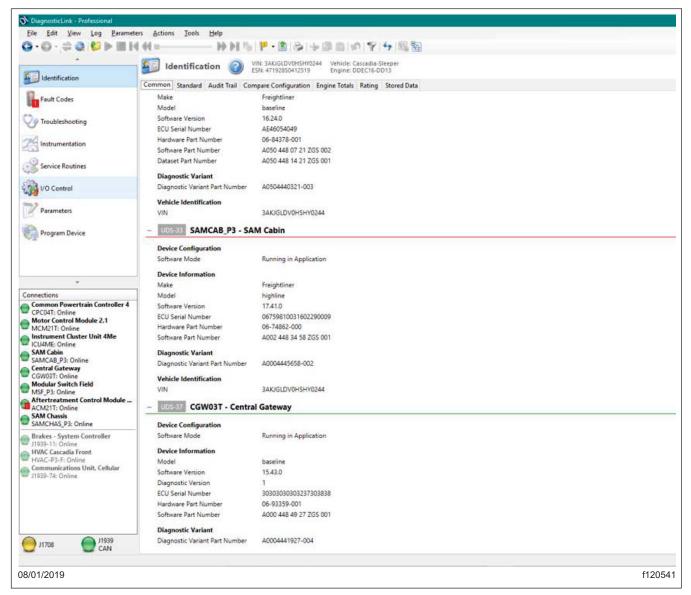
- 15. Cycle the ignition 3 times, waiting 30 seconds between key off and key on.
- 16. Turn the key to the ON position and connect the vehicle to DiagnosticLink.
- 17. Verify that Sam Cab SW is now R6.4 by clicking on the "Identification" page, locate "SAMCAB\_P3 Sam Cabin" and confirm that the Software Part Number is A002 448 34 58 ZGS 001, and that the Diagnostic Variant Part Number is A0004445658-002. See **Fig. 13**.

Fig. 13, SAM Cab Parameter
