Product Update: Display Audio Clock Off by 1 Hour

Year	Model	Trim	VIN Range
2019-20	RDX	ALL	Check the iN VIN status for eligibility.

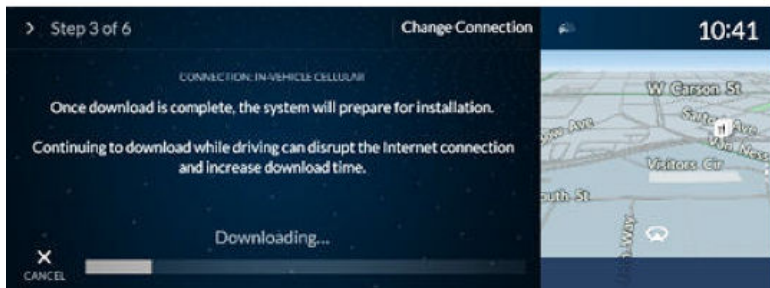
3. Once you've confirmed the vehicle is connected to AHMOTA, return to the home screen. From there, select **System Updates**, then **via Wireless Connection**.

- If the vehicle downloaded the new software, go to step 4.
- If the vehicle did not download the new software, go to step 5 to confirm current software.

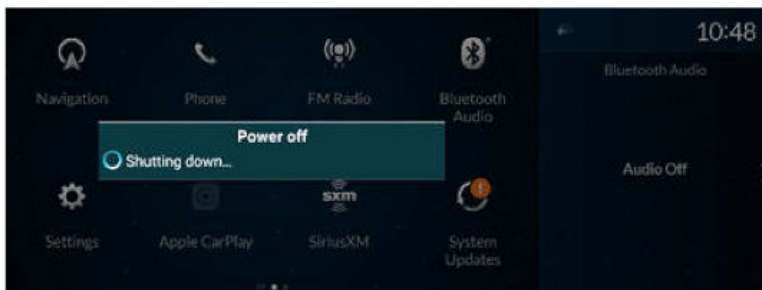
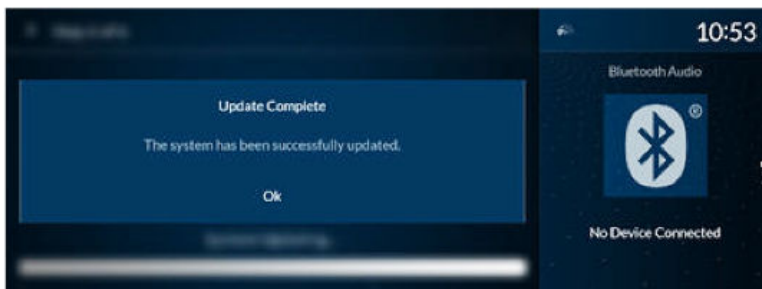
4. Once the software has been downloaded, select **Install Now**.
