# Field campaign

| Topic | Mulsanne - Infotainment unit software update (SC19/13) |
| Campaign number | EB27 |

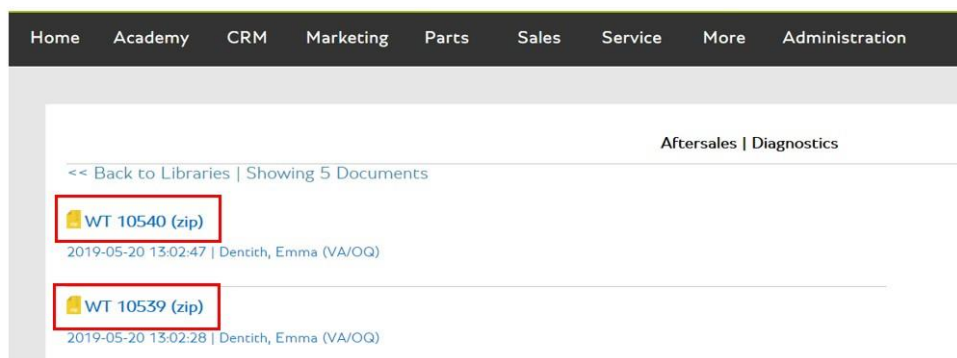
1. Locate the correct file for the build region of the vehicle on Bentley Hub in the 'Aftersales - Diagnostics' section. The file will be labelled as the part number referred to in the [Genuine Parts](#) section of this document.

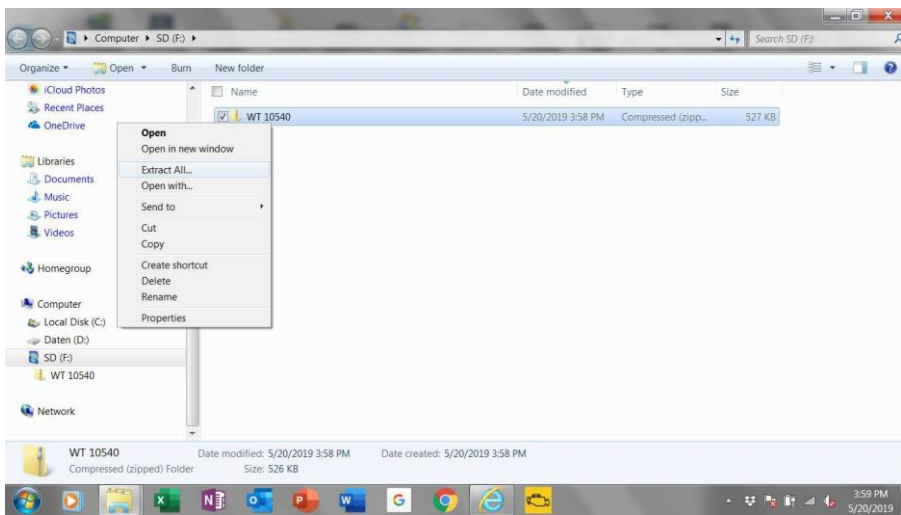
3. Rightclick on the zip file and select 'extract', select your SD card as the location for saving the files.

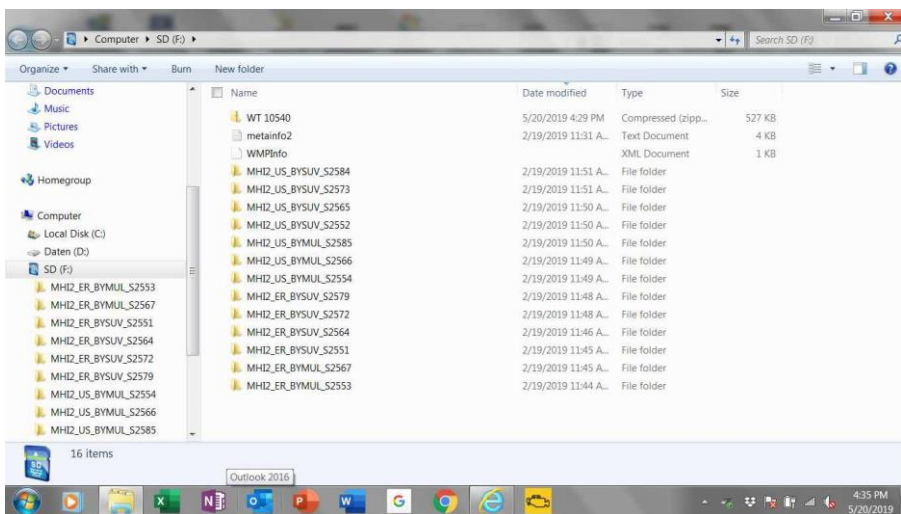
4. All software files will now be visible as below.

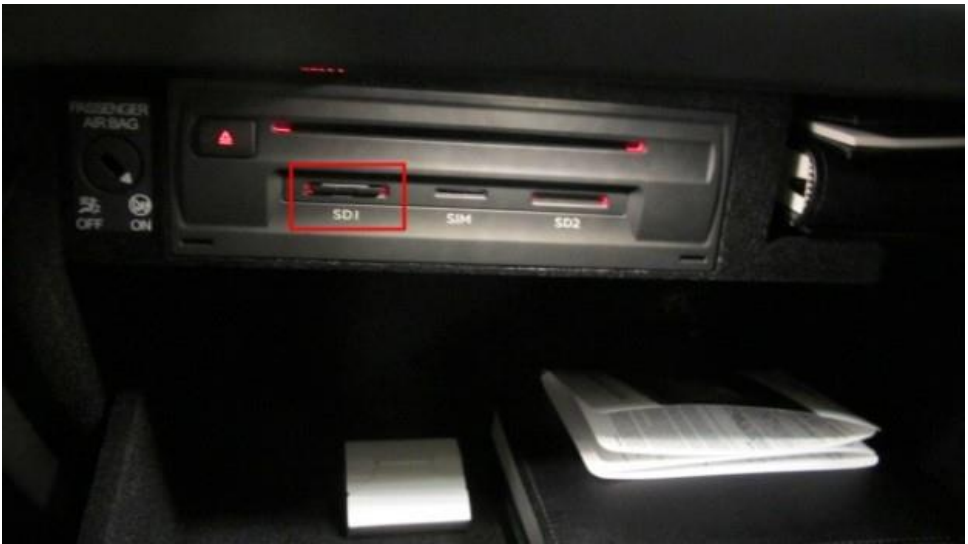
Figure 1

1. Fit the SD card in SD1 slot of the MIB, located in the glove box (see Figure 1).

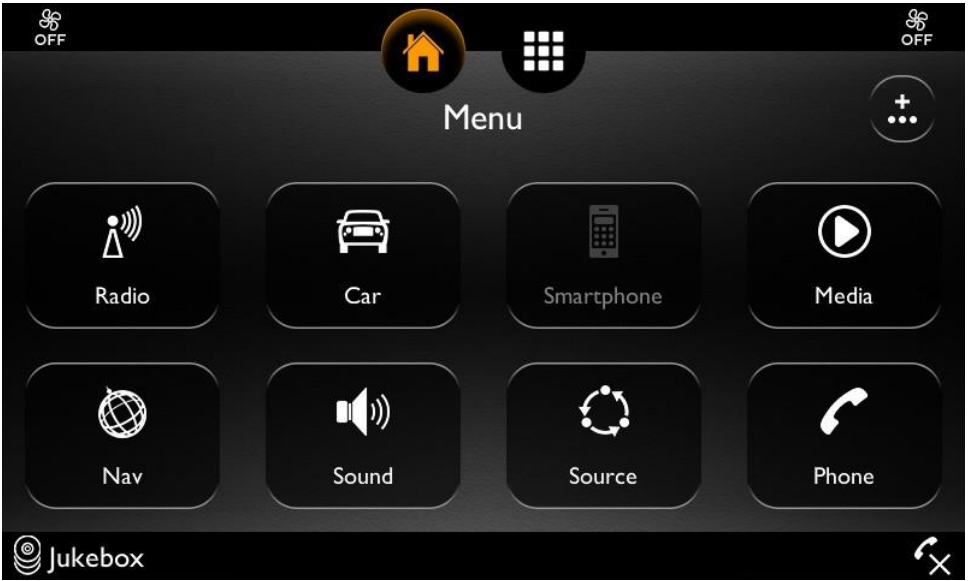
Figure 2

2. Navigate to the main menu screen (Figure 2) by pressing the home button.

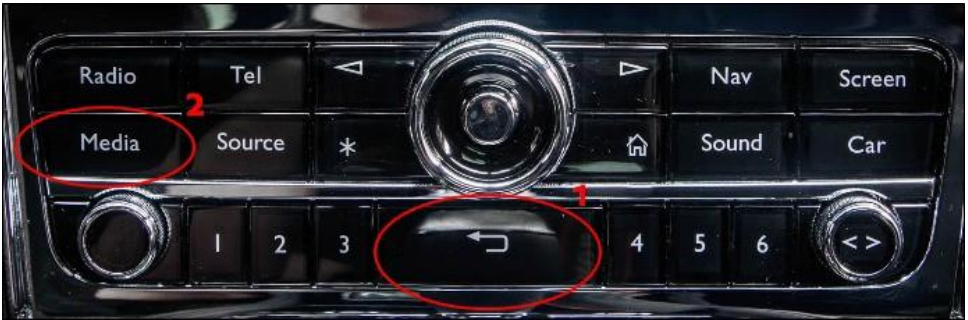
Figure 3

3. Press and hold the Return button (1) first and then immediately press and hold the MEDIA button (2) on the infotainment unit (Figure 3), keep both buttons pressed until the *Developer menu (SWDL)* screen is displayed (Figure 4).

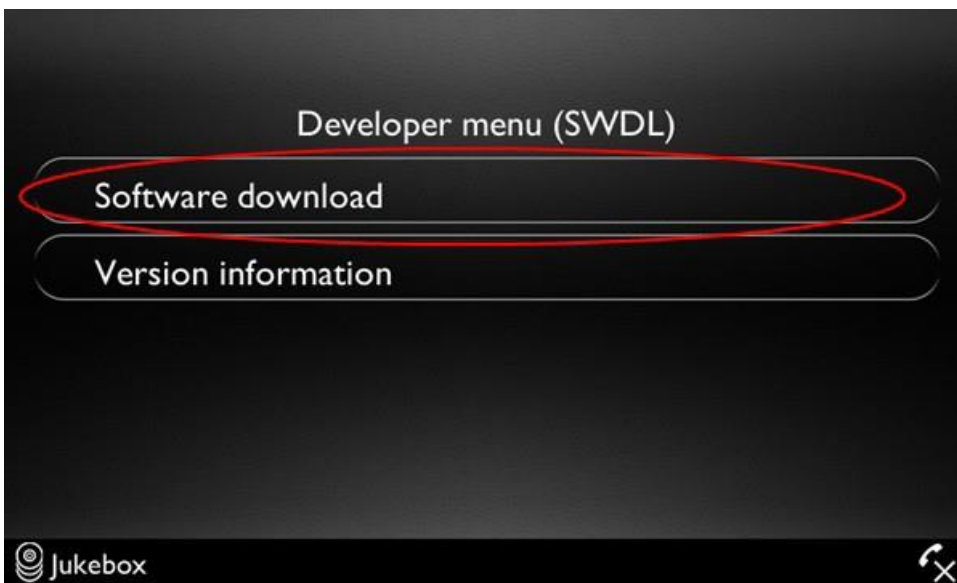
Figure 5

4. Select the Software download option (Figure 5).

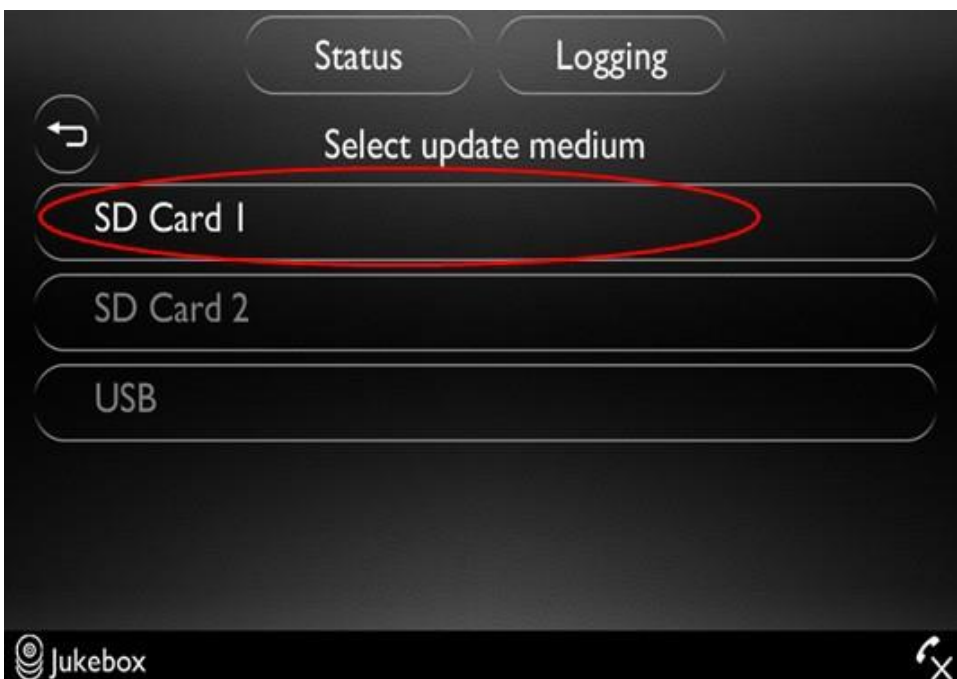
Figure 6

5. Select SD Card 1 (Figure 6), the next screen will display the reading of the SD card data (Figure 7).

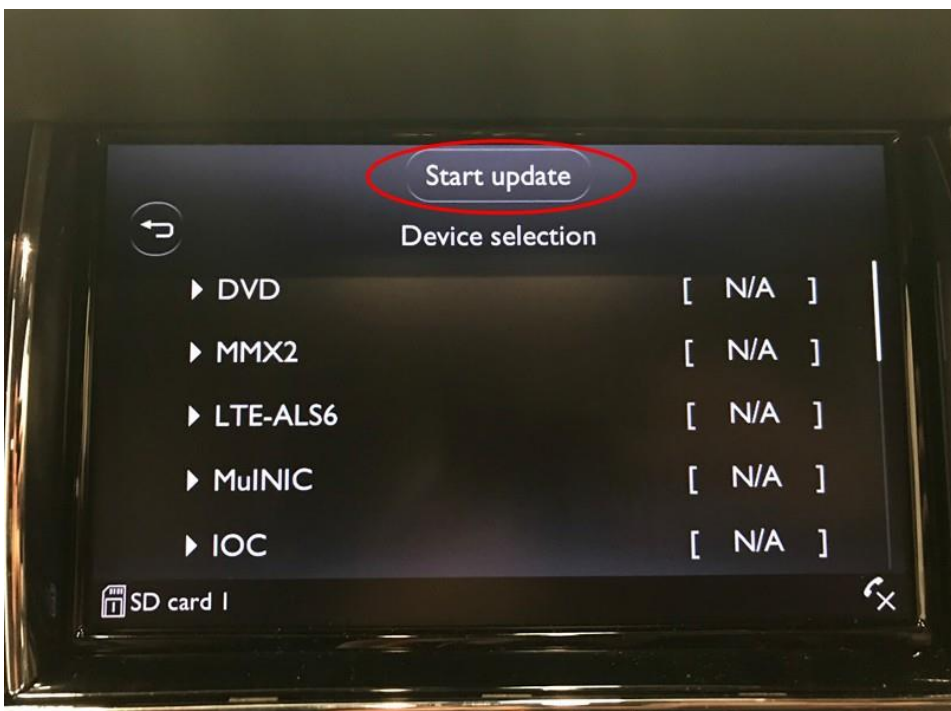
Figure 8

7. Select Start update (Figure 8).

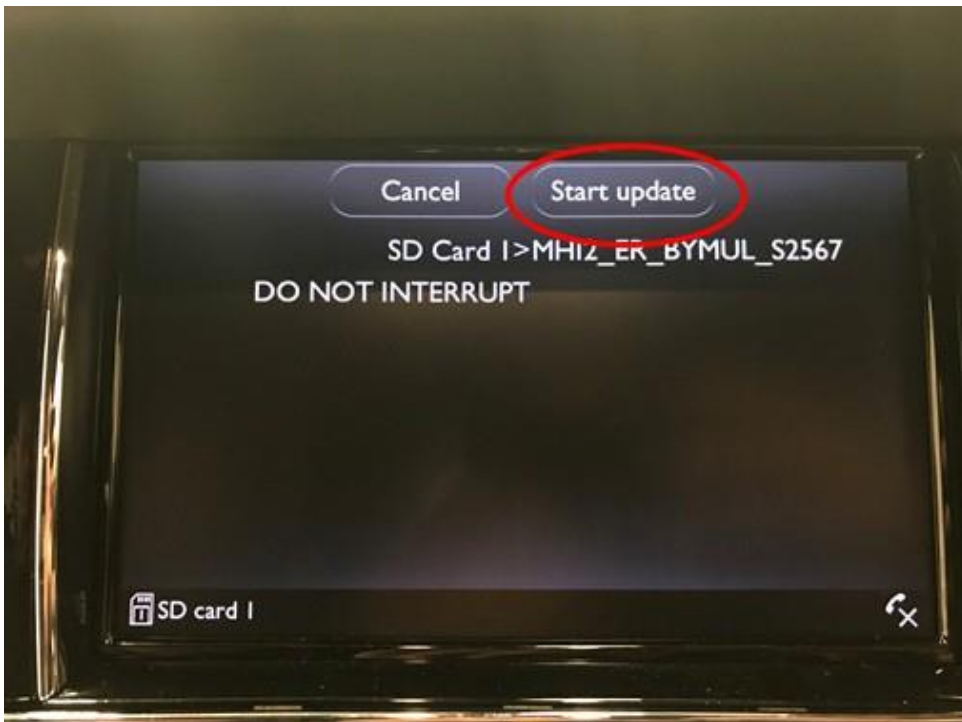
Figure 9

8. Select Start update again on the following screen (Figure 9).

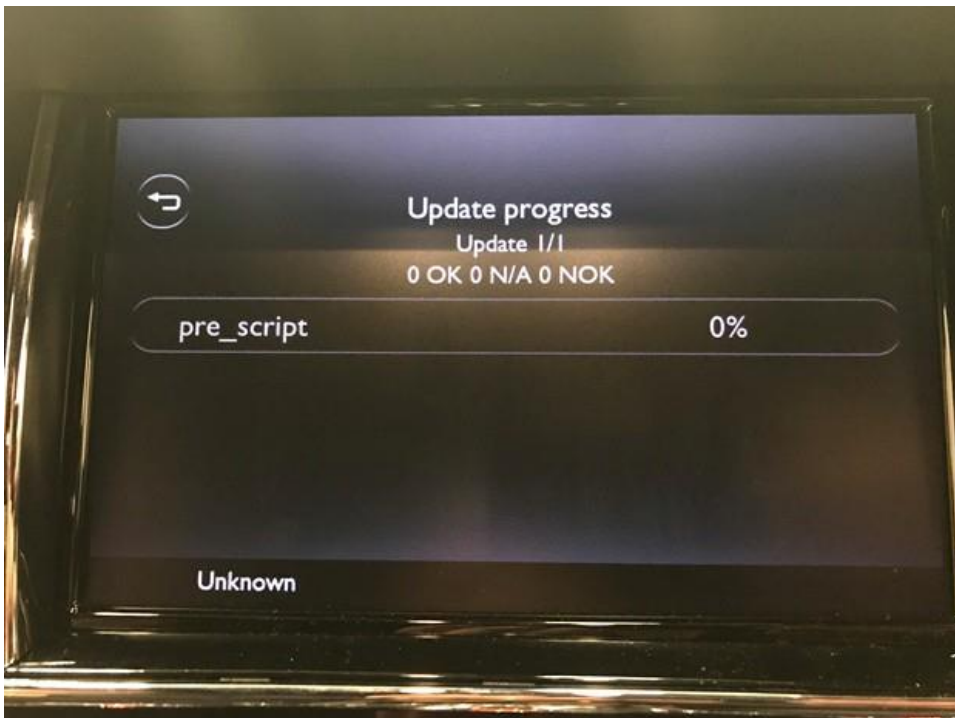
Figure 10

9. The update will now take place, the screen may go blank for short periods, various data will be displayed (Figure 10).

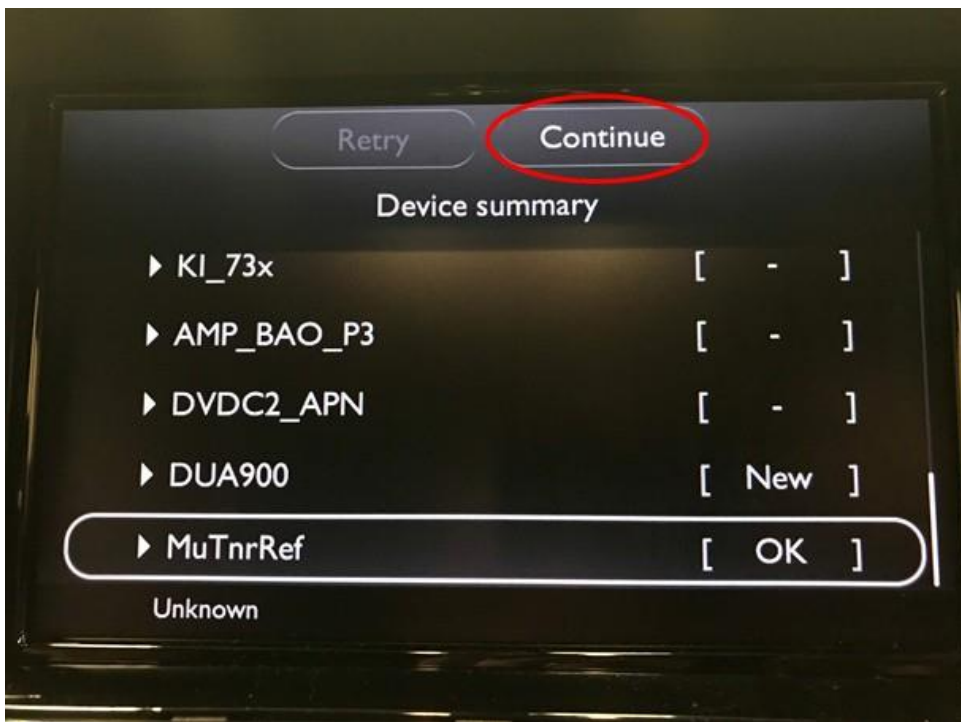
Figure 11

10. When the components have been updated, the *Device summary* screen is shown. All updated components should be marked [OK] or [-] (Figure 11)

- If any components are marked [NOK] press Try again (A)
- If all components are marked [OK] or [-], then press Continue (B)

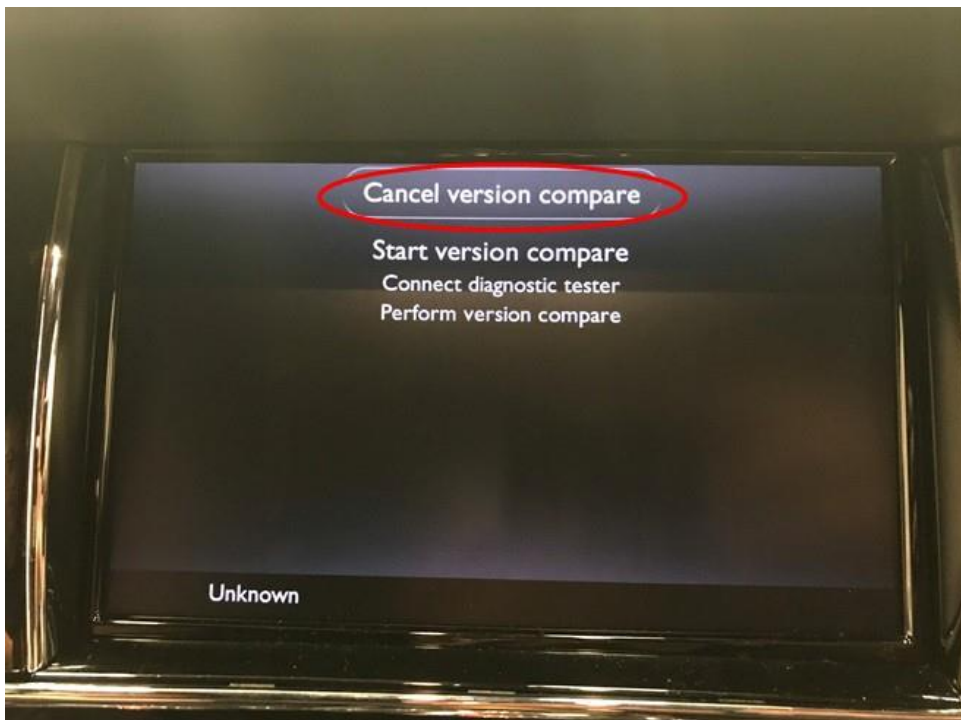
Figure 12

11. On the following screen press Cancel version compare (see Figure 12) the system will reboot.

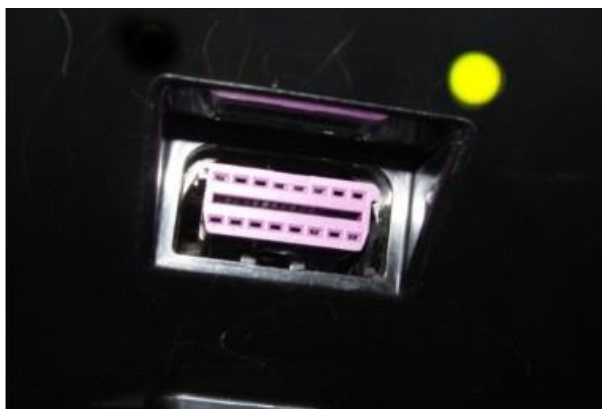
On completion apply a YELLOW campaign identification mark next to the OBD port.

If the vehicle is not already listed as repaired in the 'Repair history' section of ElsaPro, check for the presence of the campaign identification mark as shown in the 'Identification' section of this document. In the event that the campaign has not been applied, please carry out the required work in accordance with these instructions.
