## SERVICE BULLETIN

**APPLICABILITY:** 2017-18MY Impreza  
2018MY Crosstrek

**NUMBER:** 15-245-19R

**SUBJECT:** FOTA (Firmware Over-The-Air) Reprogramming Procedure to Optimize Harman Gen 3 Audio / Navigation Units

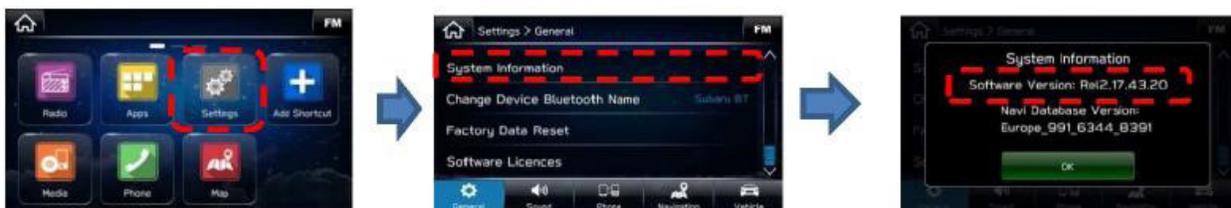
- 1-1) Turn the engine ON. When the H/U powers on, press "I Agree".  
Once audio start-up completes, press the HOME button and select "Settings".
- 1-2) From the General screen, select "System Information" to check current software version.  
(The pictures below are for illustration only and do not show the latest software version information.)

- If the current software version is **Rel\_A1.19.12.20** or **Rel\_A1.19.17.20** STOP as the head unit has the latest version installed and no further action is needed.

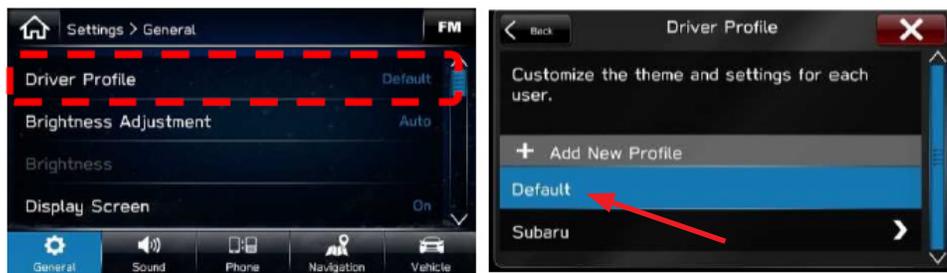
2-1-1) Confirm the driver profile (example shows “Default” as driver profile).

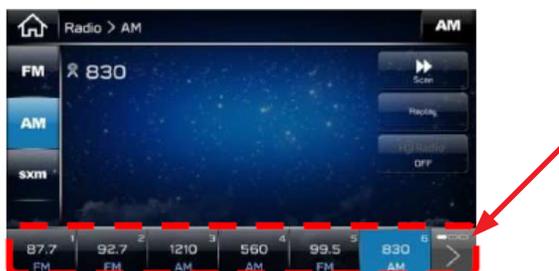
2-1-3) Record the saved preset stations (SXM, AM, and FM) (example shows #1: FM87.7 #2: FM92.7...).

**NOTE:** Make sure to check the next screen by scrolling (pressing the right arrow > button).

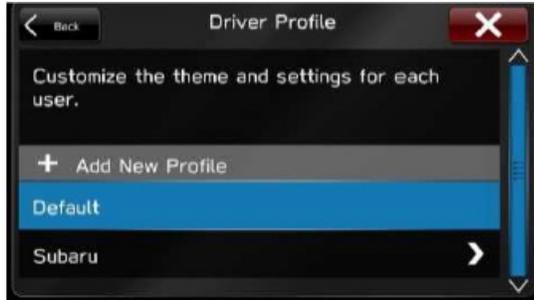
- 2-1-4) Change to next driver profile and repeat the actions above as necessary. (Example photo below shows other driver profiles. Be sure to note all the preset stations for each driver profile.)

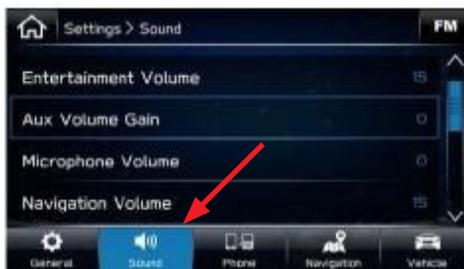
2-2-1) From the Settings > Sound screen, press the “Sound” button.

2-1-2) Record each volume setting for: Entertainment Volume, AUX Volume Gain, Microphone Volume, and Navigation Volume.

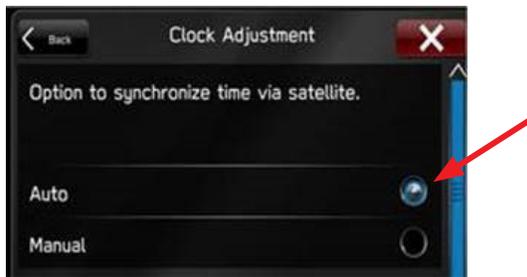
**NOTE:** The H/U clock **must** be set correctly in order to check for any available FOTA updates. Always confirm the Clock Adjustment mode is set to Auto.

1.1.1) Check current vehicle position on the map screen. If position is correct, the Navi will receive clock information correctly. Proceed to Step 1.3.5. If position is not correct, please go to Step 1.3.1.b.

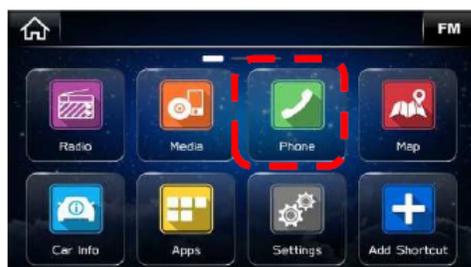
1.2.1) Select Phone on Home screen.

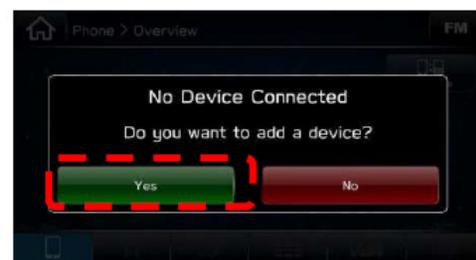
1.2.2) Select Yes on “No Device Connected” pop-up.

**NOTE:** If H/U display does not show the pop-up, please select “Add device” from the Phone Overview.

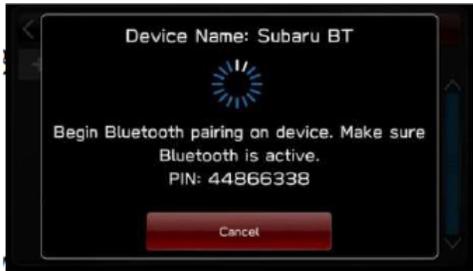
1.2.3) While the H/U displays the “waiting” screen shown below, operate the smartphone screens and select “Subaru BT” from the discoverable device list.

\*If the device name is changed on setting screen (Settings > General > Change Device Bluetooth Name), please select the proper device name.

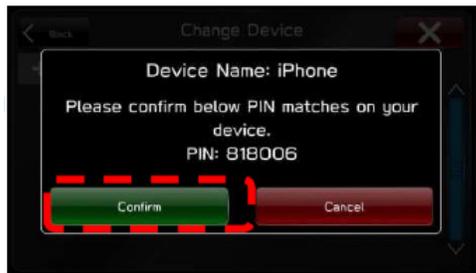
1.2.4) Confirm the same PIN code is shown on the smartphone then select “Confirm”.

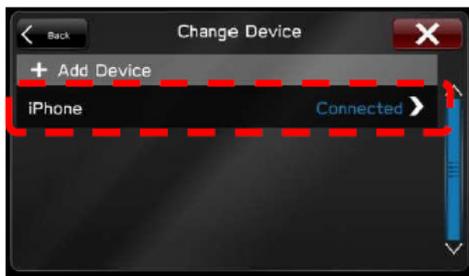
1.3.1) On the “Change Device” screen, identify the most recently paired device (iPhone is shown here).

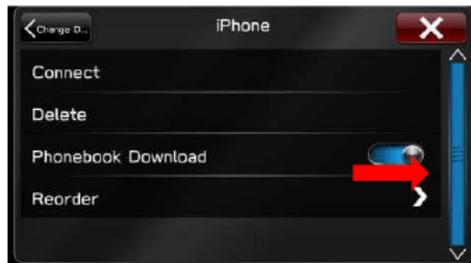
1.3.3) Turn “Phonebook Download” on.

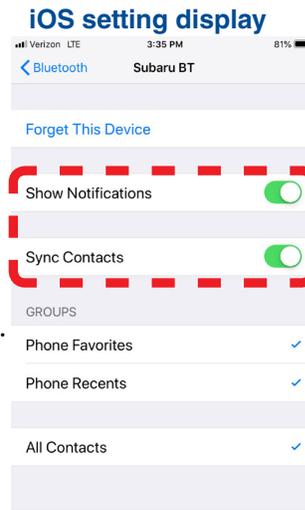
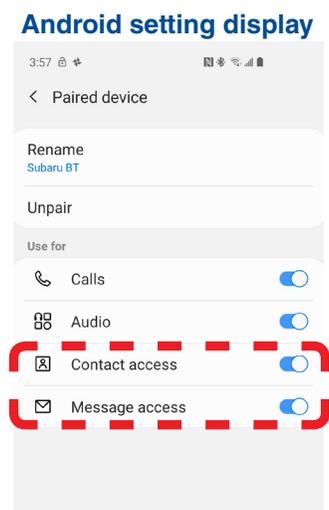
1.3.5) Check Bluetooth setting of “Subaru BT” on the smartphone. Confirm “Sync Contacts” and “Show Notifications” are both set to ON.

**NOTE:** Depending on the model (e.g. iOS or Android), these settings may need to be changed. Refer to the specific smartphone’s User Manual for more detailed information / instructions.

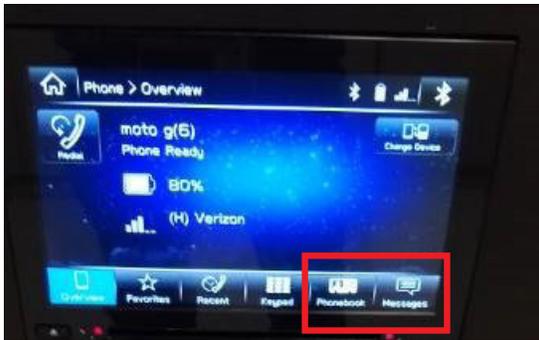
1.3.7) Confirm both the Phonebook and Messages buttons on the display are highlighted (activated) as shown below.

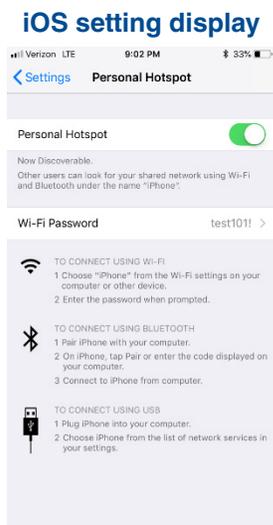
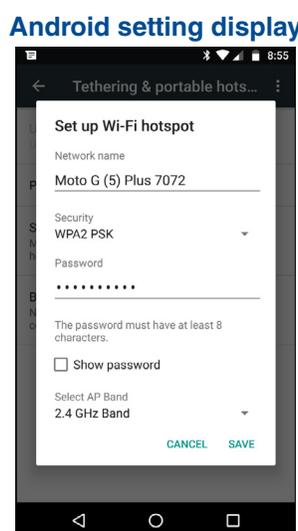
1.4.1) Prepare a Wi-Fi router device:

**NOTE:** Depending on the model (e.g. iOS or Android), these settings may need to be changed. Refer to the specific smartphone’s User Manual for more detailed information / instructions.

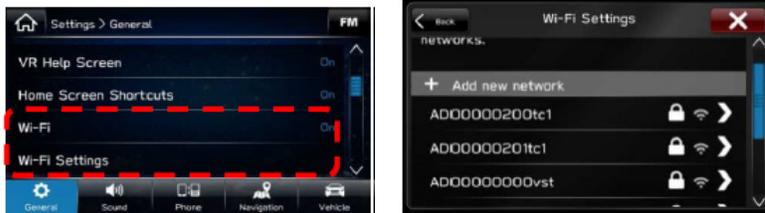
1.4.4) Select the desired Wi-Fi device from the “Wi-Fi Settings” list.

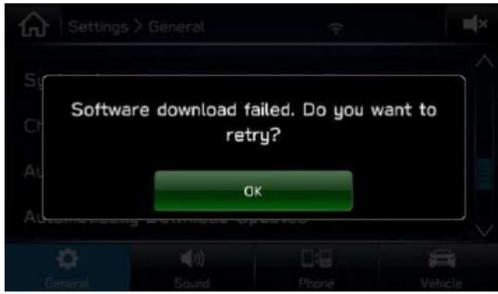
1.5.6) If the H/U display shows “Software download failed. Do you want to retry?”, there is possibility the H/U is not receiving the clock information correctly.

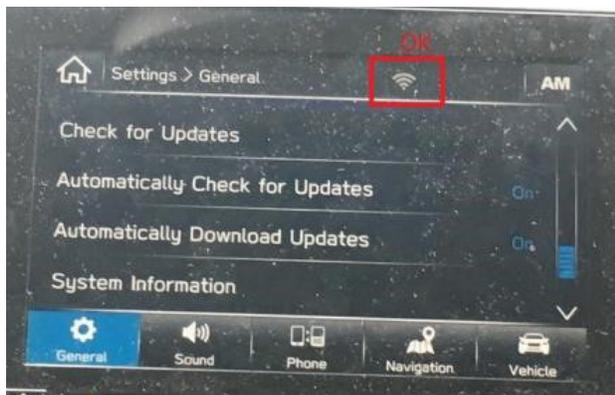
**NOTE:** Initially, it may appear that no action is occurring.

**THIS IS NORMAL.** Wait at least 2 minutes for progress percentage to appear in the upper right of the H/U screen before attempting to restart the process.

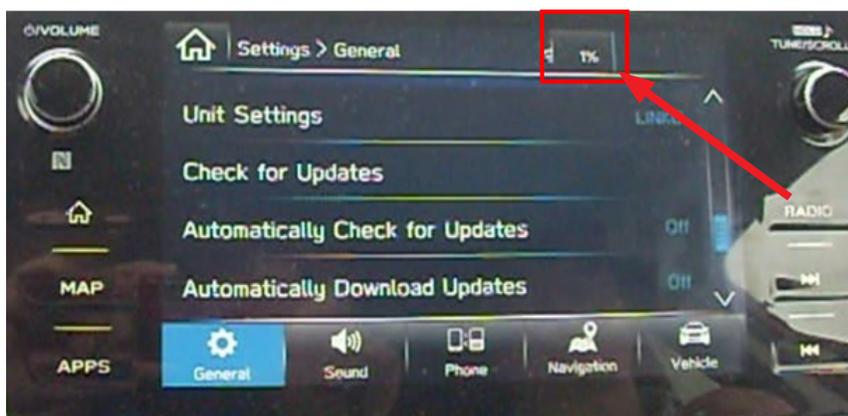
1.6.1) Wait until the download progress reaches 100%. During the software download, the H/U is fully functional. **NOTE:** It is normal for the progress to hang at some points for 1-2 minutes. This does not indicate a concern. **BE PATIENT.**

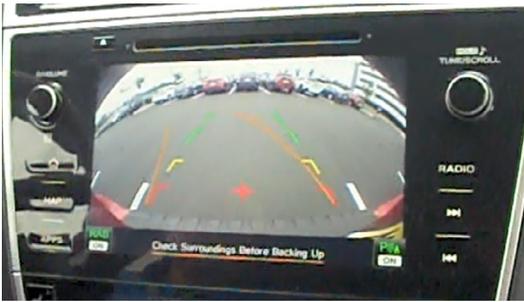
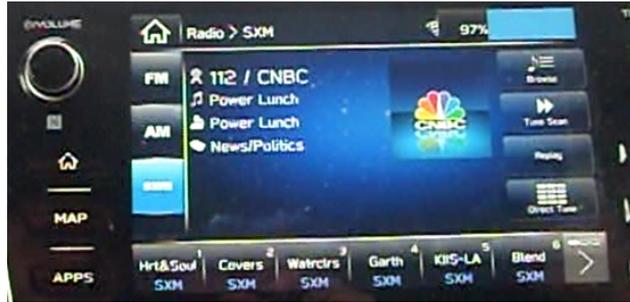
**NOTE:** When downloading via Wi-Fi, it may take anywhere from 5 to 20 minutes for the update to complete depending on the provider transfer rate signal strength.

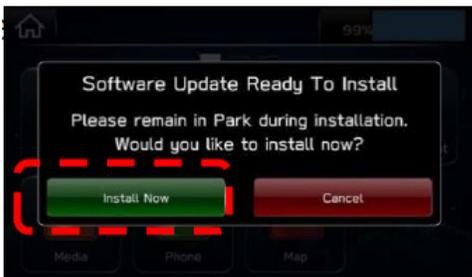
1.6.2) The image below shows the pop-up window which will appear once the download completes and the update is ready to install.

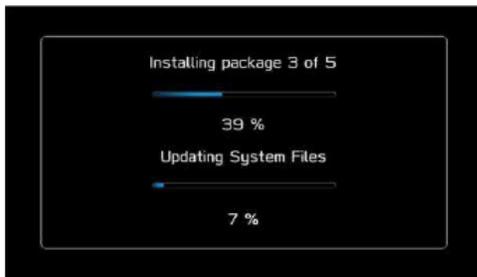
1.6.4) **Stay with the vehicle** until the install has completed.

**NOTE:** It will take approximately 10 minutes to complete the update installation.

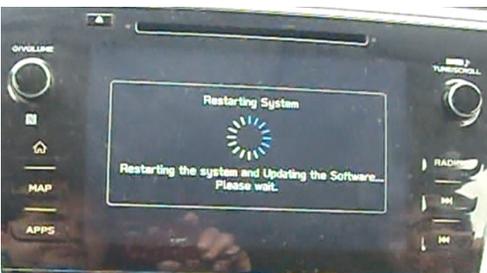
1.6.5) The H/U will automatically shut down and restart after the installation completes.

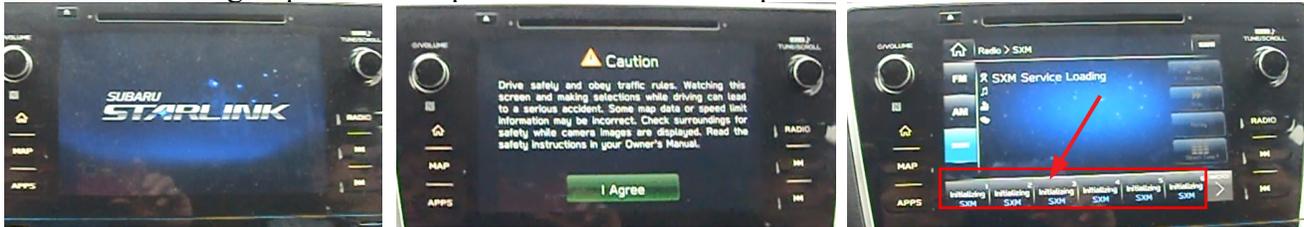
**NOTE:** The volume will go to default level suddenly even if the volume was previously turned down during or prior to the update. This is normal operation.

**NOTE:** Station presets will display as “Initializing” until the data is fully loaded for SXM stations. In case of FM and AM presets, the text will change from “Initializing” to “Hold”. To reset each preset, tune to the desired station then press and hold the corresponding preset button until the “beep” is heard to signal the reset was successful.

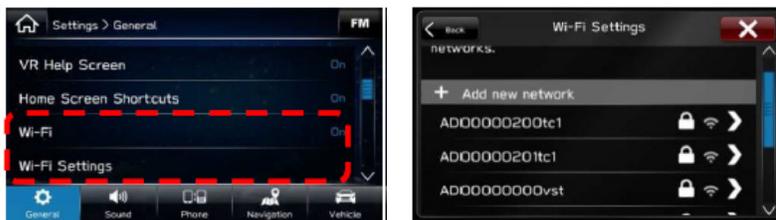
2.5) Select the desired Wi-Fi device from the “Wi-Fi Settings” list.

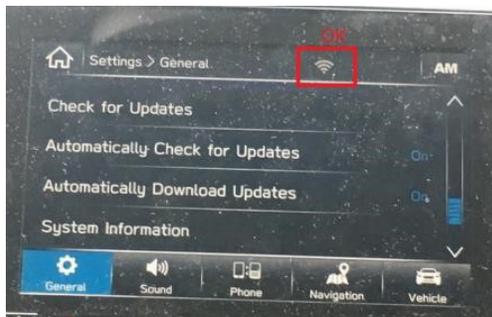
2.6) Select “Connect” and input the password of the Wi-Fi device to be used. When a connection is established, the screen will display a Wi-Fi icon on top bar.
