## PRODUCT IMPROVEMENT CAMPAIGN

SUBJECT: **KNOCK SENSOR DETECTION SYSTEM - ECU  
LOGIC IMPROVEMENT (PI1802)**

This bulletin provides information related to a software update to the Engine Control Unit (ECU) to install the Knock Sensor Detection System (KSDS) in order to protect the engine from excessive connecting rod bearing damage. This update is for:

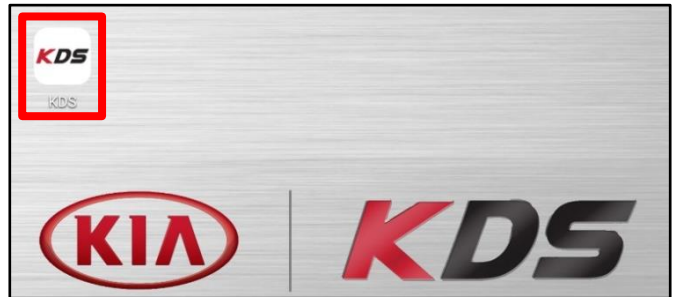
2. With the ignition ON, turn ON the KDS tablet. Select **KDS** from the home screen.

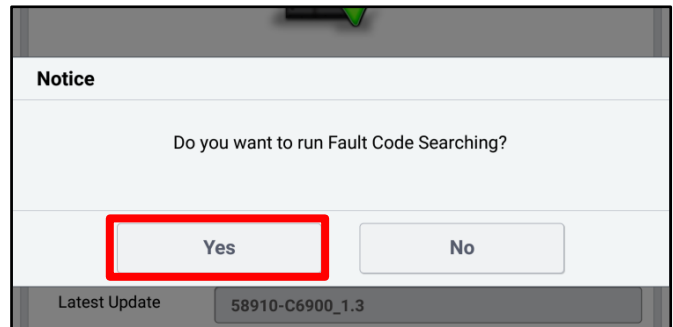
- When prompted, select **YES** to check for Diagnostic Trouble Codes (DTC) and erase any DTCs stored such as EPS, ESC, and TPMS that may have been set during the upgrade.
