GROUP FUE	MODEL 2019-2020MY Sedona (YP)
	NUMBER 042	DATE September 2019
TECHNICAL SERVICE BULLETIN		
SUBJECT: SERVICE ACTION: 3.3 GDI ULEV ECU MIL WITH DTC P0456 LOGIC IMPROVEMENT (SA397)

This bulletin provides the procedure to improve the logic of the Engine Control Module (ECM) on some 2019-2020MY Sedona (YP) 3.3 GDI 8AT ULEV vehicles, produced from February 13, 2018 through August 27, 2019, which may exhibit an ECM MIL ON with DTC P0456. To correct this concern, apply the improved logic to the ECM using the KDS ECU Upgrade function as described in this bulletin. For confirmation that the latest reflash has been applied to a vehicle you are working on, verify the ROM ID using the table on page 2 of this bulletin. Before conducting the procedure, verify that the vehicle is included in the list of affected VINs.

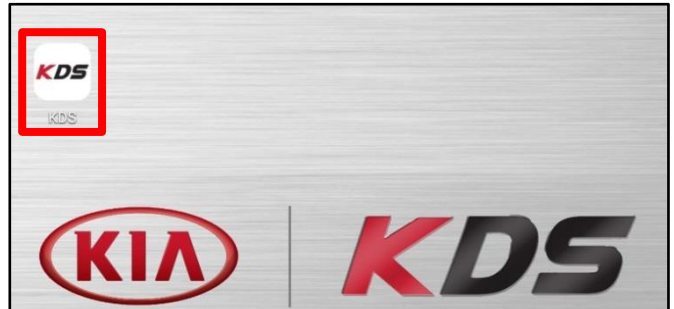
2. With the ignition ON, turn ON the KDS tablet. Select **KDS** from the home screen.

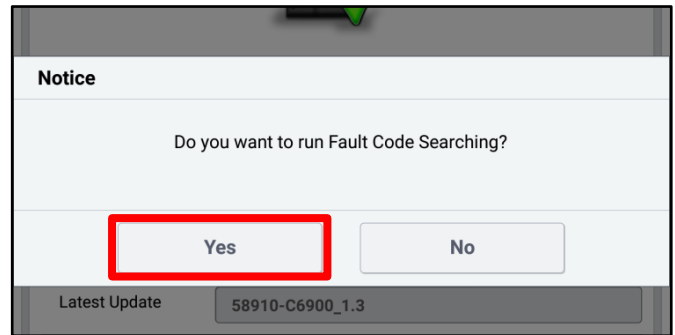
- 12. When prompted, select **YES** to check for Diagnostic Trouble Codes (DTC) and erase any DTCs stored such as EPS, ESC, and TPMS that may have been set during the upgrade.
