# Technical product information

<b>Topic</b>	DTC C1260F0 - Compressor electronics for suspension levelling - Warning light within (DIP)
<b>Market area</b>	Bentley: worldwide (2WBE),Hongkong-Macau (5HK)
<b>Brand</b>	Bentley
<b>Transaction No.</b>	2055689/1
<b>Level</b>	EH
<b>Status</b>	Approval
<b>Release date</b>

DTC C1260F0 - Compressor electronics for suspension levelling evident within address 74

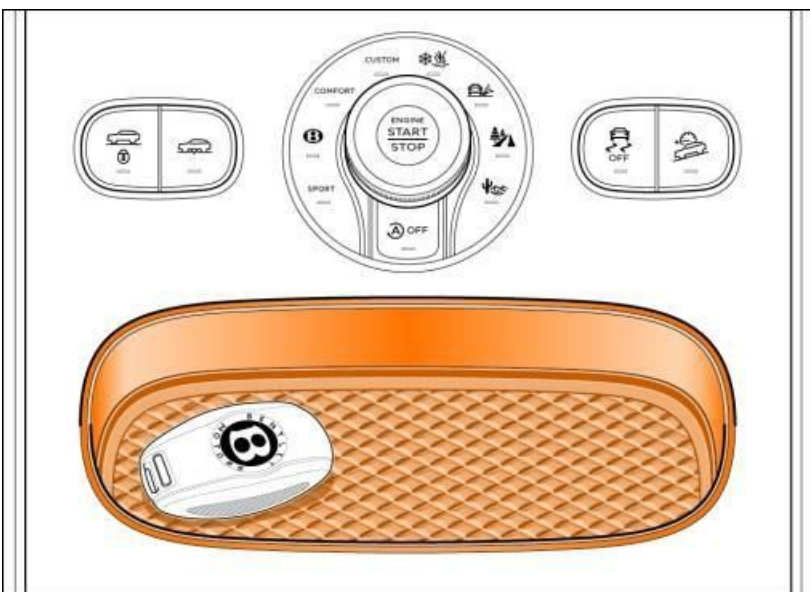
Figure 1

1. Ensure a suitable battery charger is correctly connected to the vehicle electrical system for the duration of this procedure
2. Ensure the ignition key is located in the remote control key reader and switch on the ignition (Figure 1)

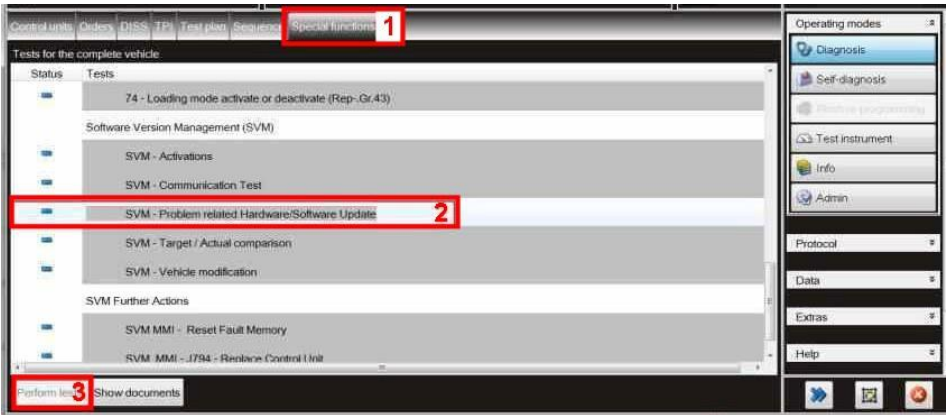
- Referring to Figure 2 - Select Special functions (1), Select SVM – Problem related Hardware/Software Update (2), Select Perform test (3)

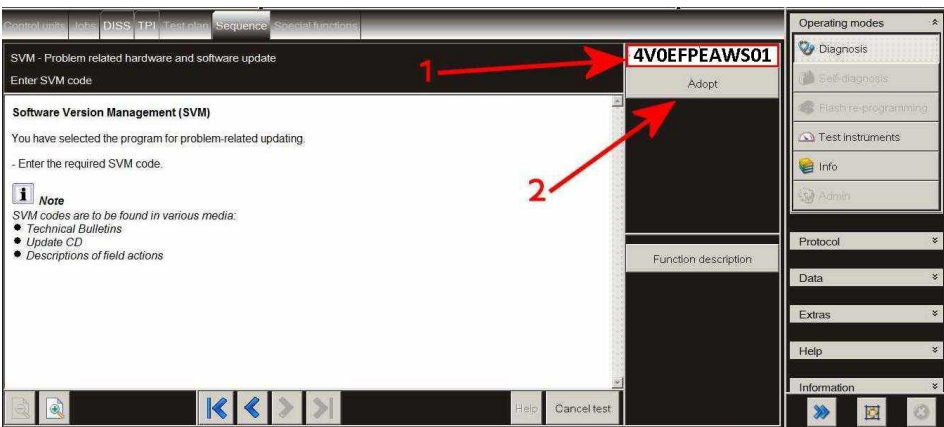
- Referring to Figure 3 – At the SVM screen (1) enter the specific SVM code 4V0EFPEAWS01 and then select Adopt (2)

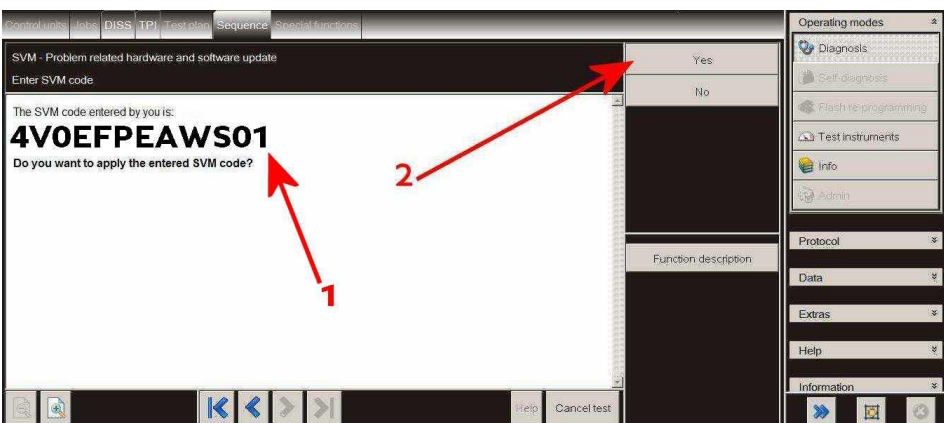
Figure 4

- Referring to Figure 4, Check you have entered the correct SVM code (1) and select Yes (2) and follow all on screen prompts

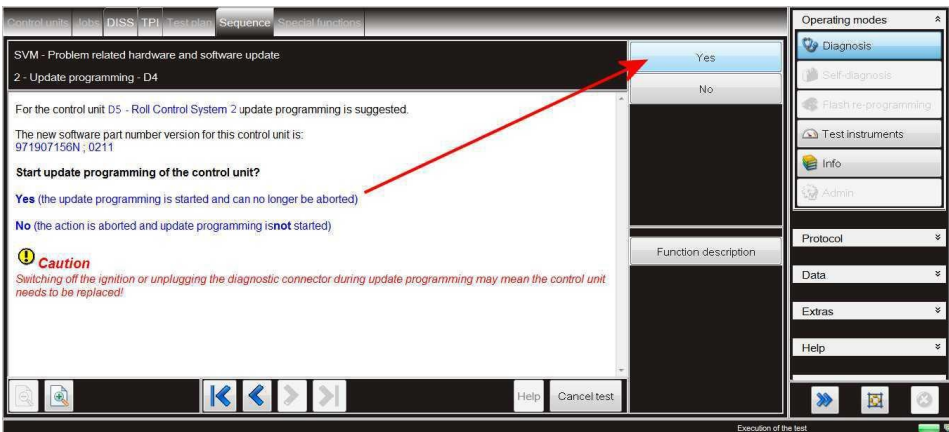
Figure 6

10. Once 74 - Chassis Control has been updated you will automatically be requested to update D5 – Roll Control System 2 (Figure 6) - Follow all instructions to update – D5 Roll Control System 2

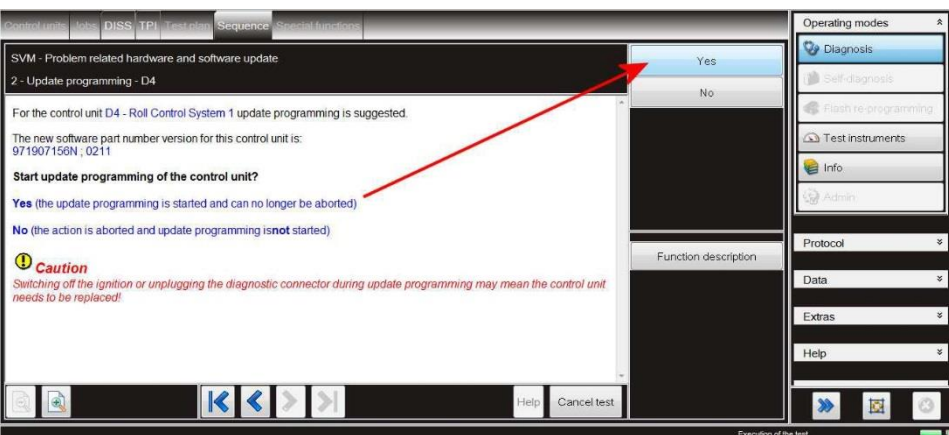
Figure 7

11. Once the update to D5 Roll Control System 2 is complete, follow all remaining screen prompts to update D4 – Roll Control System 1 (Figure 7)

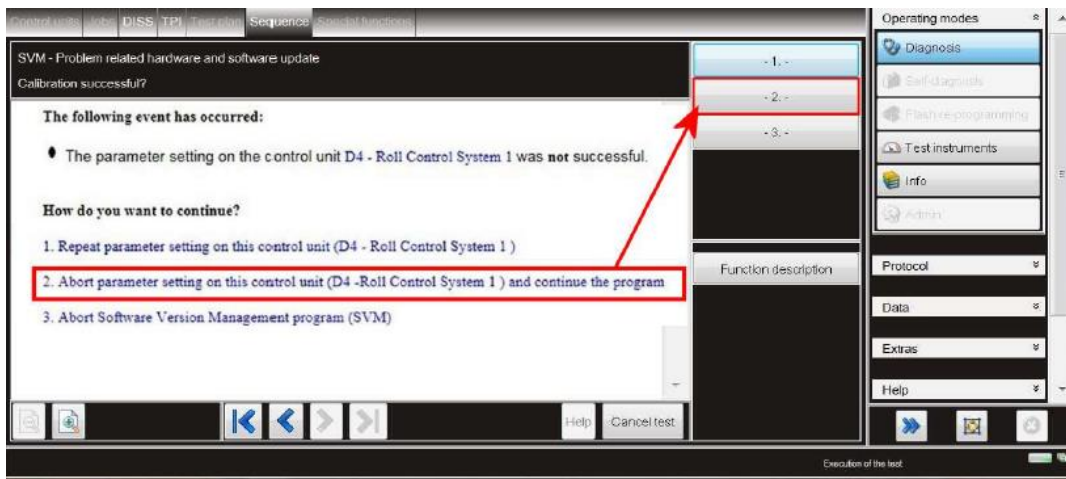
Figure 8

IMPORTANT: In the event the screen is evident as shown in Figure 8, select -2- and follow all on screen prompts, the parameter settings for D4 will be automatically conducted
